TIMBER FRAMING

JOURNAL OF THE TIMBER FRAMERS GUILD

Number 105, September 2012

Covered Bridge Truss Engineering

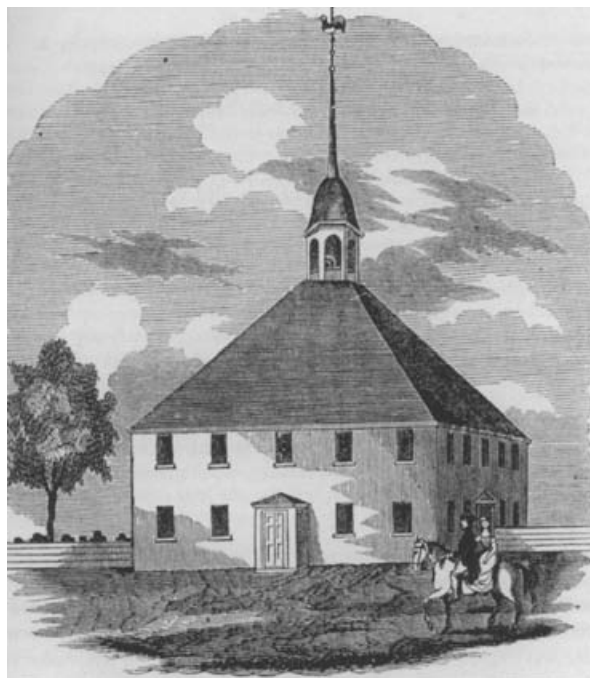
Old-Town Meeting-House, Newbury, Massachusetts. Reproduced by Benes from Joshua Coffin, *A Sketch of the History of Newbury, Newburyport and West Newbury* (1845).

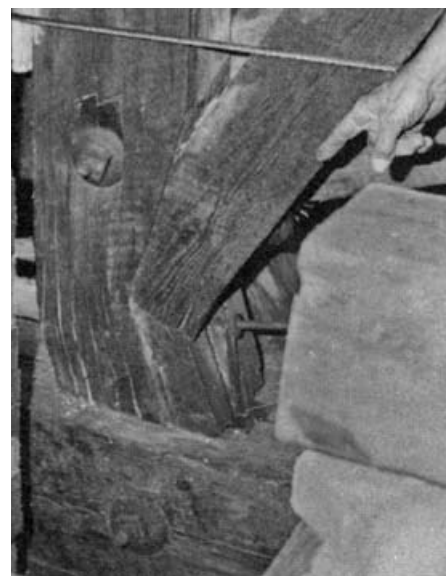
Truss overload amplified strut force to destroy this post bottom in the 1866 Bedell Bridge at Newbury, Vt.

The vertical component pushes up or down on the post, loading it axially, but the horizontal one pushes sideways against the post. When the strut bears on the post at a spot remote from the panel point, the strut's horizontal force then imparts both bending and shear stress to the post because of the vertical separation between the strut-to-post and post-to-chord intersections. Over the long haul, these products of eccentricity can have serious consequences and strut side thrust can actually fracture or crush the end of a post (photo).

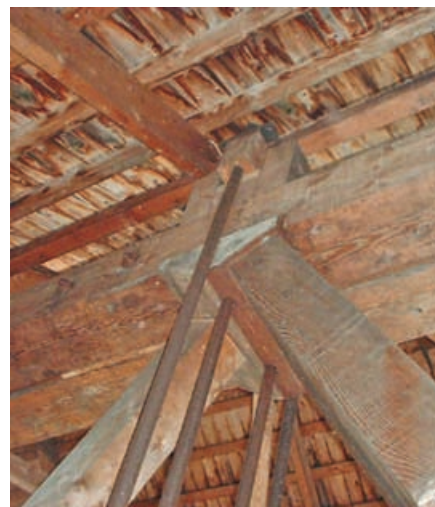
White oak bearing block housed in Howe truss top chord, Packard Hill Bridge, Lebanon, N.H. (1991). Tension rods flanked by counterbrace rising from left, double struts from right. Captive steel shoe on strut side of block.

In the Howe load diagram, since the struts and counterbraces simply lodge against the bearing blocks, neither member can carry tension load, thus the counterbraces are dormant in the uniform load case, and called into action only by asymmetric local live loads. In the second load diagram, uniform live load has been decreased in favor of a significant point load representing a truck with its loaded axle directly over the first post to the right of the bridge centerline. The strut in the panel just to the right of center is now unloaded and the counterbrace in that panel has gone into compression.

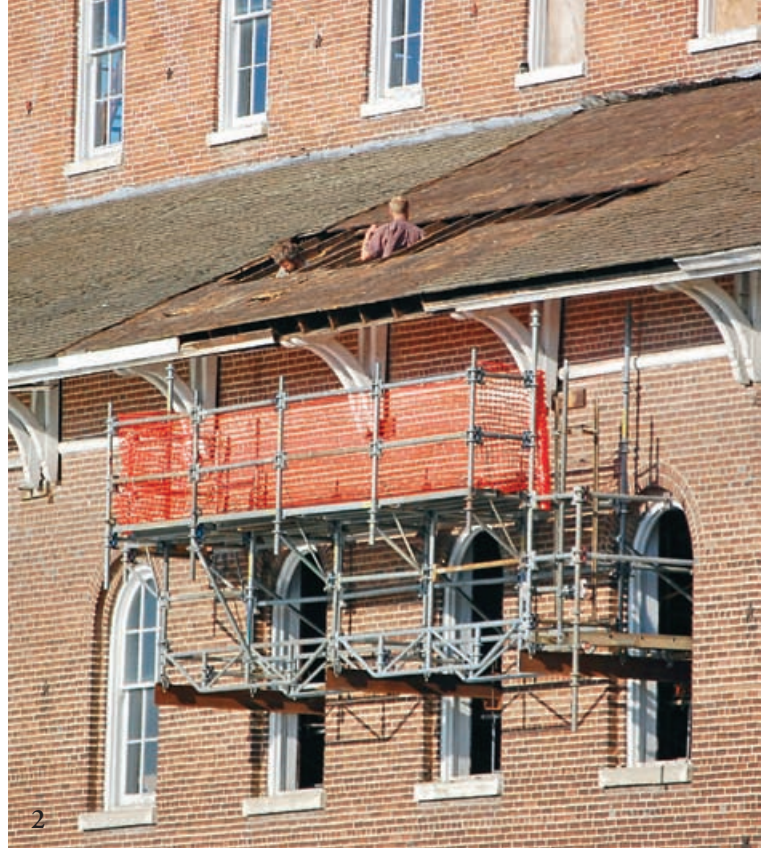
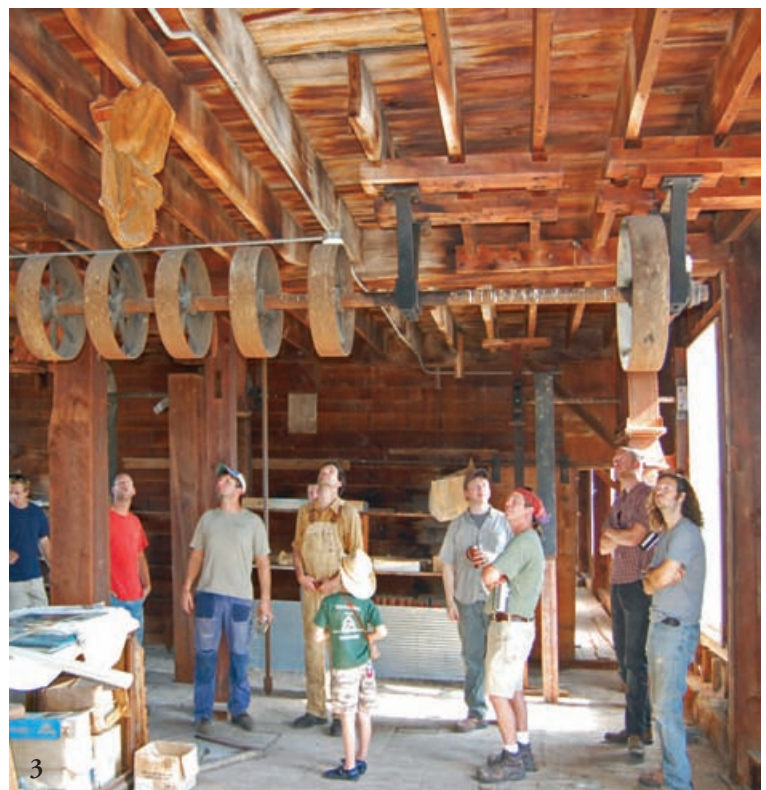
Facing page, Independence Mills, Independence, Iowa (1870), now called the Wapsipinicon Mill, viewed from the northeast. At top, cantilevered steel scaffolding in place at east shed roof eaves, over the river. Above, Rick Collins (left center in blue jeans) leads the group on a tour of the mill. Much shafting and many pulley wheels remain.

Puzzling conditions observed Before any significant carpentry work could begin on the damaged plate rafters and rafter tails over the river on the east side of the mill, a scaffolding system was required that cantilevered out from the second floor windows (Fig. 2).

While this system was being installed by a scaffolding subcontractor, our group had an opportunity to assess the mill. Rick Collins guided an attic-to-cellar tour explaining the mill's history and the characteristics of the timber framing (Fig. 3).

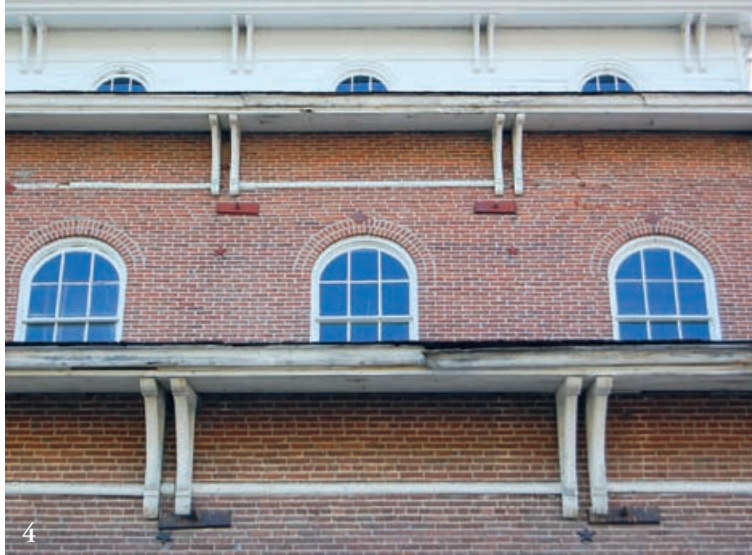
At top, west elevation detail showing large bearing plates associated with tie rods that run through building at frame lines. Above, east view of the Wapsipinicon Mill, ca. 1874, four years after construction. Below, composite view from north revealing bow to the east of all roof eaves.

Large tie rods with rectangular bearing plates mounted on the exterior of the building at the third, fourth and fifth floors, an obvious feature of the building now (Fig. 4), clearly were not original to the construction, as we could verify in an 1874 stereo view of the mill (Fig. 5).

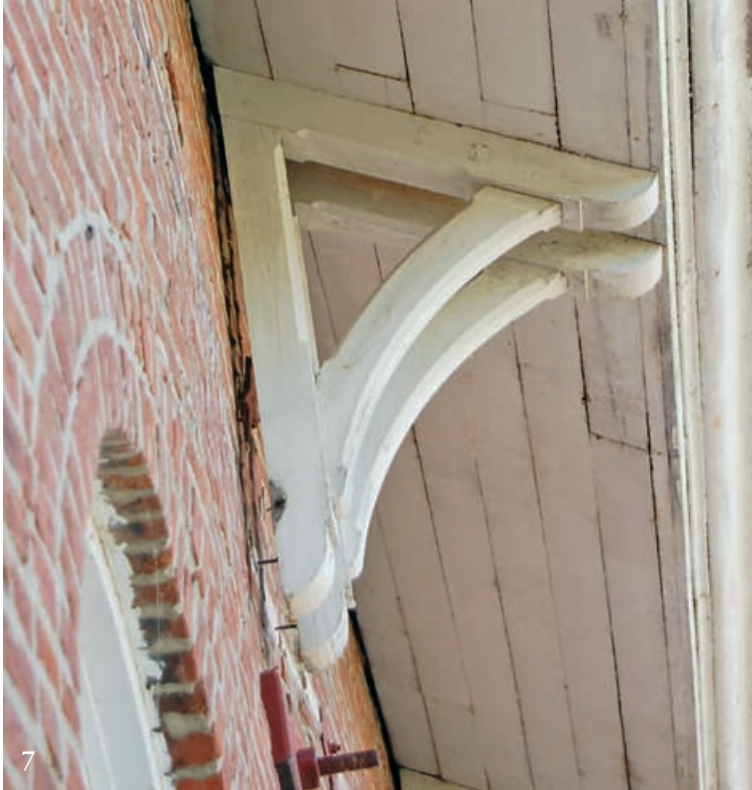
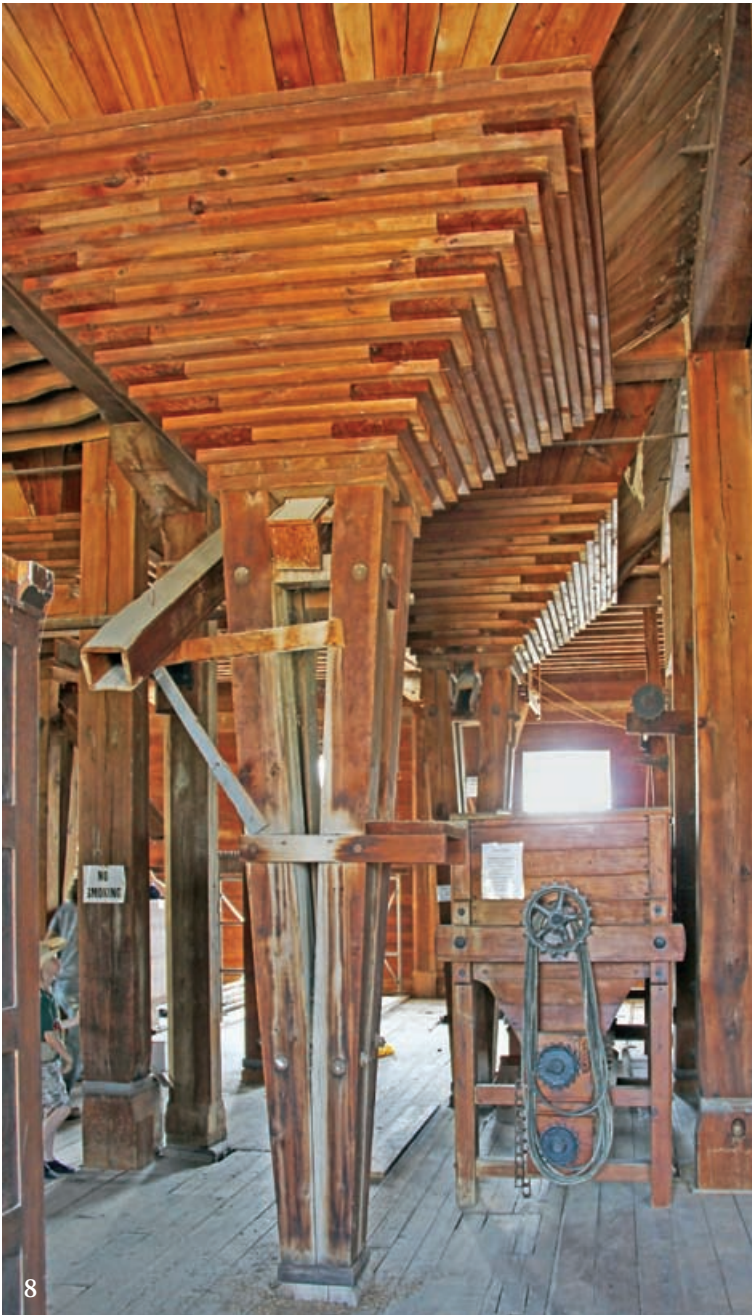
Above, decorative bracket separated from wall. Below, multistory grain bins, independently supported down to foundation.

We noticed that the decorative brackets set beneath the eaves and gable end overhangs typically hung well clear of the brick walls (against which we would expect them to bear), sometimes by nearly 2 in. (Fig. 7). Trillium Dell had reattached some of these brackets as part of their work in 2009; determining the cause of detachment and appropriate remedial action to take on the remainder was to be part of this week's work.

Although the main building frame was fairly straightforward and repetitive, developing a good understanding of the three-dimensional relationships in the building was complicated by three large grain bins, each occupying a full bay, penetrating the third, fourth, and fifth floors and independently supported on posts from the foundation to the third floor (Fig. 8).

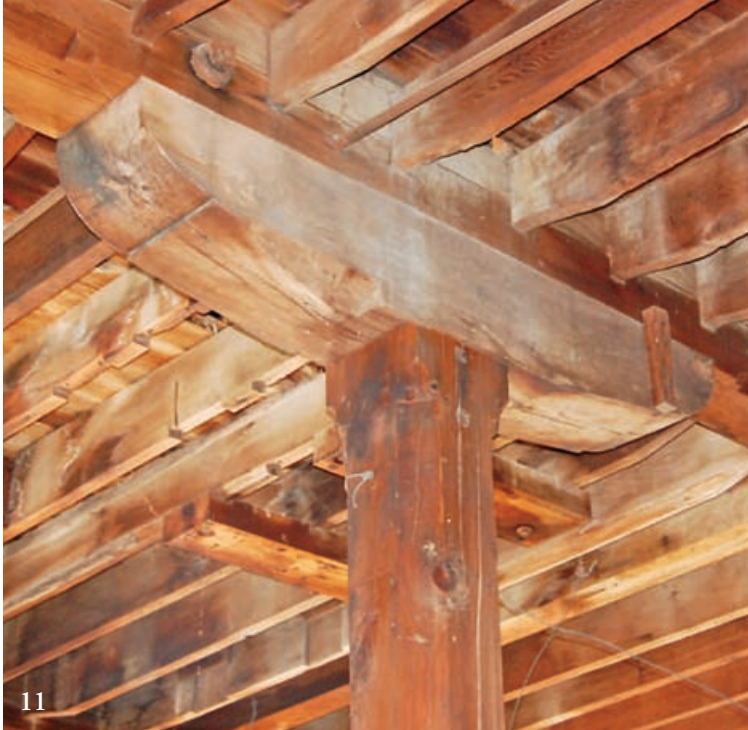
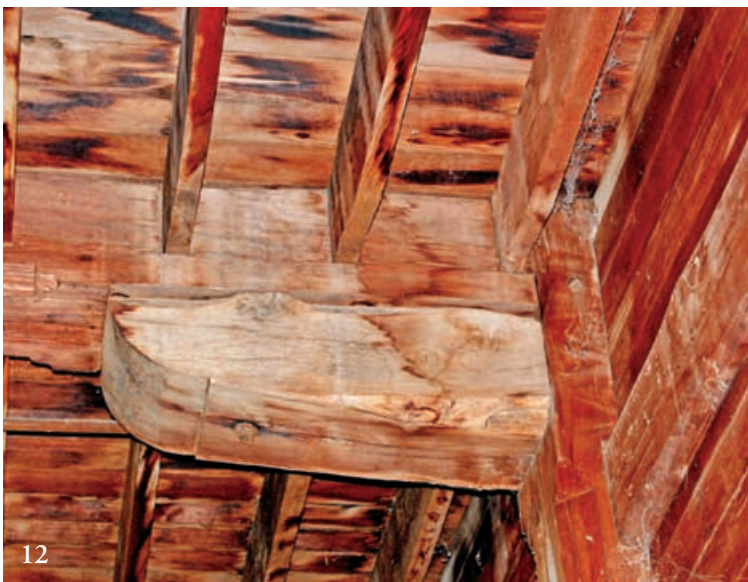
At top, typical interior post with oak bolster. Notch in bolster may reflect clearance for object no longer present. Note reductions on joists, stopped chamfers on beam and post as well as stepped profile of bolster, all signs of conscious craftsmanship. Above, tenoned half-bolster at exterior post, through-bolted to girder. Below, plan and elevation views of bolstered girder joint at post.

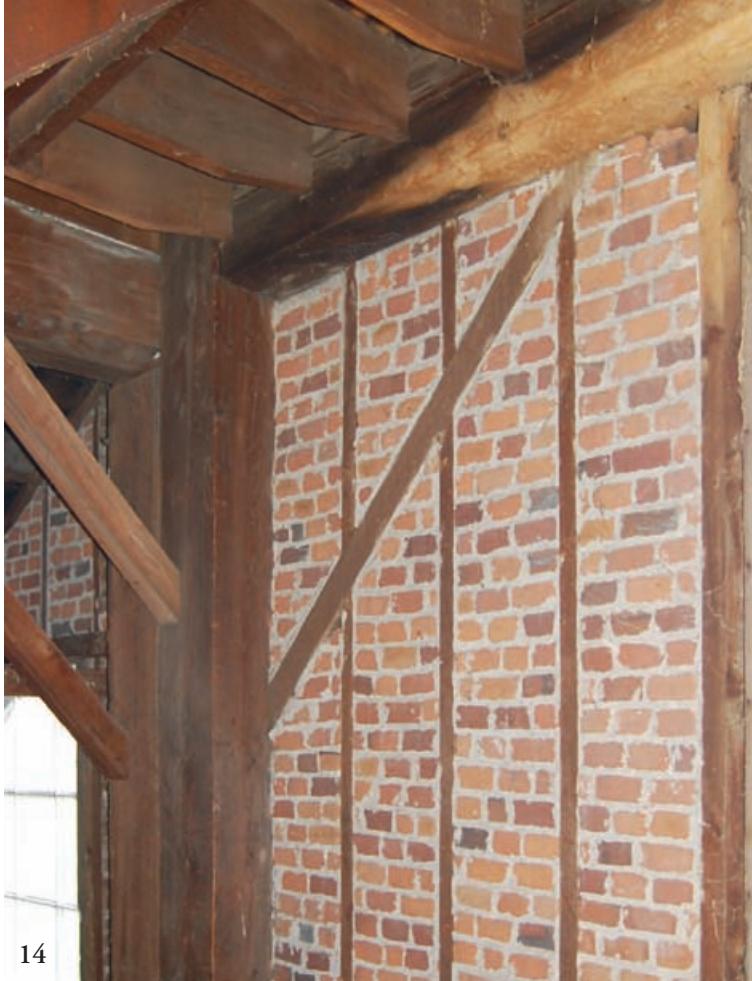
14

At top, brick infill at third floor, placed against inside face of sheathing between studs. Above, joists at tie beam, joint detail. Below, representative split white oak joists, a result of double bearing in the joint and loss of support at lower bearing.

It is instructive to look at how the joist bearing at the beams performed under these heavy loads. The cross-section of the typical beam showing the stepped bearing for the joists is given in Fig. 15. We were able to confirm these dimensions at locations where joists were missing and the joist housings were visible for inspection. We noted that the sides of each housing were initially cut with a hand saw and then the remainder of the housing cut out with chisels.

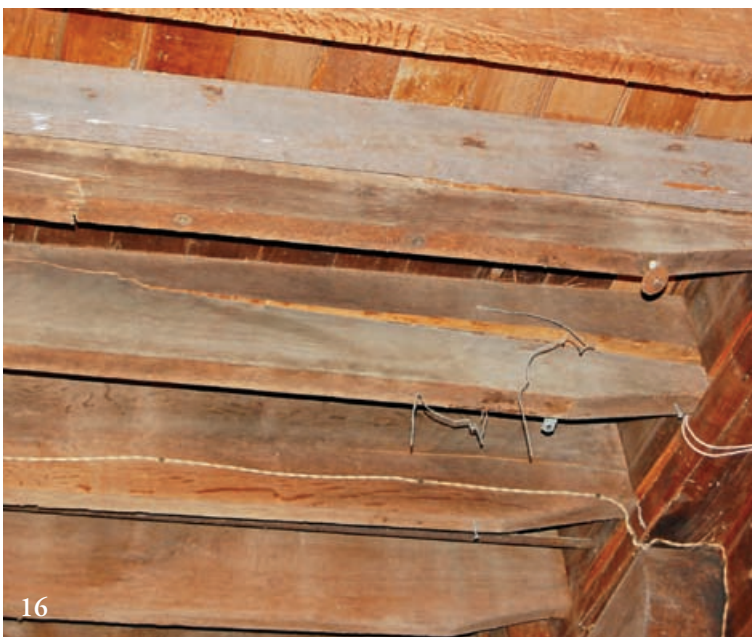
16

Timber frame engineering issues identified Engineer Joe Miller's team identified two areas on the second floor where severe damage from overloading was evident (Fig. 16). It is not often that one has the opportunity to conduct a load test to near destruction on such a well-crafted structure, but previous mill operators had done that for us. According to history provided by Leanne Harrison of the historical society, grain storage bins in addition to the main bins already described had been constructed on the second floor some time after original construction was complete at the two locations in question. Recall that the main multistory bins were independently supported and rose through penetrations in the floor framing without imparting gravity loads to the timber framing of the mill. The mill was in constant flux during its history, however, as the required types of grains and processing changed, and it was evident from our survey that numerous ad hoc storage bins, mixing

So what happened? As you might expect, a number of the joists cracked at midspan. The notched ends split. The bearing surface in the beam fractured and gave way (Fig. 16). The beam fractured in bending. The beam-and-bolster connection at the exterior column failed and had been supplemented with a bearing block and interior post to replace the failed bolster. Meanwhile, over interior posts we found evidence of crushing, bending and fracture of the oak bolster.

These failures probably did not all occur simultaneously, but rather developed over time as the bin became progressively loaded, leading to a series of reinforcing measures. To put the magnitude of this overload in perspective, a 14-ft.-deep load of kernel corn at 45 lbs. per cu. ft. acting as a fluid would produce bending stresses in the joists of 4500 psi, shear parallel to the grain stresses of 420 psi, and bearing stresses perpendicular to grain at the end of the joists of over 1100 psi.

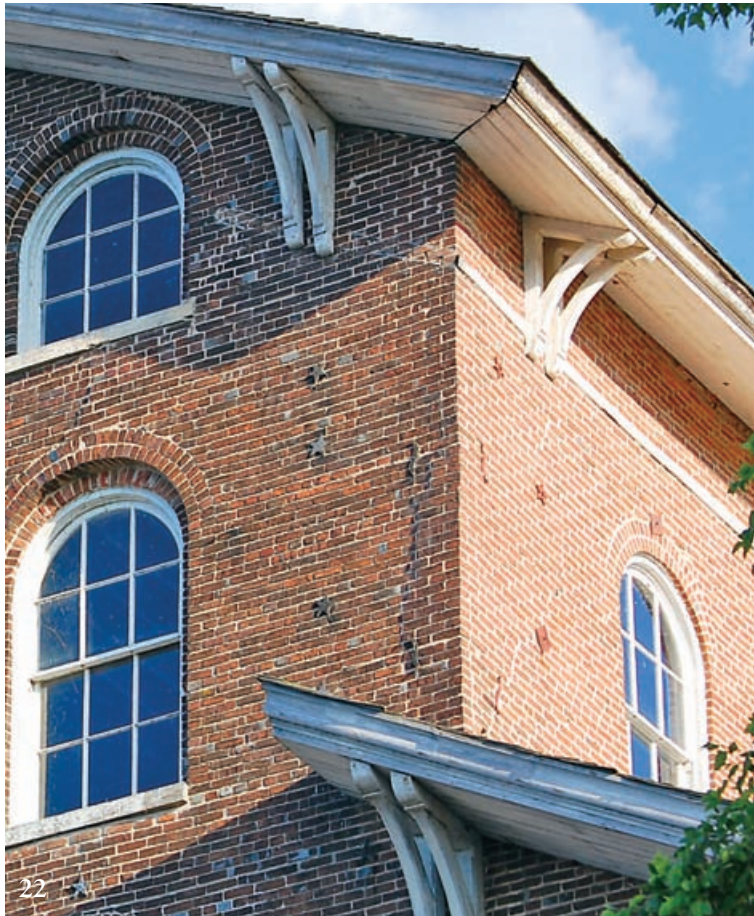
Above, cracking and distortion at monitor northwest corner, a fault in large brick buildings without expansion joints. Note star brick ties. Facing page, top left, east monitor wall, north end, with large diagonal fractures, previous repairs and distortion of brick coursing lines. Top right, west monitor wall showing rotation and misalignment of stone sills, bowing of wall below windows. Middle left, cast-iron star brick tie that held cladding to wood sheathing, across an air space. Middle right, clinching-head spike used as supplemental tie for the 4-in. brick cladding. Below left, section at top of main wall.

The diagonal cracks we found in the east and west (long) monitor walls at the north end are easily understood in light of the change in support conditions that occurs as the masonry turns the corner from the gable end wall to the sides of the monitor. The gable brick wall was supported rigidly on the stone foundation, and if anything, longterm expansion of the brick would create a slight upward growth of the gable wall. The monitor sidewall masonry, on the other hand, was supported on a 12x14 timber sill devoted to this task (plus carrying the shed rafters), itself supported by posts at 12-ft. centers that in turn were supported by the 12x12

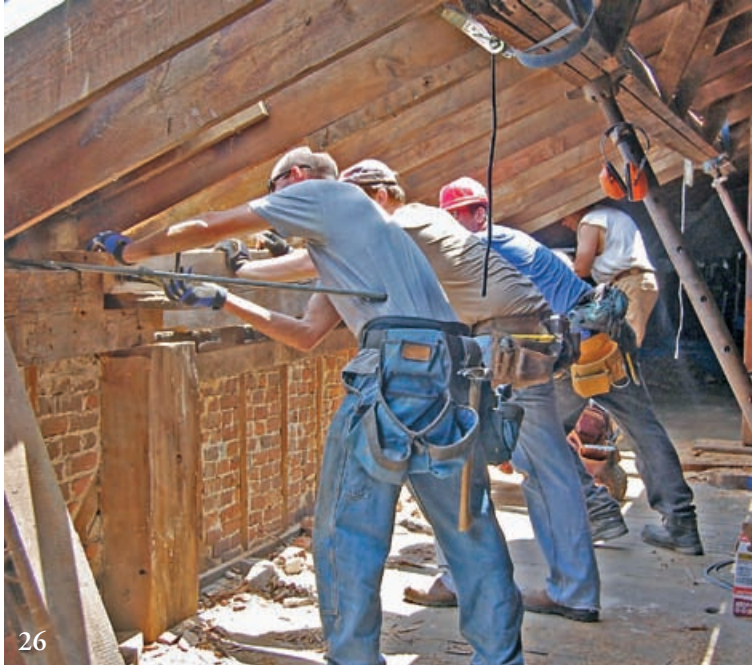
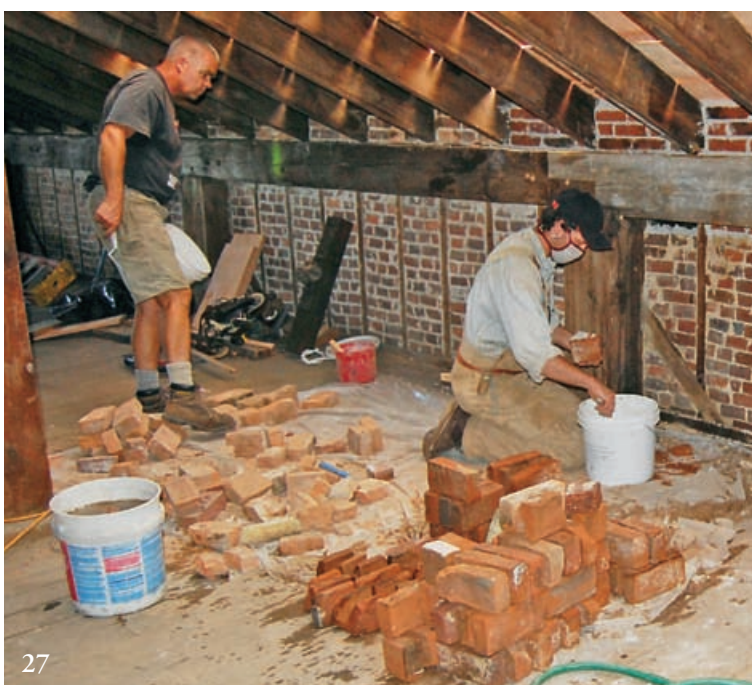
At top, left to right, Jake Amadon, Joe Miller, Joseph Ferencik and Tom Haanen coax plate into place over stud tenons. Above, Michael Murphy, left, and Will Fowlkes repair masonry infill. Below left, Tim Whitehouse checking actual needed brace length. Below right, lower end of replacement brace swung into position via overcut mortise and small chiseled relief, then blocked in tightly.

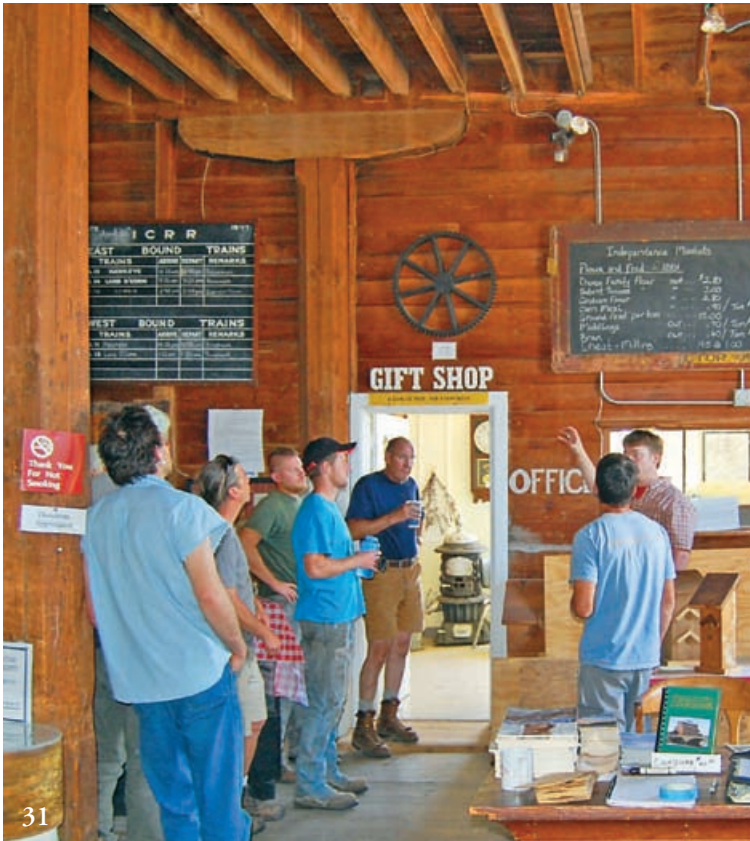
30

At top, Dan Roberts, Tim McGee and Brad Collins on their way up to the eaves in the 135-ft. lift. Above, morning lecture series: Joe Miller, right, discusses damaged floor framing and proposed repairs. Below, our hosts from the Buchanan County Historical Society, from left Wanda Goins, president Leanne Harrison and Judy Scott.

The weather was hot during the first half of our week in Independence. A 90-degree-plus high-pressure system whipped up some serious wind that definitely added to the thrills for the crew operating the 135-ft. man-lift (Fig. 30).

They were able to reach most of the eaves and gable overhangs on all but the river side of the building, to remove and replace damaged fascia and reattach soffits and decorative brackets. During the work on the rotted plate and rafter repairs at the east wall, we saw clearly that the soffit had pulled away from the underside of the rafter tails, with gaps of as much as an inch, and had taken the decorative brackets with it. Though well-enough made with pegged joinery, the brackets were just spiked into mortar joints at their lower ends and never attached firmly enough to transfer weight from the rafter tails. Additional bracket separation resulted from the tightening of the tie rods that had been run through the building, which simply pulled the brick away from the brackets (Figs. 7 and 24).

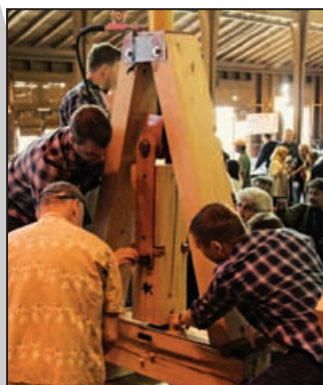
Fire Tower team removing failed wedged-dovetail thru tenon sample from tension tester at Asilomar.
