TIMBER FRAMING

JOURNAL OF THE TIMBER FRAMERS GUILD

Number 114, December 2014

Framing a Roof in Hispaniola

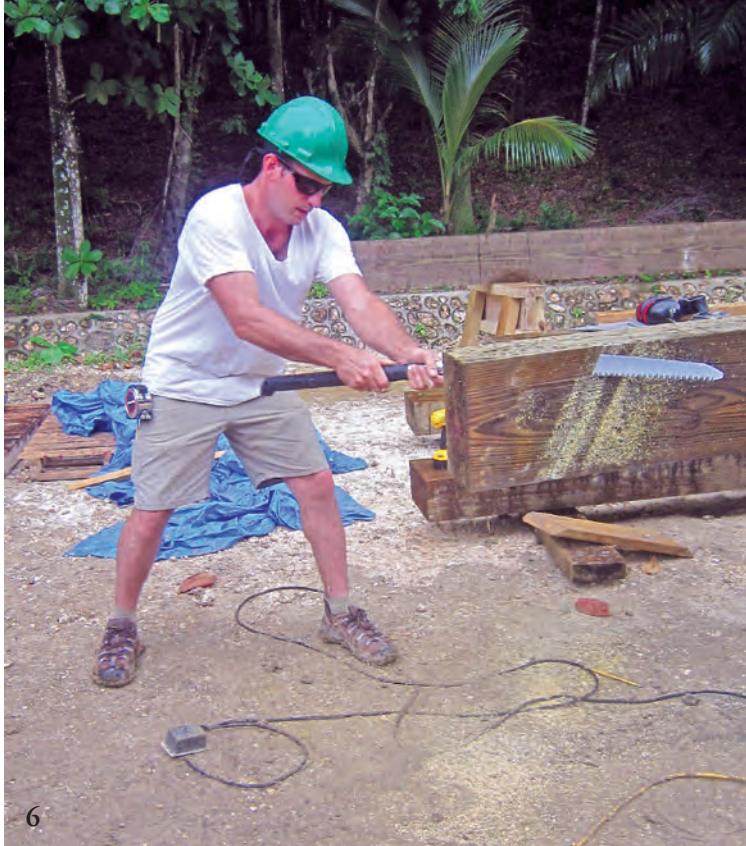
6 Dale Emde mastering deep compound-angle cut with Silky Katanaboy saw.

Proceeding with layout and cutting, Dale Emde, who has worked with us for over ten years and is deft with a handsaw, made the complicated cuts on the hip and jack rafters (Fig. 6), while I worked on the ridge beam and the principal rafters. We had selected a flat worksite that afforded shade in the morning hours thanks to the tropical vegetation on a steep adjacent hillside. As the days were hot and humid, the shade was most welcome. Before long, we realized that the same hillside that blocked the sun also prevented us from anticipating the approach of the sudden and frequent rain showers. Each tropical downpour triggered a mad scramble as we gathered and covered tools. Shop drawings got wet and were hard to read. Often the shower would be over and the sun shining again by the time things were battened down. Most days this drill was repeated multiple times. One storm was sufficiently furious that serious flooding ensued, damaging roads and breaching a watercourse, and the entire resort construction site was flooded. At those moments, the advantages of a proper workshop might have outweighed New Jersey's lousy, damp weather and short, cheerless days.

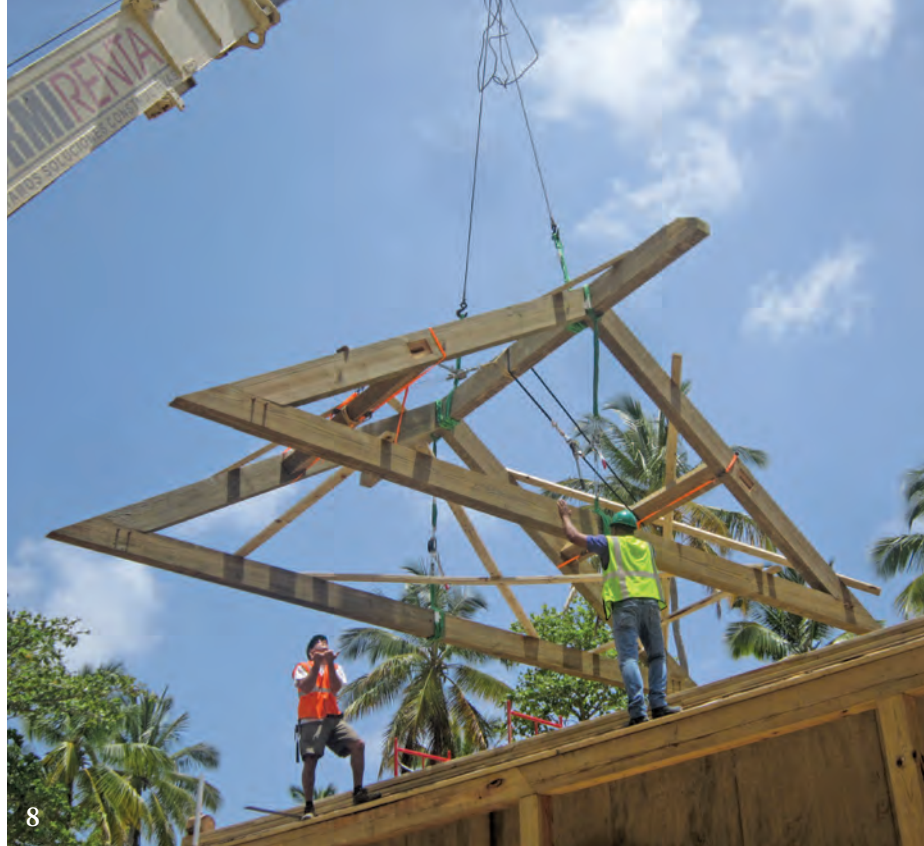
8 Flying in principal rafter assembly with purlins and ridge.

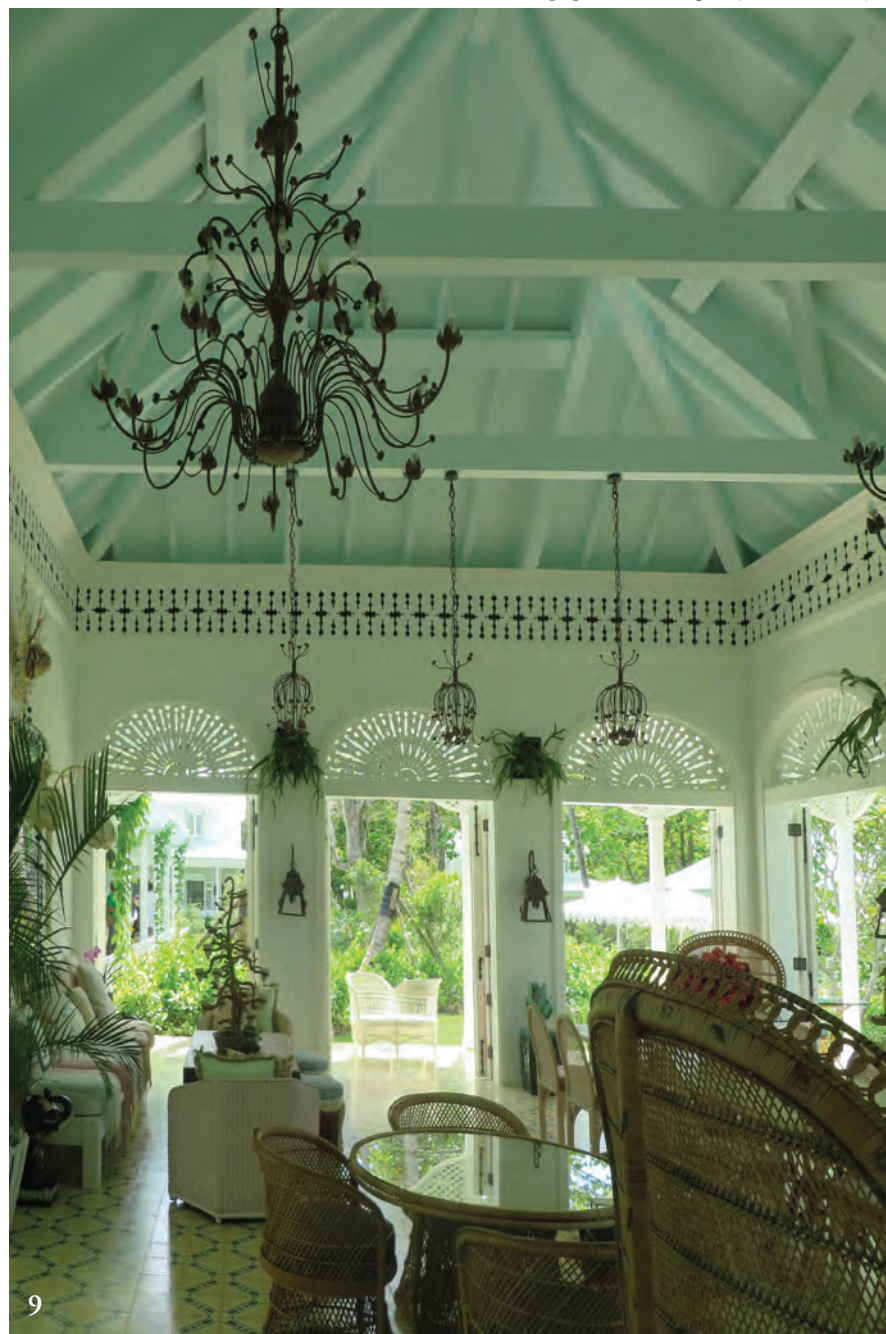
9 Completed hip roof in service over hotel lobby.

Fig. 9 shows the finished product, post-interior decorators. Given the opportunity, we would do it again. The beetle was too heavy to bring back. Left behind, perhaps it will come in handy on some future job—if the termites don't eat it first. Sadly, Ed Levin passed away just weeks after the roof frame was built. Certainly it was not among his most ambitious designs, but I do wish he could have seen it. I'm pretty sure he would have been pleased, and he surely would have enjoyed the adventure. —ALEX GREENWOOD
Alex Greenwood (njbarncompany@aol.com) is a principal at The New Jersey Barn Co. in Ringoes, N.J.

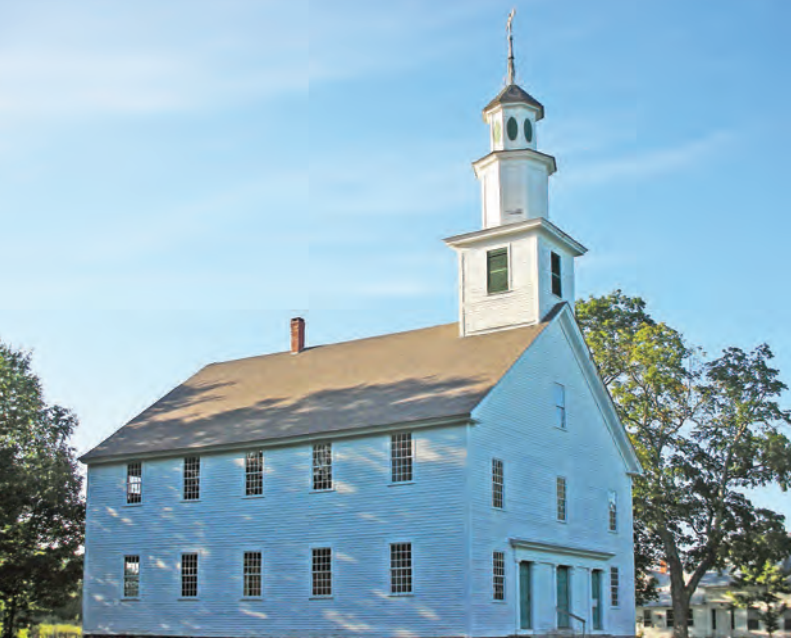
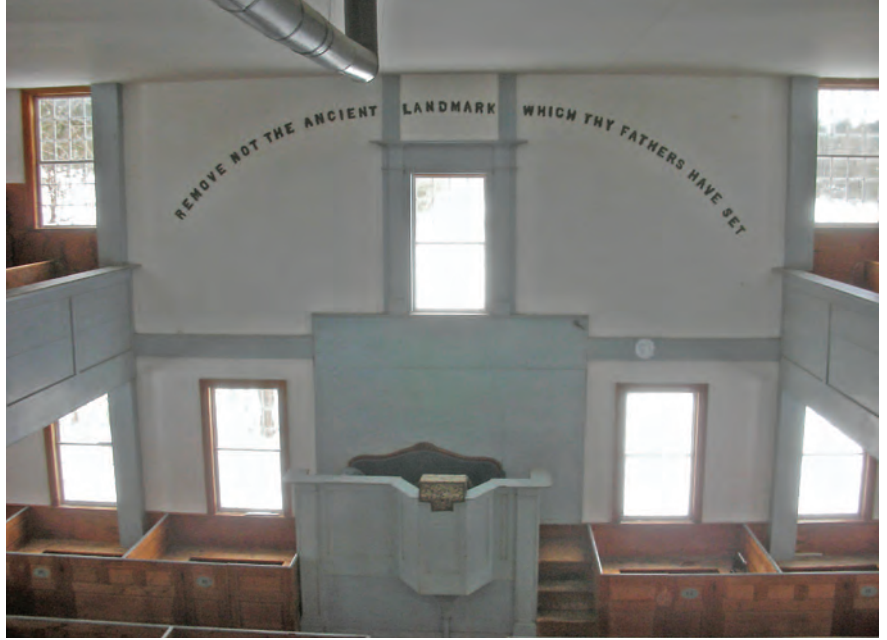
1, 2 Old West Church, Calais, Vt., 1823, with interior view of pulpit, box pews and ends of three-sided gallery.

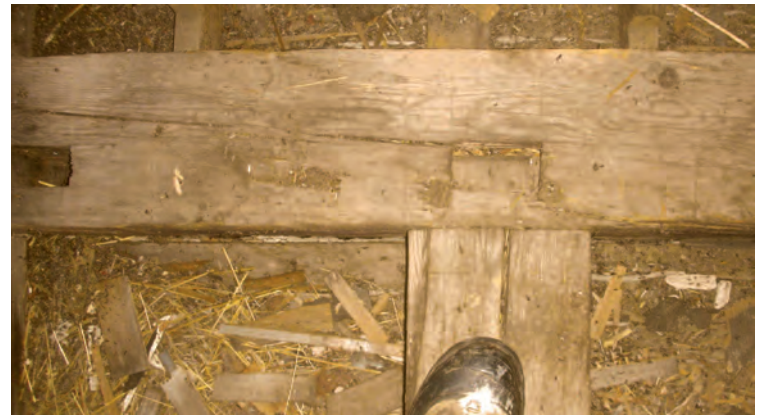
11 At right, empty stud mortises at original gable tie beam (running across photo).

WHAT'S odd about the construction of the Old West Church in Calais is the alteration on the fly of the original design. The Calais town history records that the August 30, 1823, meeting of the First Meetinghouse Society in Calais "had agreed upon a building lot and drawn a plan 40 by 42 feet, forty pews on the lower floor, 5 feet by 6, and eighteen above, the same bigness." Exploration of the attic reveals that the frame had originally been designed to have four bents, creating a three-bay footprint roughly 44 ft. square with the 10-ft.-square tower at the east end (Fig. 8). The frame was subsequently filled out after the raising (but possibly before closing in) to yield a fourth bay at the east end, absorbing the tower into the gable and thus setting the steeple on the roof and requiring the rear steeple posts be supported on a tie beam in the roof framing (Fig. 9). Unused stud mortises can be seen at the fourth tie beam on either side of the steeple tower where the gable wall had originally been intended (Fig. 11).

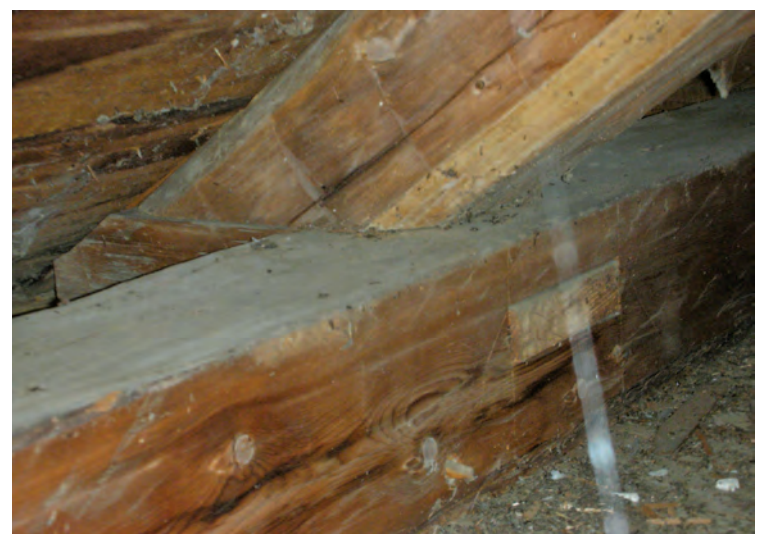
12 At right below, fourth-bay rafter on tenoned dummy tie-end.

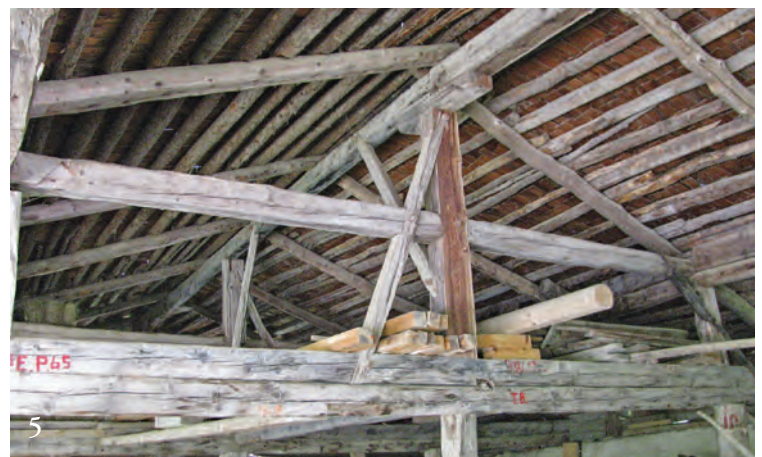
5 *Spannbalken* in service, horizontal beam here connecting two purlins to resist inward movement. Ballenberg Museum, Hofstetten, Canton Bern.

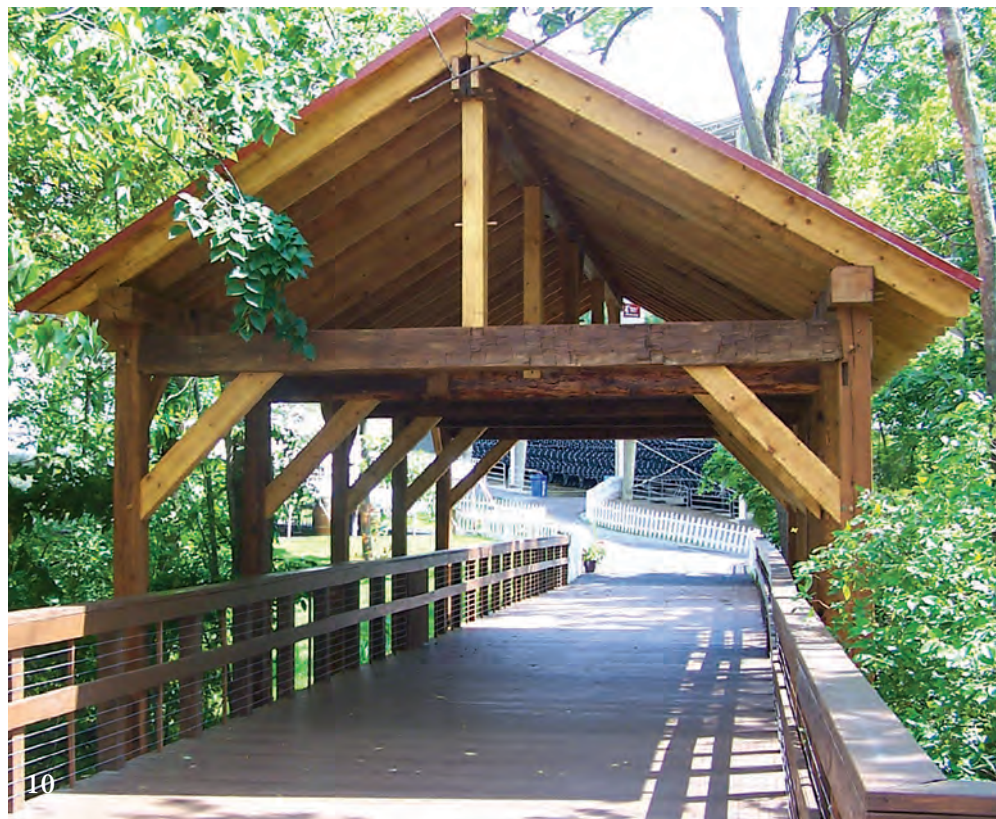
10 Cover 22x45 ft. for existing footbridge over creek and wetland, CMAC Performing Arts Center, Finger Lakes Community College, Hopewell, N.Y., built by Keith Holcomb of Fairport, N.Y., and designed "to make the 180-ft. trip from box office to amphitheater more interesting." Posts each side go to longitudinal girders tied transversely and supported on concrete columns. Oak, chestnut, elm and hemlock agricultural salvage timbers.

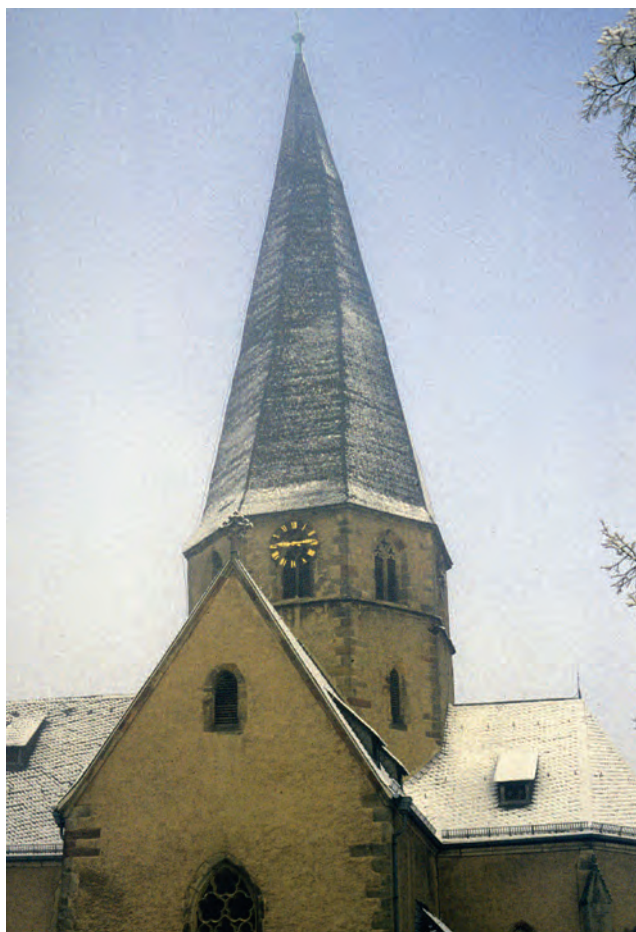
1 Spire of Collegiate Church, Rasdorf in Hesse, Germany, 14th century.

The oldest of three spires that I investigated some 20 years ago is twisted in three sections (Fig. 1). This spire sits atop the stone

crossing tower of the Collegiate Church in the village of Rasdorf in Hesse (N 50° 43.143' E 009° 53.825'). Several repairs and additions to the framing have reduced the original timber material over the years, but enough remains to reconstruct the original design. Dendrochronology dated the youngest piece of original timber to the year 1349.

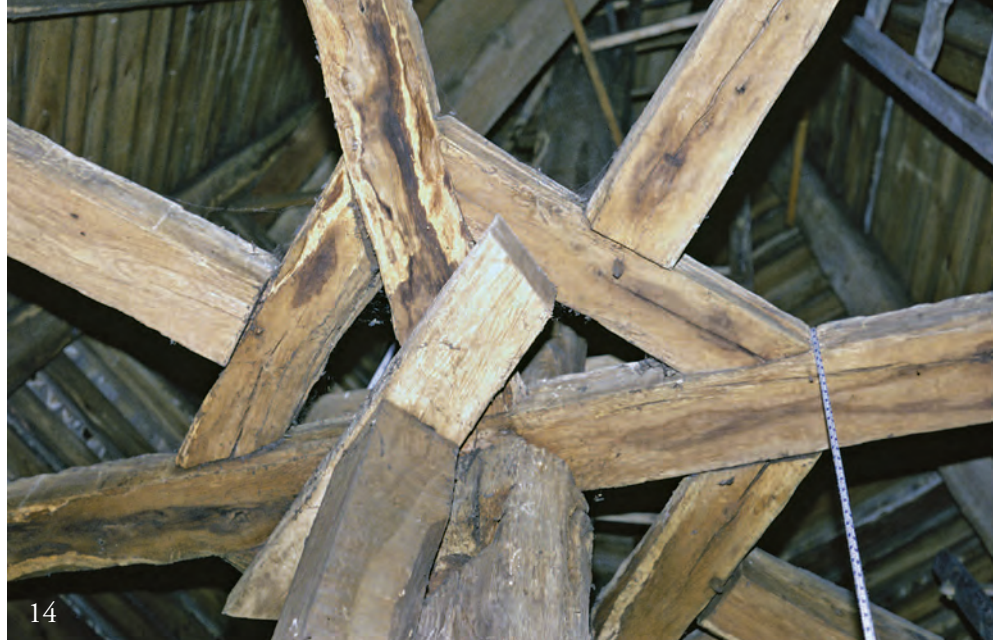
13 Replacement 19th-century collars join mast awkwardly in upper half of second stage.
