JOURNAL OF THE TIMBER FRAMERS GUILD

Number 111, March 2014

# Documentation and Assessment Methods for Timber Structures

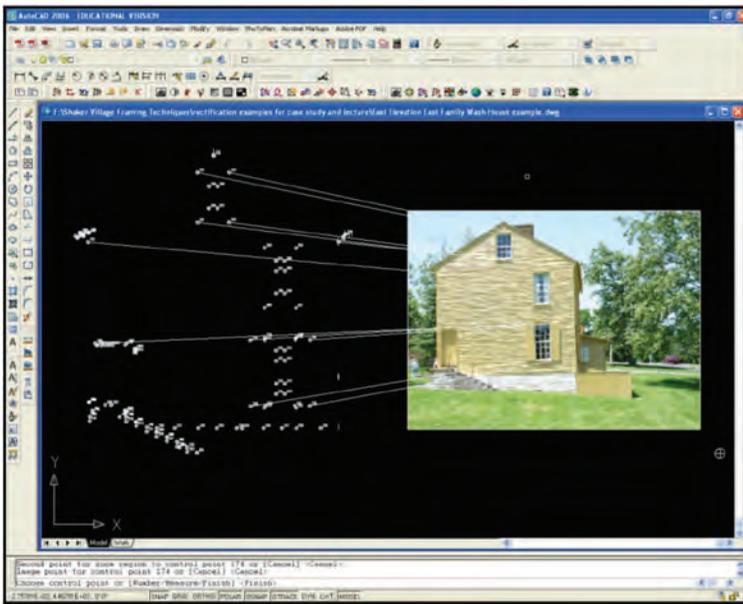
1 Above, screenshot of XYZ data points gathered using total station, East Family Wash House at Shaker Village of Pleasant Hill, Kentucky, then referenced with corresponding locations on digital image of building, indicated by lines, imported into AutoCAD.

Once all necessary XYZ coordinates and field measurements are obtained, digital images of each elevation are imported into the AutoCAD file containing the field measurements. Using rectification software embedded within AutoCAD, the XYZ data points obtained in the field are aligned with their corresponding location on the digital image (Figs. 1 and 2). The digital image is then altered to remove any perspective distortion.

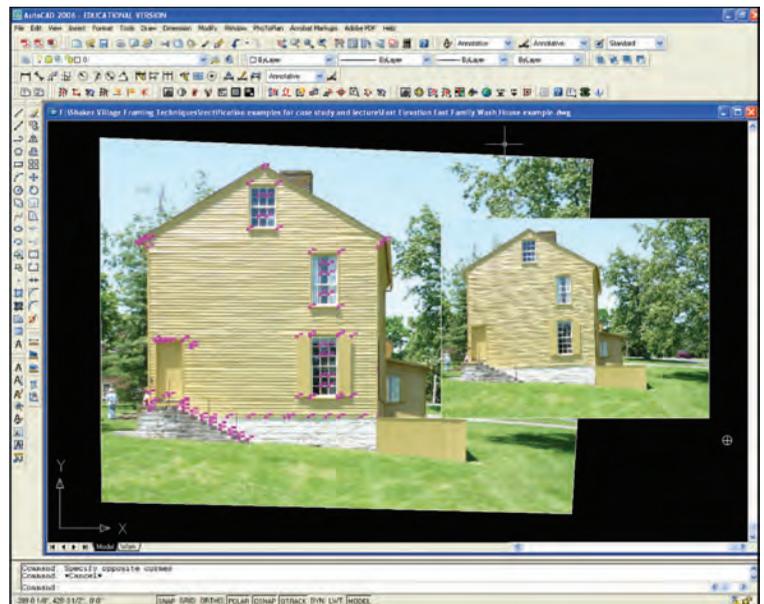
2 Above right, screenshot of image rectified by Kubit software's PhoToPlan program. Prerectified image (right) adjacent to rectified image (left). Magenta points now align with corresponding locations on the digital image, thereby removing any perspective distortion.

Lens distortion can be removed at the same time by using focal length settings previously calibrated by taking an image of a set of perpendicular grid lines at a known focal length. The digital image of the structure can then be altered to coincide with actual line trajectories.

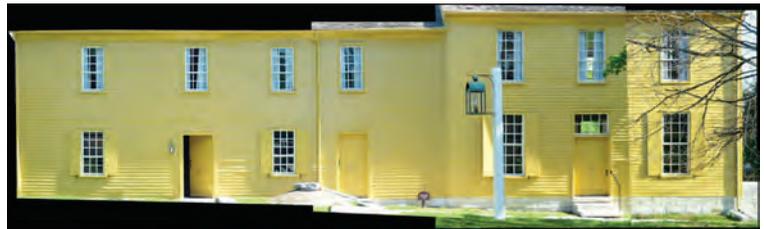
3 At right, top, composite digital image of East Family Wash House rectified and combined using points obtained through a total station and use of both TachyCAD and PhoToPlan software.

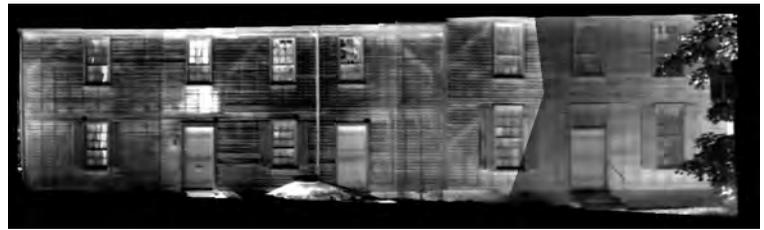
4 At right, middle, infrared images taken of same elevation during assessment, likewise combined and rectified, yielding a single, accurate image highlighting concealed framing.

The technique can also be used to help identify the placement and relative size of concealed timber members by taking advantage of the different thermal transmission rates inherent within frame wall construction. Used in conjunction with photorectification techniques, such images can accurately convey the size, placement and even deflection associated with timber-framed structures, allowing for more accurate and less destructive evaluations (Figs. 3–5). The technology's short learning curve is another advantage, with only a basic understanding necessary for qualitative assessment and analysis.

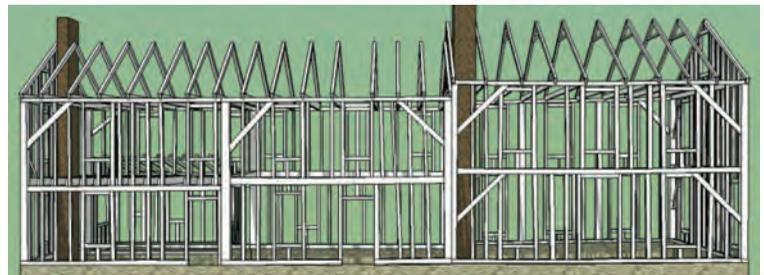
5 At right, bottom, accurate 3-D model (shown 2-D) of framing developed in SketchUp from composite infrared image.

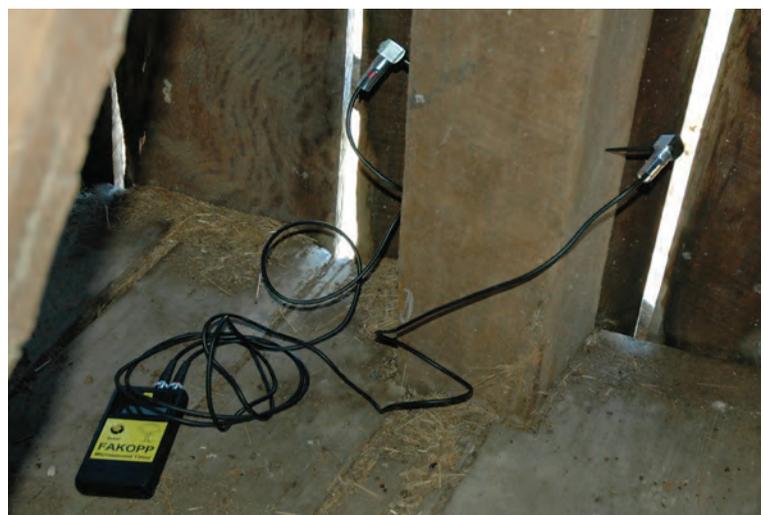
6 Microsecond timer used for stress-wave timing analysis. Transducer probe on right is struck with hammer, inducing stress wave to receiver probe. Device records wave flight time.

The technique works by connecting a timing device to a transducer and receiver placed directly opposite on parallel surfaces of the wood member under investigation (Fig. 6). Both transducer and receiver are firmly attached to the wood by spikes driven about 1/4 in. deep and placed at about 45 degrees to the surface. The observer then strikes the transducer with a small hammer, starting the timer and inducing a stress wave that propagates through the wood member. The receiver senses the leading edge of the wave and stops the timer, providing an accurate measure of the time of flight of the stress wave. The stress wave can move quickly when wood is solid but slows when rotten material is encountered. Time

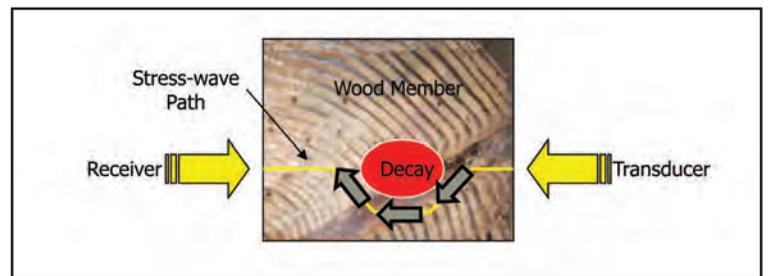
7 Stress wave passing along transverse plane of wood sample in mostly radial direction. Rotated 90 degrees clockwise in image and stress wave would be going in mostly tangential direction. Rot or decay slows stress wave, resulting in longer transmission times. Bend in wave represents diffraction in much-simplified form.

The anisotropic nature of wood is important to take into consideration when stress-wave timing, as wood-grain direction and growth-ring orientation can affect transmission times. Typically in historic structures the timber's grain orientation allows for stress-wave timing tests to be conducted across the grain in both the radial and tangential directions. Shortest transmission times are found when testing in the radial direction, while the longest times are along the tangential direction at 45 degrees to the growth rings<sup>2</sup> (Figs. 7 and 8). Temperature and moisture content of the wood under investigation can also play a role and require the application of adjustment factors.

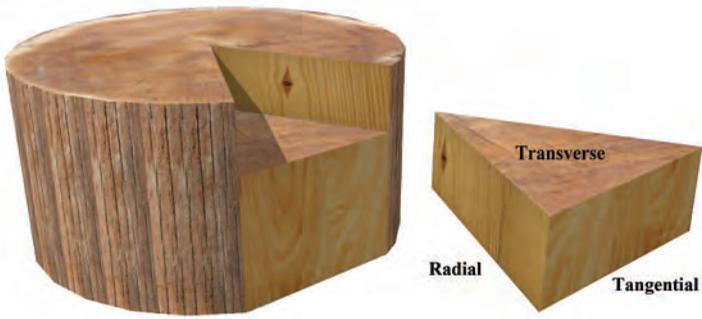
8 Three planes to specify path of stress-wave through timber.

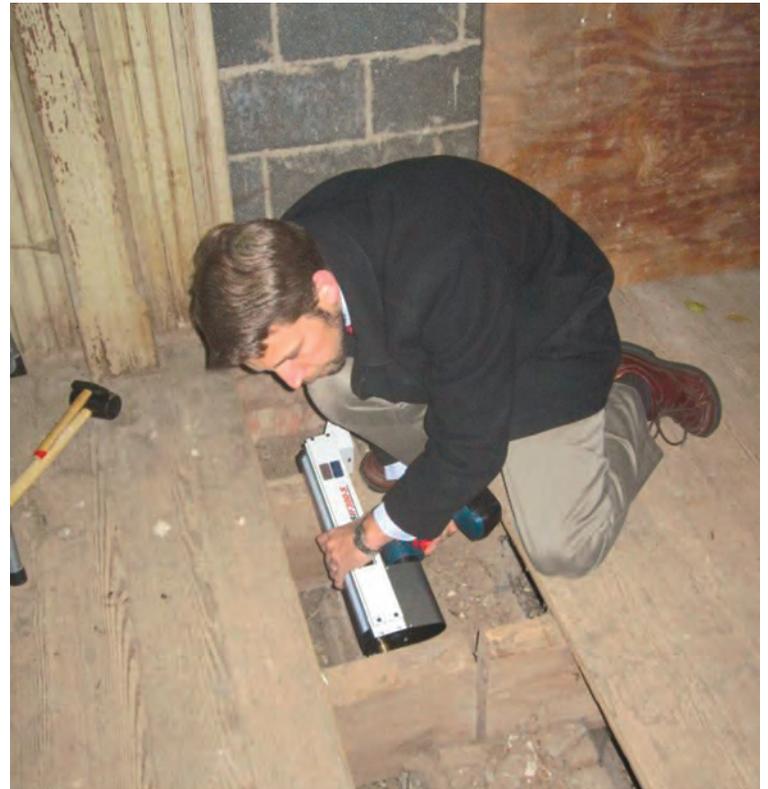
9 IML Resistograph being used by author to assess a joist at Union Church (ca. 1819) in Falmouth, Virginia.

Easy to use, the resistance drill works like a traditional cordless drill with a housing containing the drill bit and a recording device situated on top (Fig. 9). When the trigger is pressed, the 3mm-dia. drill bit is sent through the piece of wood under investigation. As the bit moves through the wood, resistance it encounters is passed along to the calibrated stylus, which inscribes results in a 1:1 ratio on wax paper strips. Recent innovations also allow results to be captured digitally and downloaded to a computer to be analyzed. When sound wood is encountered, high resistance is conveyed on the wax paper strip, whereas when decay is encountered the resistance drops toward zero. Such results allow for the investigator to determine the degree of deterioration as well as its extent within a particular location in a wood member, making it a great tool for confirmation of suspected degradation.

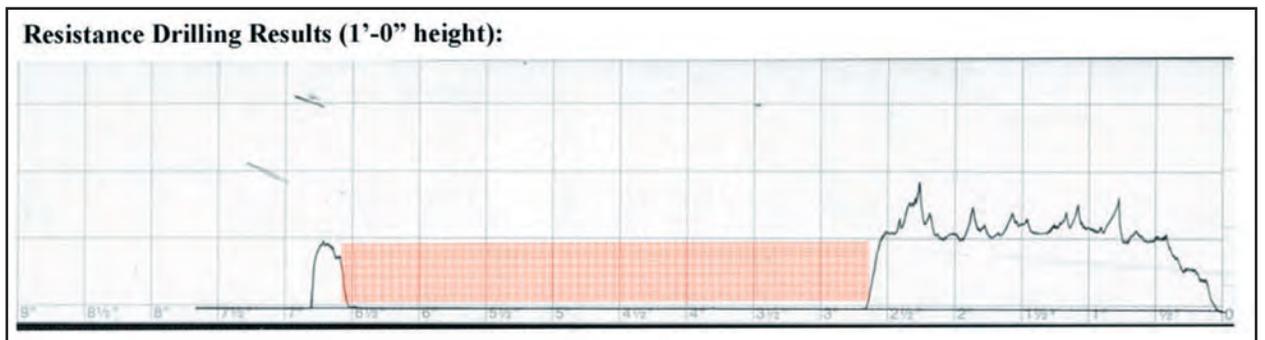
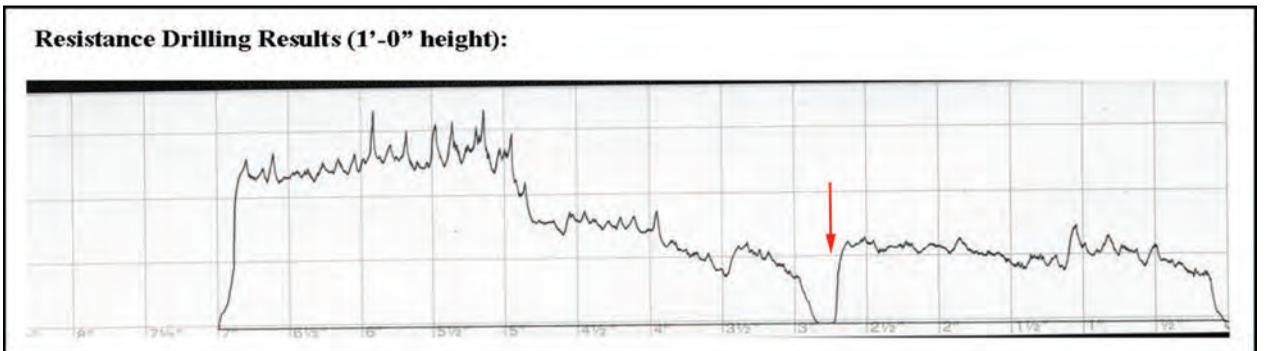
10 Resistance drill readings from Bowman-Hite post 15 (top) and post 19 (above) with each square equal to 1/2 in. Shaded red area on post 15 readout denotes extent and location of rot starting just 1/4 in. under surface of post. Peaks in sound portion of wood (right side) denote denser latewood. Red arrow in post 19 reading indicates high stress-wave results despite majority of its wood being sound.

Tests performed at the Bowman-Hite bank barn utilized two drillings for each of the three posts identified by stress-wave timing as having possible deterioration. The drilling locations repeated the stress-wave timing locations. Each drilling measured the resistance along the radial direction of the post. Results of the resistance drilling conducted confirmed that only post 15 was deteriorated (Fig. 10).

Results for posts 13 and 19 indicated invisible checks and splits had caused the higher stress-wave timing results.
