TIMBER FRAMING

JOURNAL OF THE TIMBER FRAMERS GUILD

Number 31, March 1994

Restoration Strategies

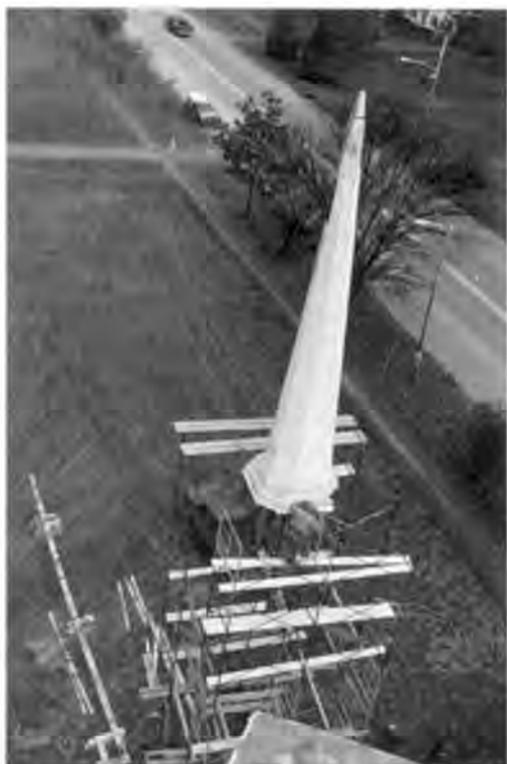
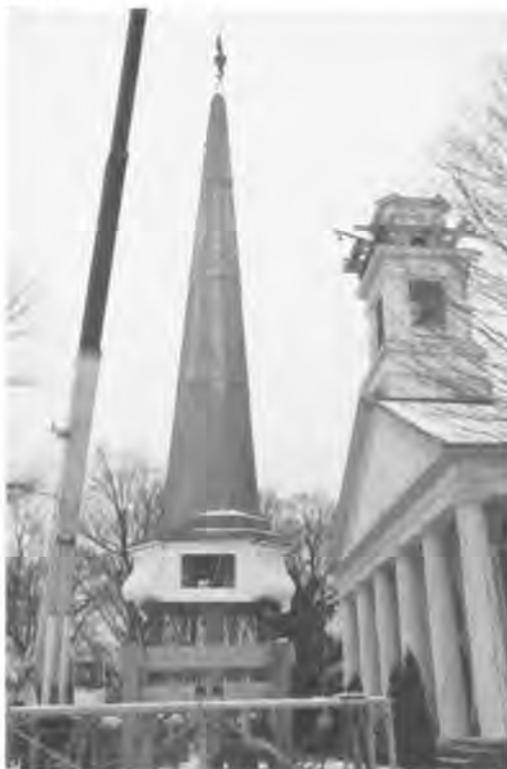
Above, the spire of the Castleton Federated Church, Castleton, Vermont (1832), removed from the church. A hole in the ground made way for the internal mast and allowed the spire to be lowered to a convenient working height (below). The original mast had rotted from the top; the new one, a 50-ft. hickory 9x9, lies on blocking at far left above. The mast, unfooted, hangs in the spire, exerting considerable compression on the steep rafters attached near its top, and may also resist wind forces.

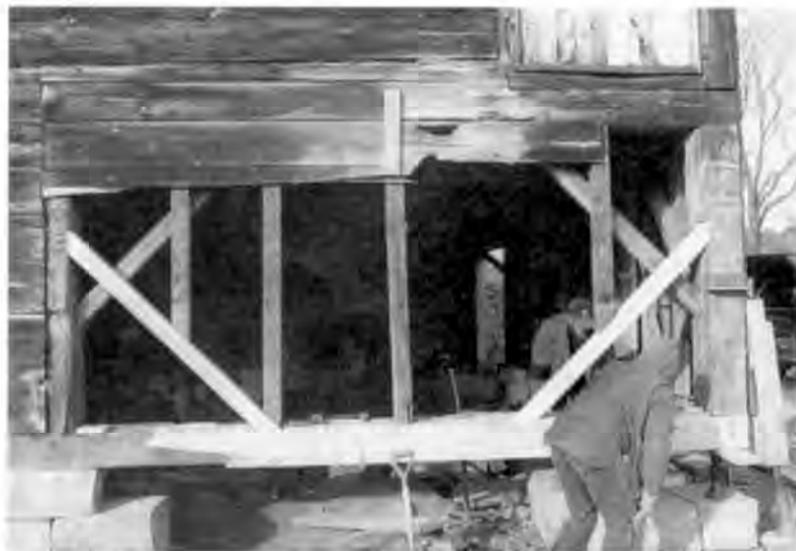
Sill and brace restoration by Paul Ide and Don Estes. Note jacking plate on corner post. Foundation to be restored. Kent Barn (1844), Calais, Vermont.

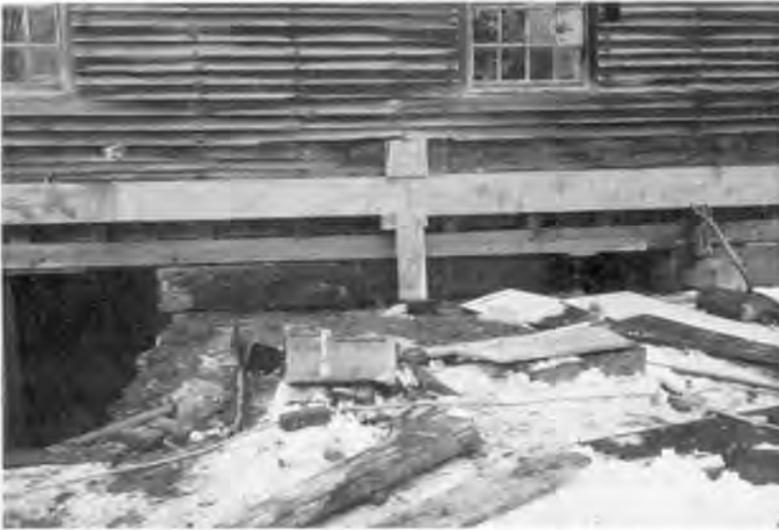
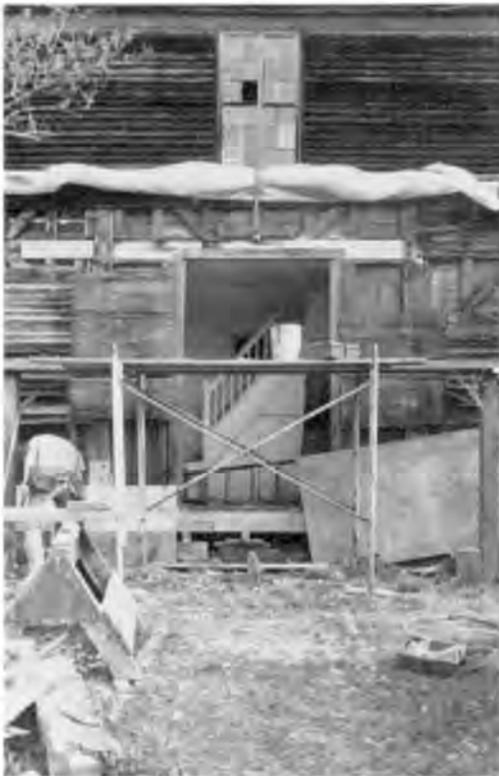
Above and below, work at the Theron Boyd house, built 1787 at Quechee, Vermont, and now owned by the state, called for preservation undisturbed of the original interior. Most repairs were thus carried out from the exterior. Shown here are new beech sills joined to the old and a glimpse of the interior. The jacking plate in the photo above is bolted to every post and stud.

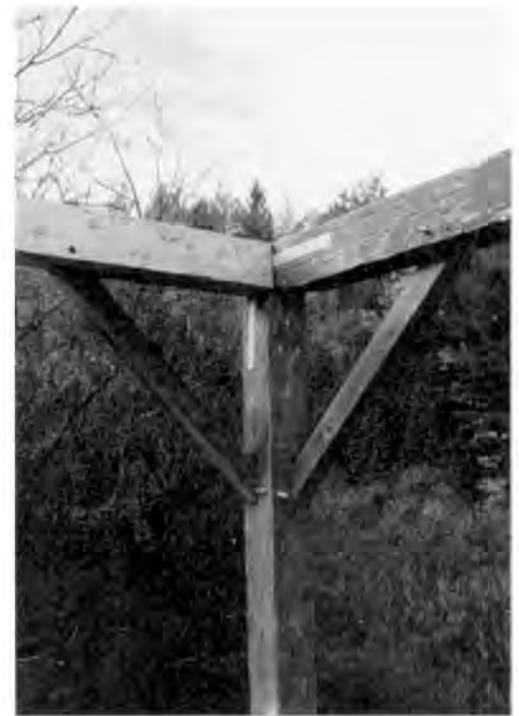
New hewn gable plate with free tenons fitted to post and eave plate, preserving most fabric. Bean barn (c. 1820), Barnet, Vermont.

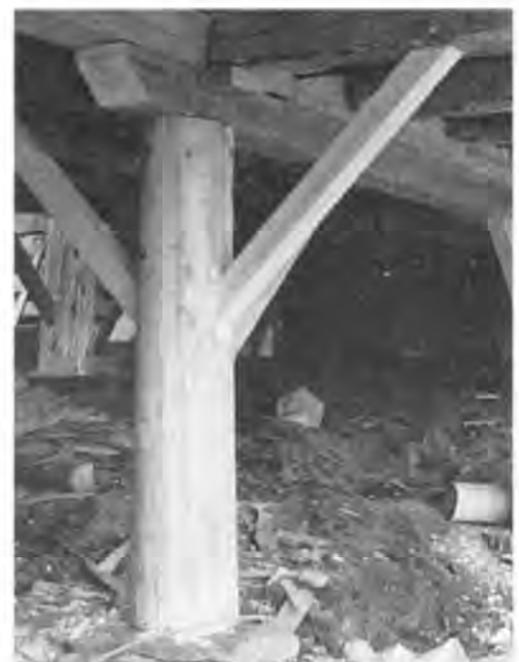
New cedar posts and braces under the Hadsell barn (c. 1860), St. Johnsbury, Vermont, a fully-functional repair.
