TIMBER FRAMING

JOURNAL OF THE TIMBER FRAMERS GUILD

Number 84, June 2007

Projects at Old Salem, North Carolina

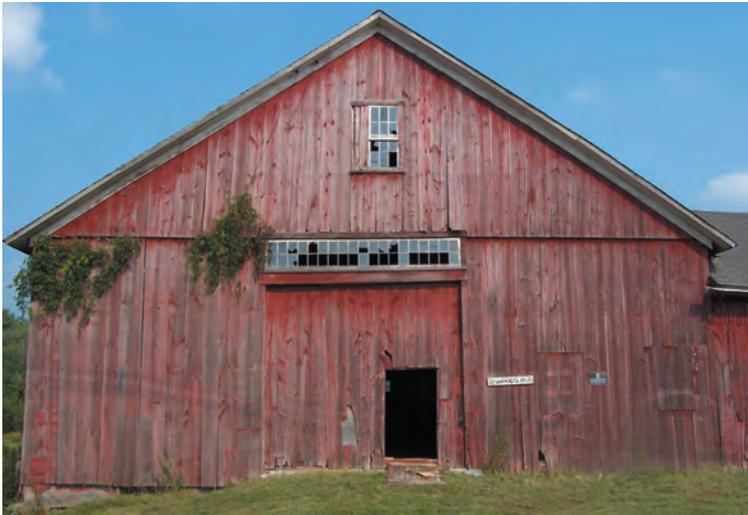
Photos and drawings Shaun Garvey
Fig. 1. *The Chase barn as found, apparently 19th-century.*

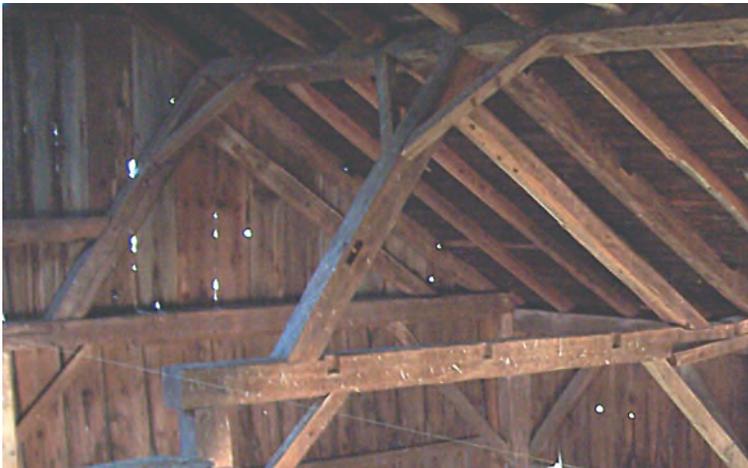
Fig. 2. *English barn cut and spread apart, with new roof framing.*

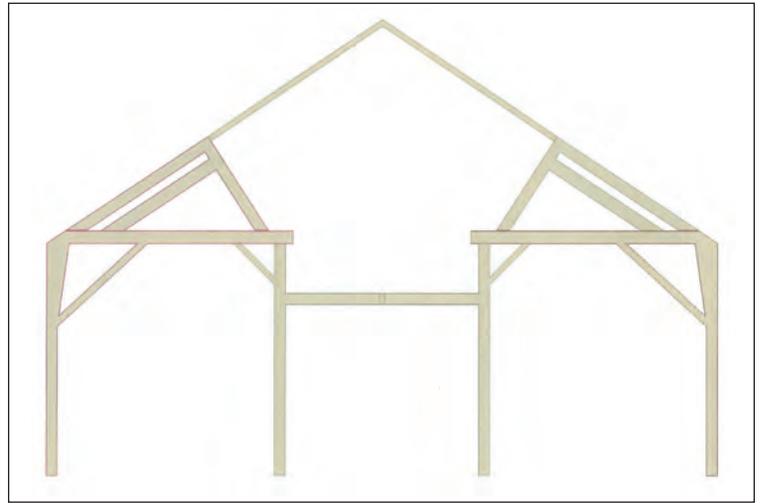
Fig. 3. *Cross-section of the 40x65-ft. Chase barn as found, with cut and spread tie beam and canted purlin posts. English tying joints were first clues to barn's origin as two 30x40-ft. English barns.*

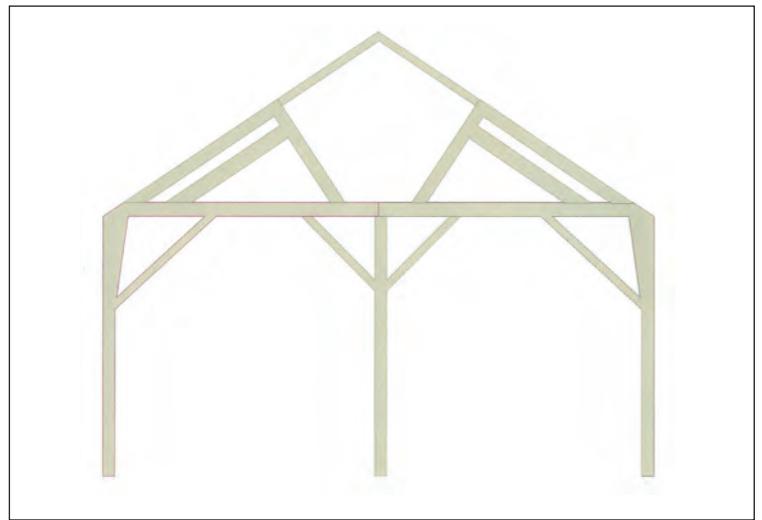
Fig. 4. *Cross-section of barn rebuilt as house frame on new site.*

inside will be for a bathroom. Outside, earthen ramps will rise to swinging barn doors hung from strap hinges, and the original threshing floor planks will be reinstalled as finish flooring.

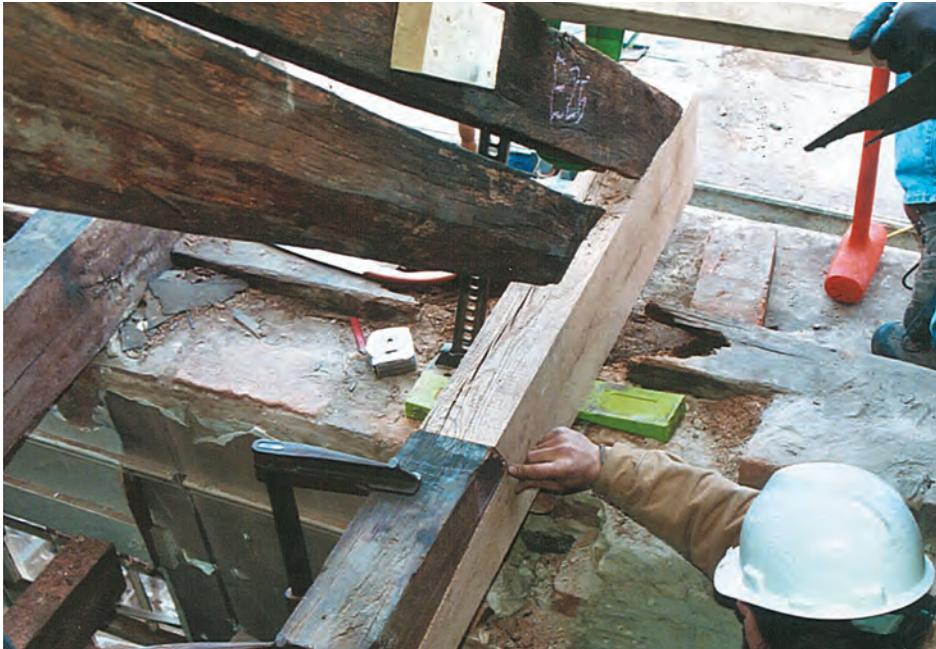
Fig. 2. Repairs to a principal frame at the Single Sisters' House, Old Salem.

beams supporting the upper attic and tie joists supporting the third floor. Timber frame work required traditional timber repairs to the ends of the floor joists and to the lower portions of principal and common rafters (Fig. 2).

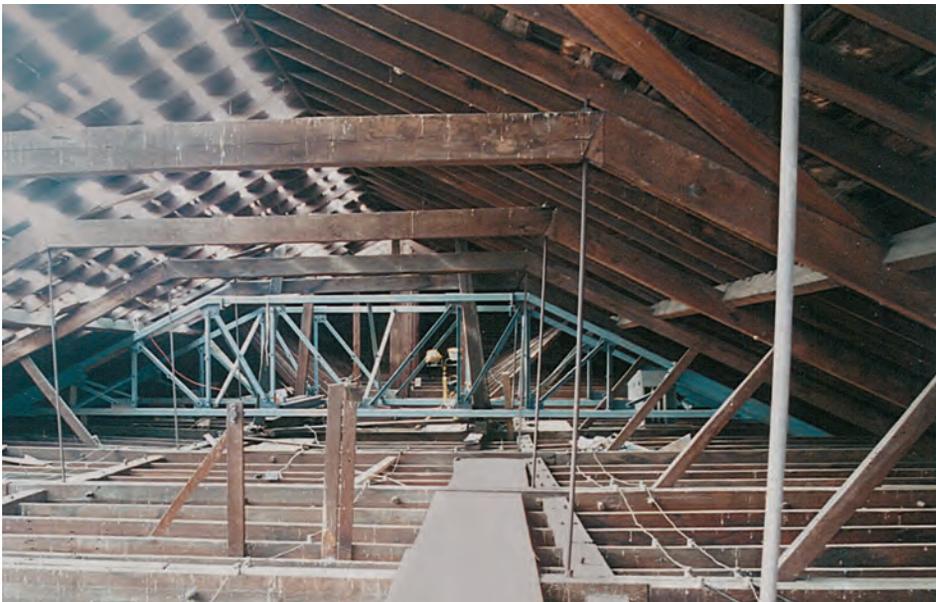
Fig. 3. A pair of light steel trusses now support the steeple in the attic of St. Philip's Moravian Church. Main roof trusses are composite vernacular queenrods.

The roof of the 1860 church is framed with "queenrod trusses" consisting of 5x8 timber top chords, double 7/8-in. square iron queenrods, 2 3/4 x 3 1/2-in. braces (webs) and a bottom chord of doubled 4x10 timbers spliced together and fastened with trunnels (wood pegs). Properly, these members together constitute an assembly better described as tied and braced principal rafters with sag rods. We added two light steel trusses to replace remnants of steeple supports (Fig. 3).

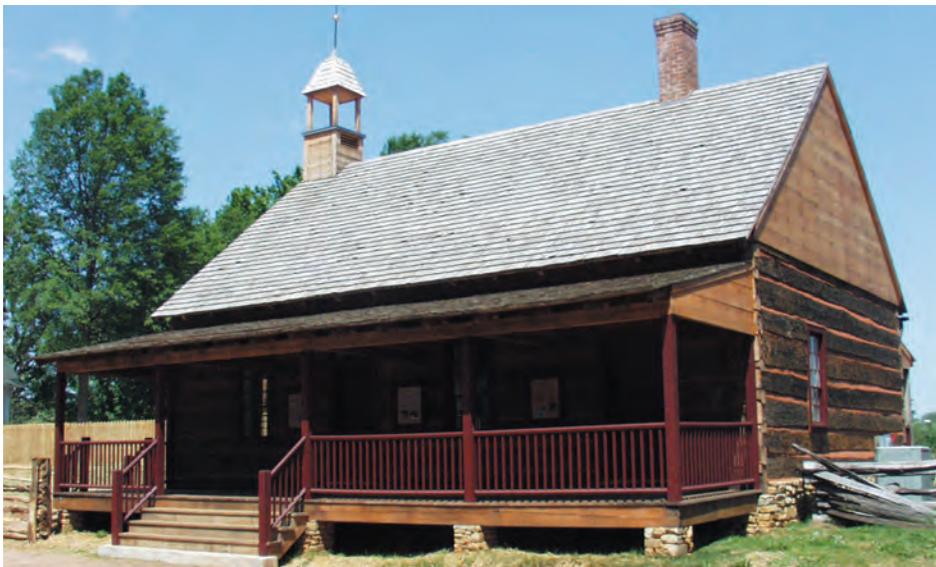
Fig. 4. Reconstruction of the 1823 Moravian Log Church.

Work at St. Philip's also included construction of a replica of the 1823 Log Church based on photographic and archaeological evidence. Structural design issues at the Log Church included the A-frame roof structure, support of the false chimney clad with brick veneer, bracing of the gable endwalls, support of the open belfry, porch and balcony details and tiedown details connecting the log structure to the foundation (Fig. 4).
