**COMPRESSION TESTING OF TRADITIONAL TIMBER
FRAMING TRUSS JOINERY**

THESIS

Master of Science
In
Civil and Environmental Engineering

December 2022

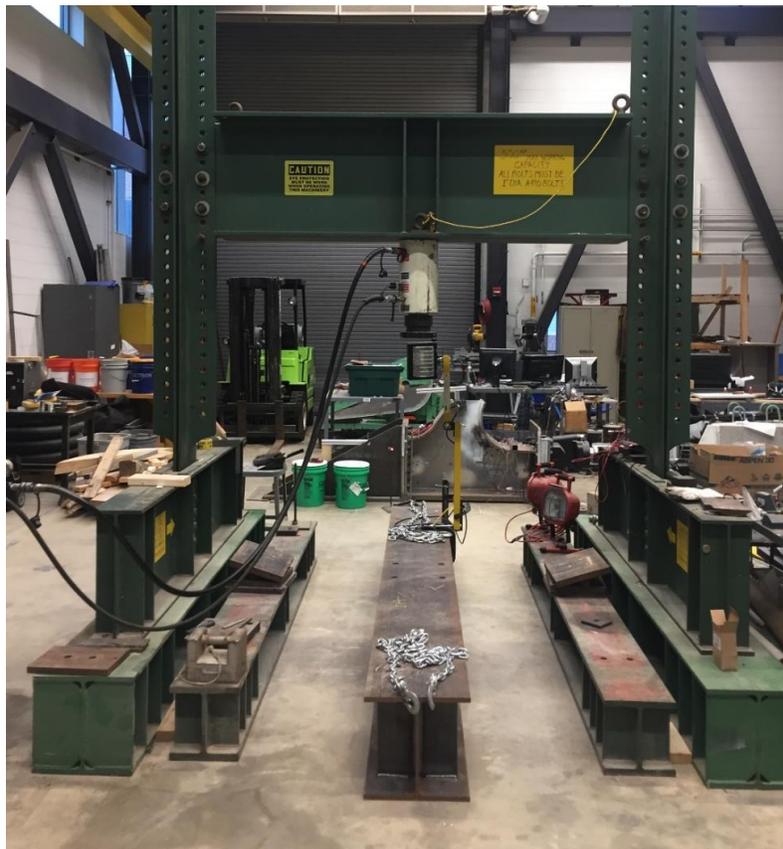
Figure 2-15: Testing frame available at UNH.

The testing apparatus used was the UNH High Bay reaction (Figure 2-15). The steel reaction frame consists of two pairs of parallel I-Beams that are bolted to the foundation of the

high bay. Four steel angles, oriented vertically, are bolted to the parallel I-Beams. The four steel angles support a horizontal I-Beam that can be adjusted vertically to accommodate testing specimens of various heights. The clear horizontal spacing of the testing apparatus is approximately 6' 8" and can accommodate test specimens up to 10' tall.

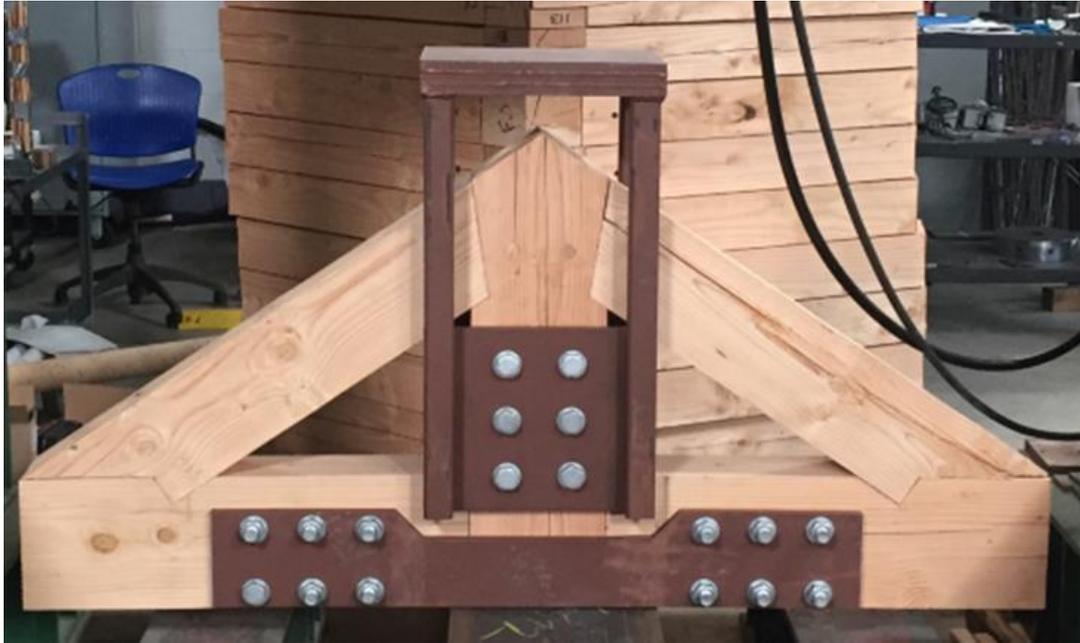
Figure 2-17: Steel loading frame and gusset plates shown on example Truss A1 specimen.

A steel frame was designed by the author to allow observation of the truss peak while transferring the vertical load from the ram above the truss peak into the king post through steel side plates and bolt bearing (Figure 2-17).

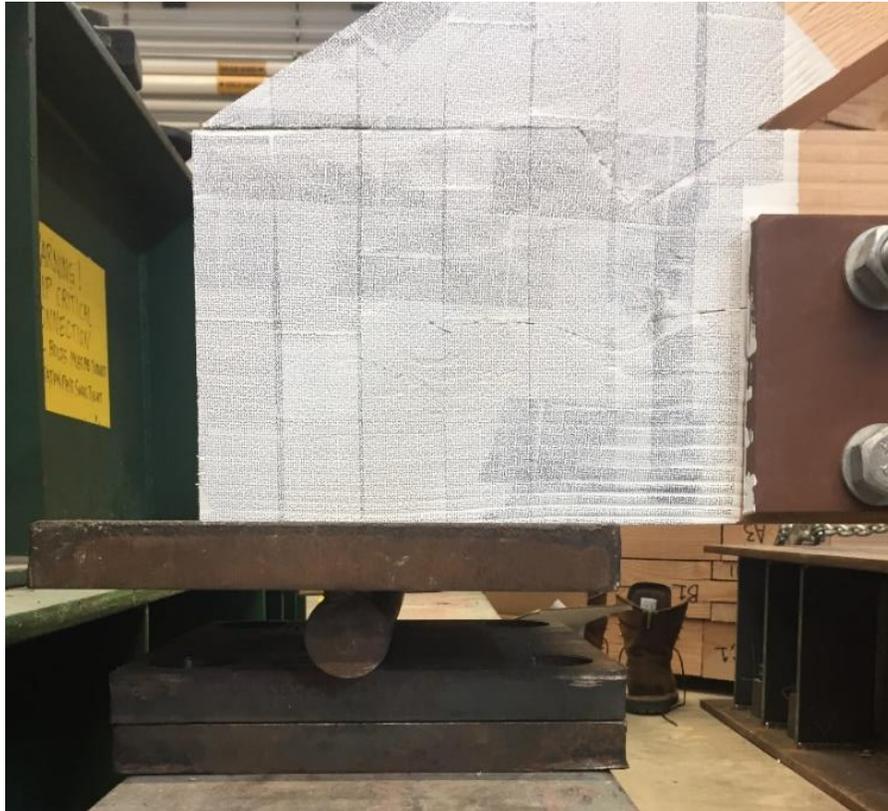
Figure 2-19: Truss heel support condition, showing roller support.

The timber trusses were supported by roller supports on each end of the bottom chord. This reaction system provided a vertical reaction at the supports but allowed rotation and horizontal displacement of the bottom chords (Figure 2-19).

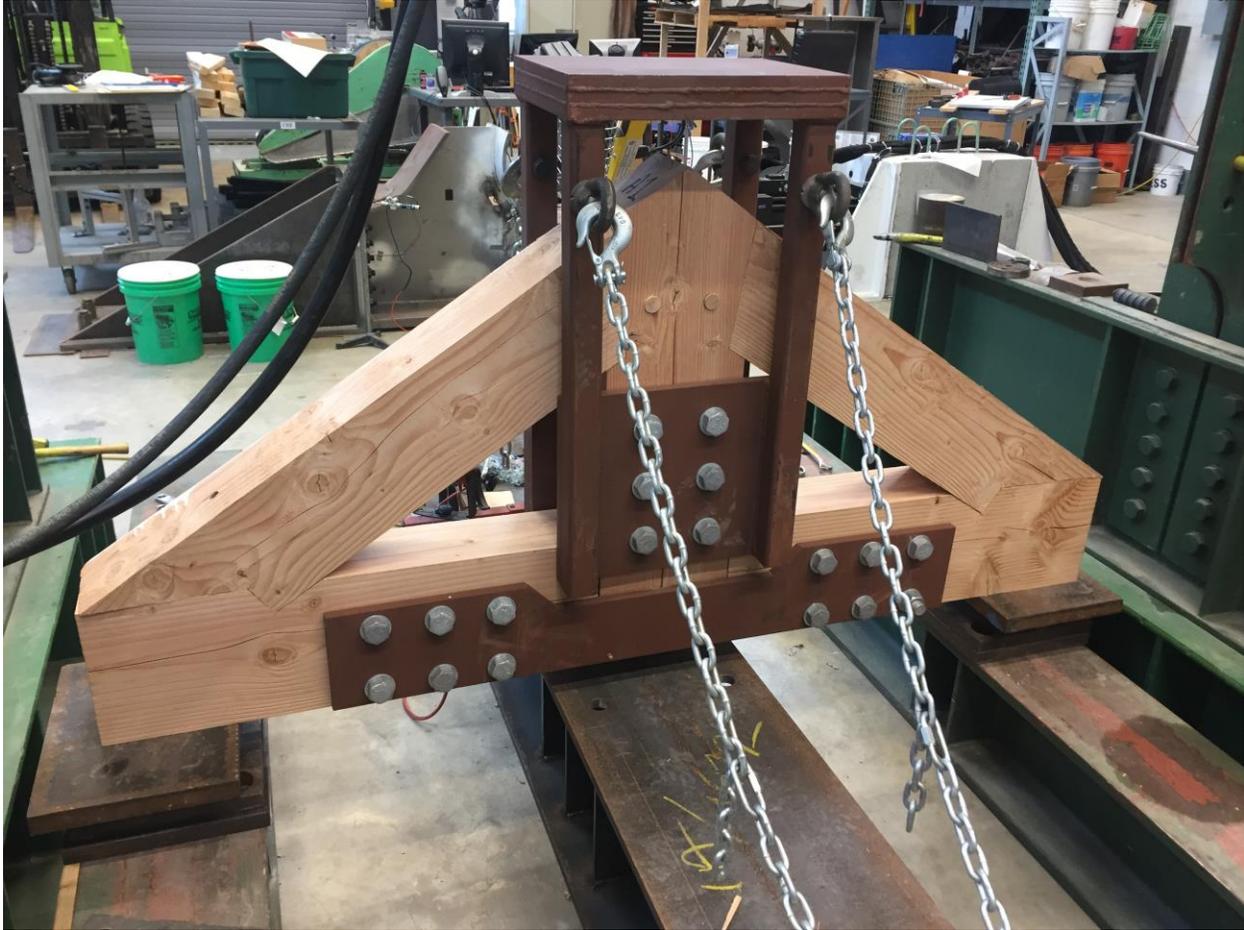
Figure 2-22: Truss in place in the UNH reaction frame (side shown is opposite the DIC painted side).

The trusses were moved into position beneath the hydraulic ram using an overhead crane. The truss was centered beneath the hydraulic ram in both directions, and the heel supports were adjusted so each heel location was supported by the steel plate/roller for nine inches from the end of each bottom chord timber to replicate in-practice loading conditions. Two chain tension ties were attached to the front and back of the steel testing frame as a safety device to restrain the truss in case of lateral buckling (Figure 2-22).

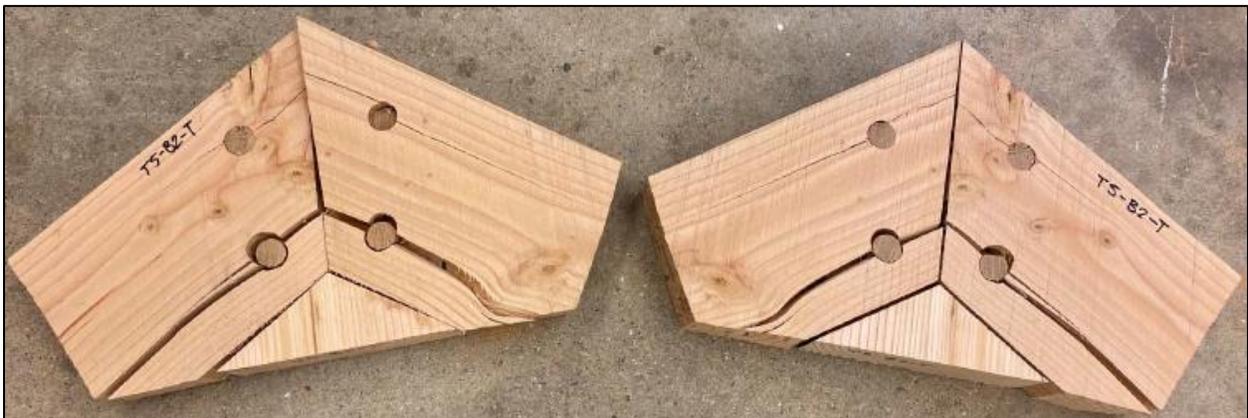
Figure 3-7: Cut view of Trial 5 Truss B2 crack formation at lower peg location.

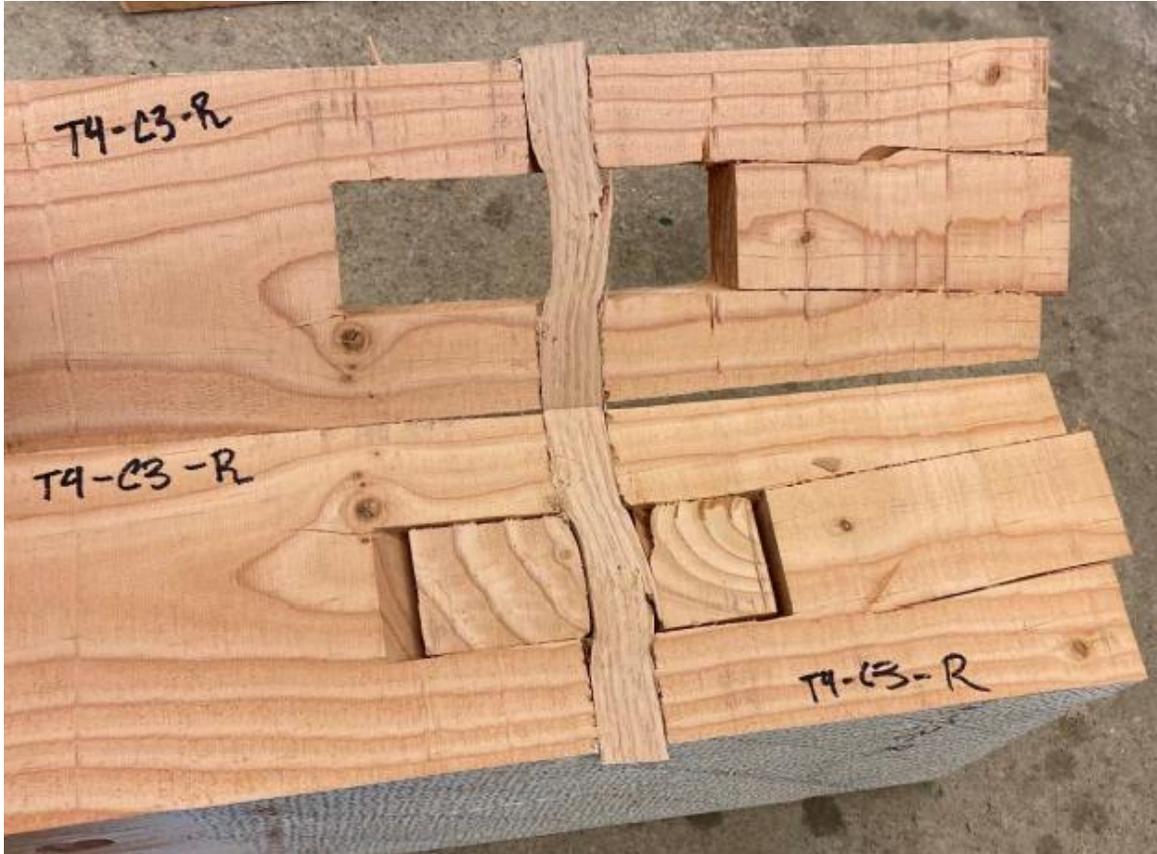
Figure 3-11: Yielded peg failure concurrent with block shear of the BC at Trial 4 Truss C3 Heel 2.

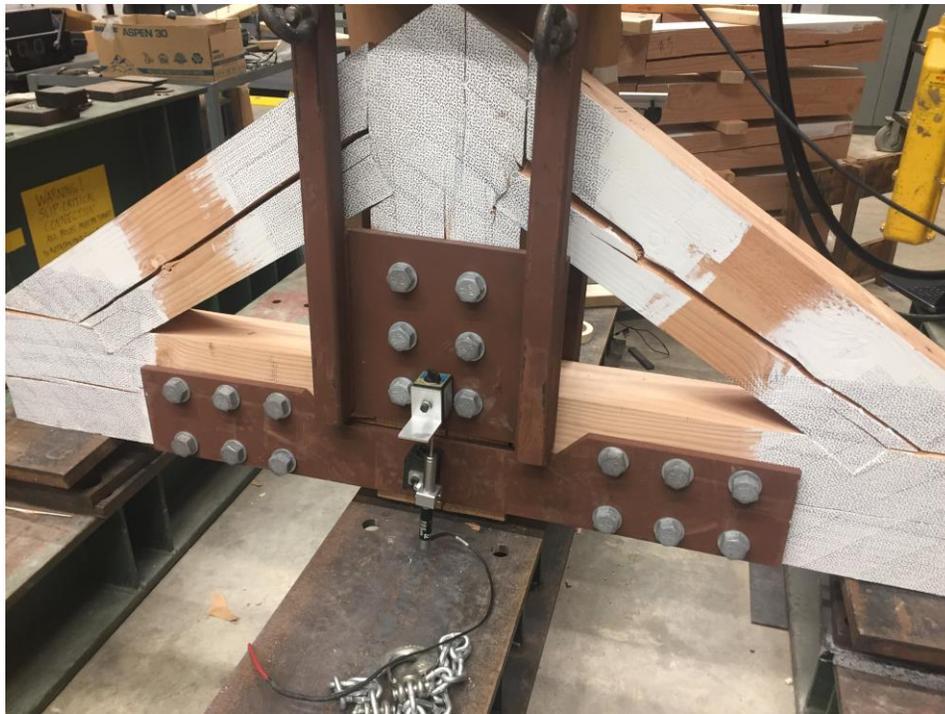
Figure 3-27: Full-length splits of both top chords of Trial 6 Truss C1.

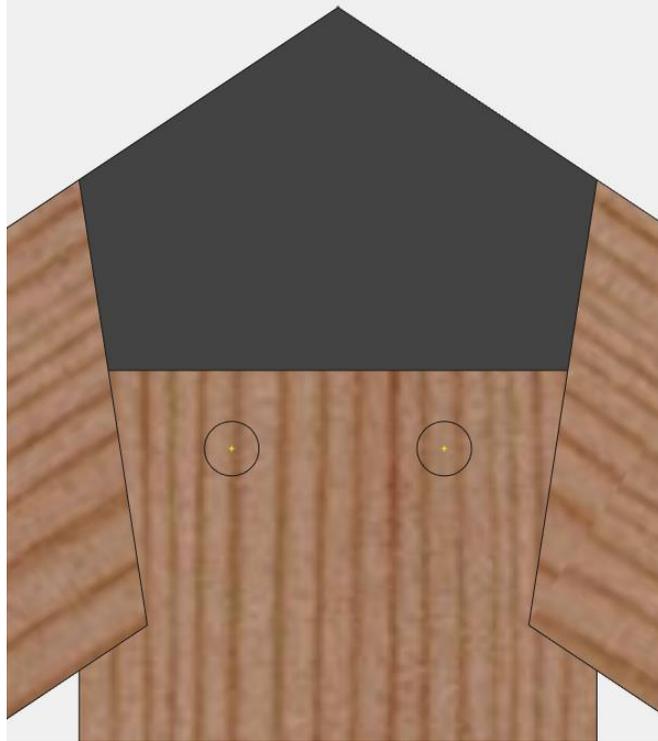
Figure C-2: Cross-section of a block shear plane in the KP of Peak Style A.

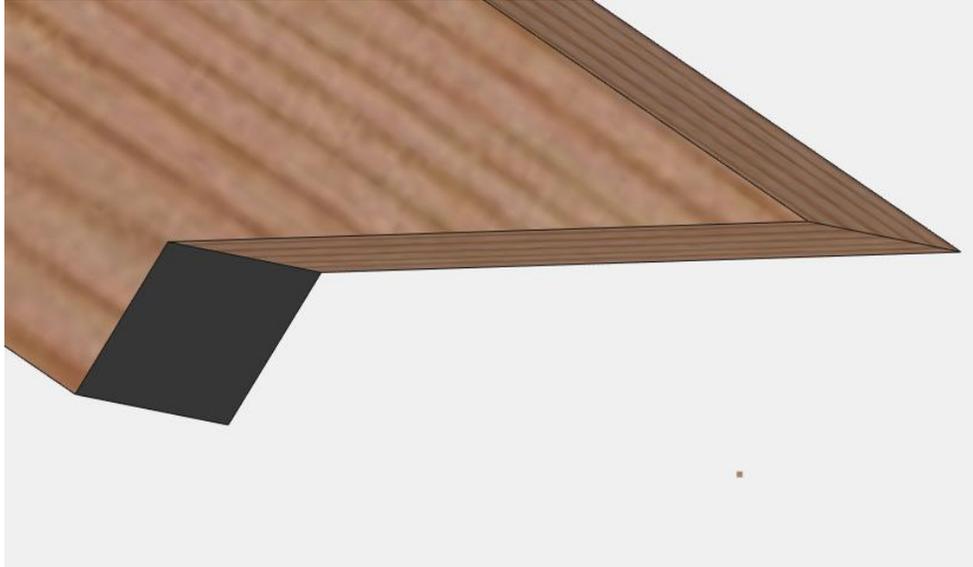
Figure C-5: Bearing area of TC shoulder for Heel Style 1.

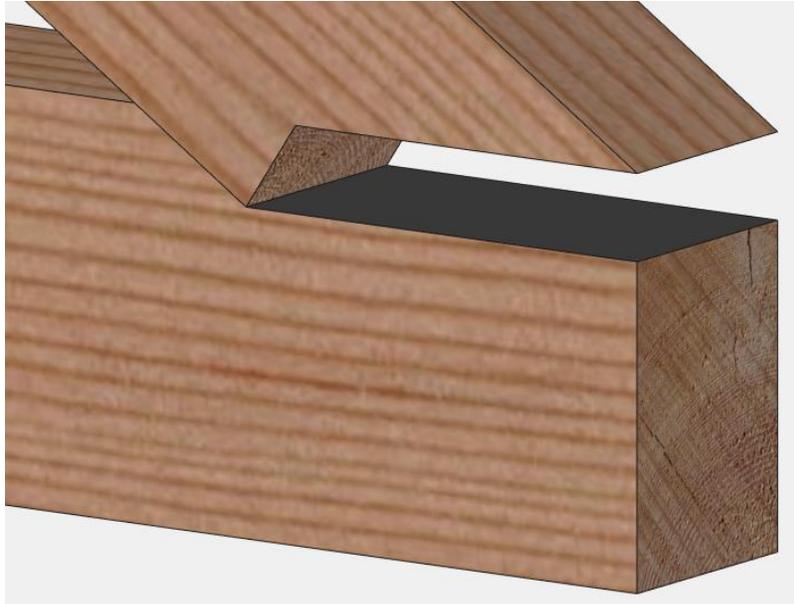
Figure C-6: Block shear plane of BC for Heel Style 1.
