TIMBER FRAMING

JOURNAL OF THE TIMBER FRAMERS GUILD

Number 103, March 2012

THE SWING-BEAM BARN IN SOUTHERN
WASHINGTON COUNTY, NEW YORK 4
Molly McDonald and William Krattinger

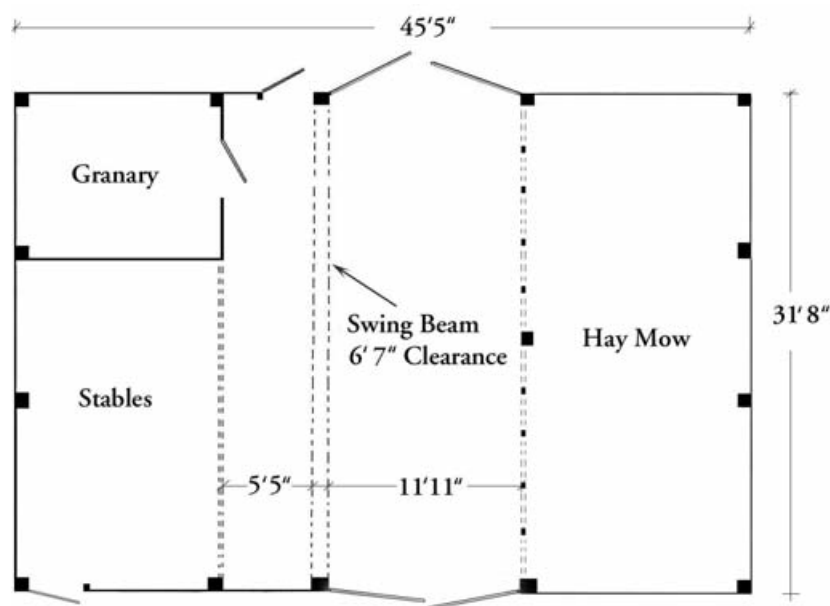
5 Plan view of 32x45-ft. barn at Hillview Farm near North Cambridge, N.Y. Hewn pine swing beam is 18 in. deep (see Fig. 11 for detail view of swing beam).

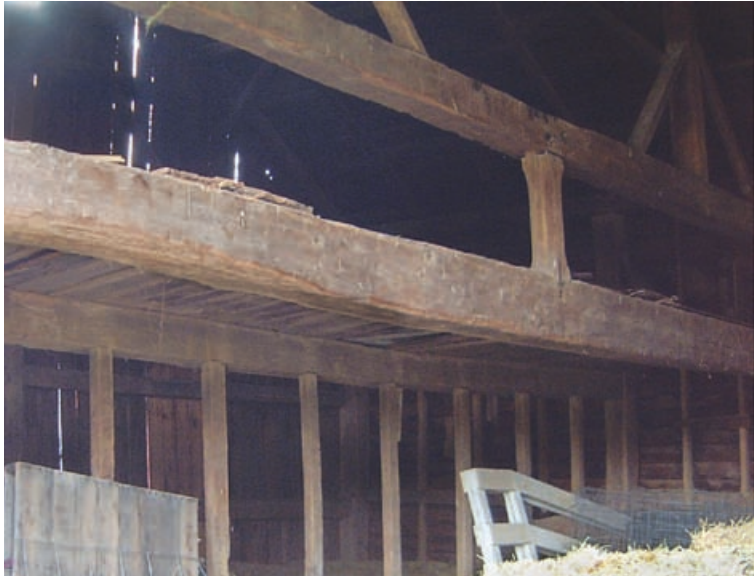
6 Swing beam in barn at Sharts Family dairy farm, North Road, near Greenwich, N.Y., formed of two swing-beam barns placed end to end. Studded wall, once boarded, partitioned off animals and grain room. Note sturdy chamfered strut to upper beam supporting braced purlin posts (one dimly seen at upper right). Scaffold poles (now removed) ran over threshing floor for drying crop to be threshed.

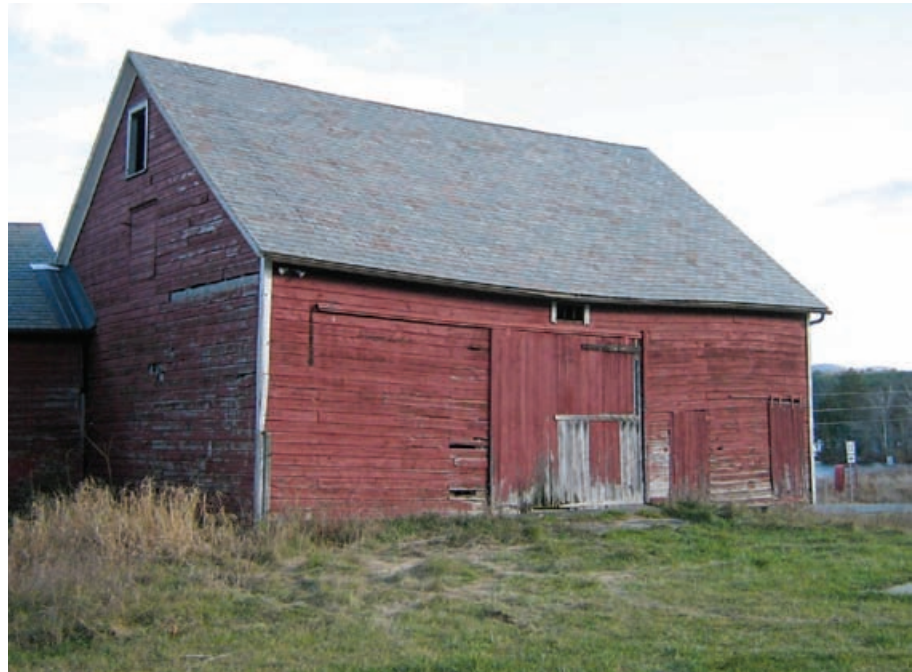
7 Barn at Kenyon Hill Road, Jackson, N.Y., signed J.D. and dated 1812 on its swing beam. In form and framing, barn follows New England-style four-bent, eaves-entry English barns, with added bent.

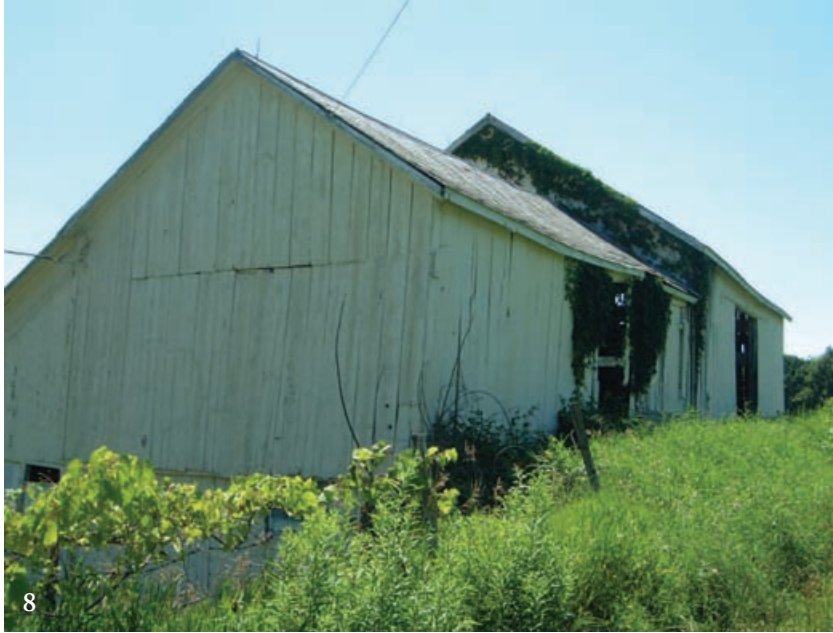
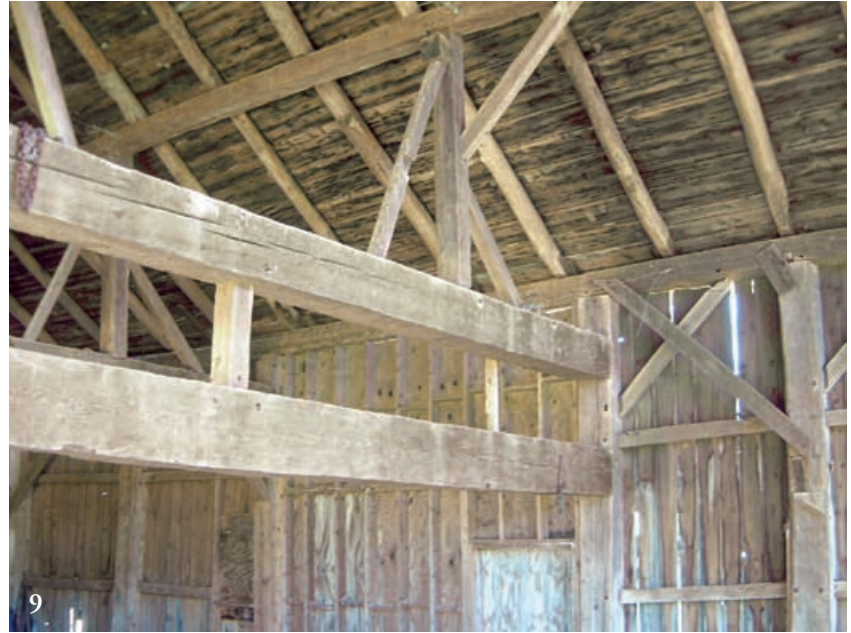
8, 9 A. McLean barn, 30x46 ft., North Cambridge, N.Y. Transverse beam once was installed in post at far right of Fig. 9, supported by regularly spaced studs that partitioned off animals and grain room.

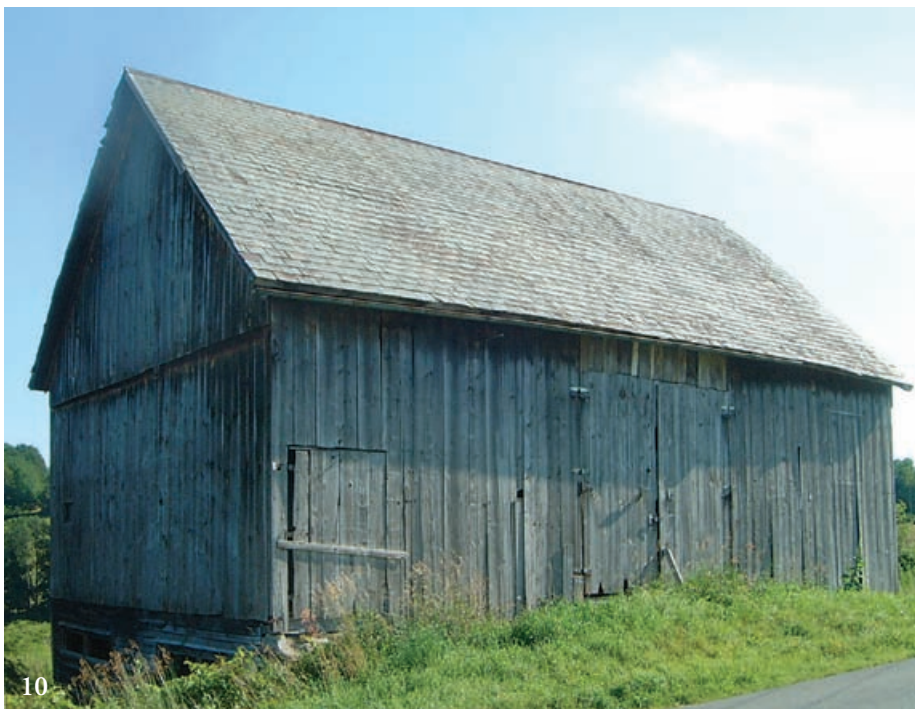
10 English barn with somewhat elongated eaves walls, on King Road, Cambridge. Distinctive interior features include a crowned swing beam and a wind-braced ridgepole.

on King Road near Cambridge (Fig. 10). This barn is unique among examples encountered thus far in its use of a ridgepole and associated sway bracing. The swing beam has a crown, one of three examples observed in the region to date, and was rabbeted on the inside corner of its upper face to receive planking for the loft above stables and granary. The central strut joining the swing beam and upper tie beam is also distinctive, having been fashioned from a tapered section of 2-in. plank.

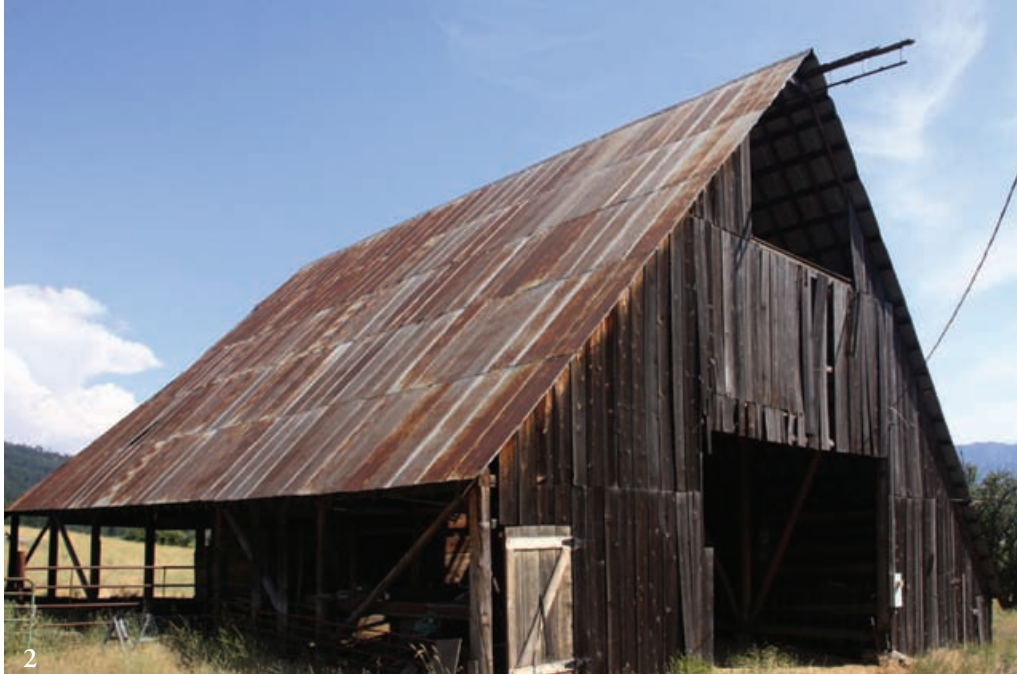
- 1 Barn cluster in Sierra Valley seen near Vinton, California.
- 2 Hannon barn, Indian Valley, 51x60 ft., after 1890.
- 3 Hannon barn interior, mostly round timbers.
- 4 Map of area discussed. Broken lines are Gold Rush trails.
- 5 Cabodi barn, Susanville, possibly 1870s, all hewn square.
- 6 Cabodi barn, detail of necked tying joint at purlin plate.
- 7 Exploded view of typical necked tying joint.

The Hannon barn, in the Indian Valley about a hundred miles north of the Carson Valley (see Fig. 4) is 60 ft. long with a 24-ft. central aisle and side aisles 12 and 15 ft. wide. The barn has round cedar posts, round sills and square purlin plates, and round cedar saplings for rafters. Longitudinal bracing runs aisle sill to purlin plate in a V pattern. Visible connections are mortised and wire-nailed, the latter dating this barn to 1890 or later. I could not determine the tie beam-plate connection. In theory, a tenon could rise from the top of the post up through the tie beam and into the purlin plate, or a rod or heavy lag screw could be bored down from the upper face of the plate through the tie beam into the post (Figs. 2 and 3).

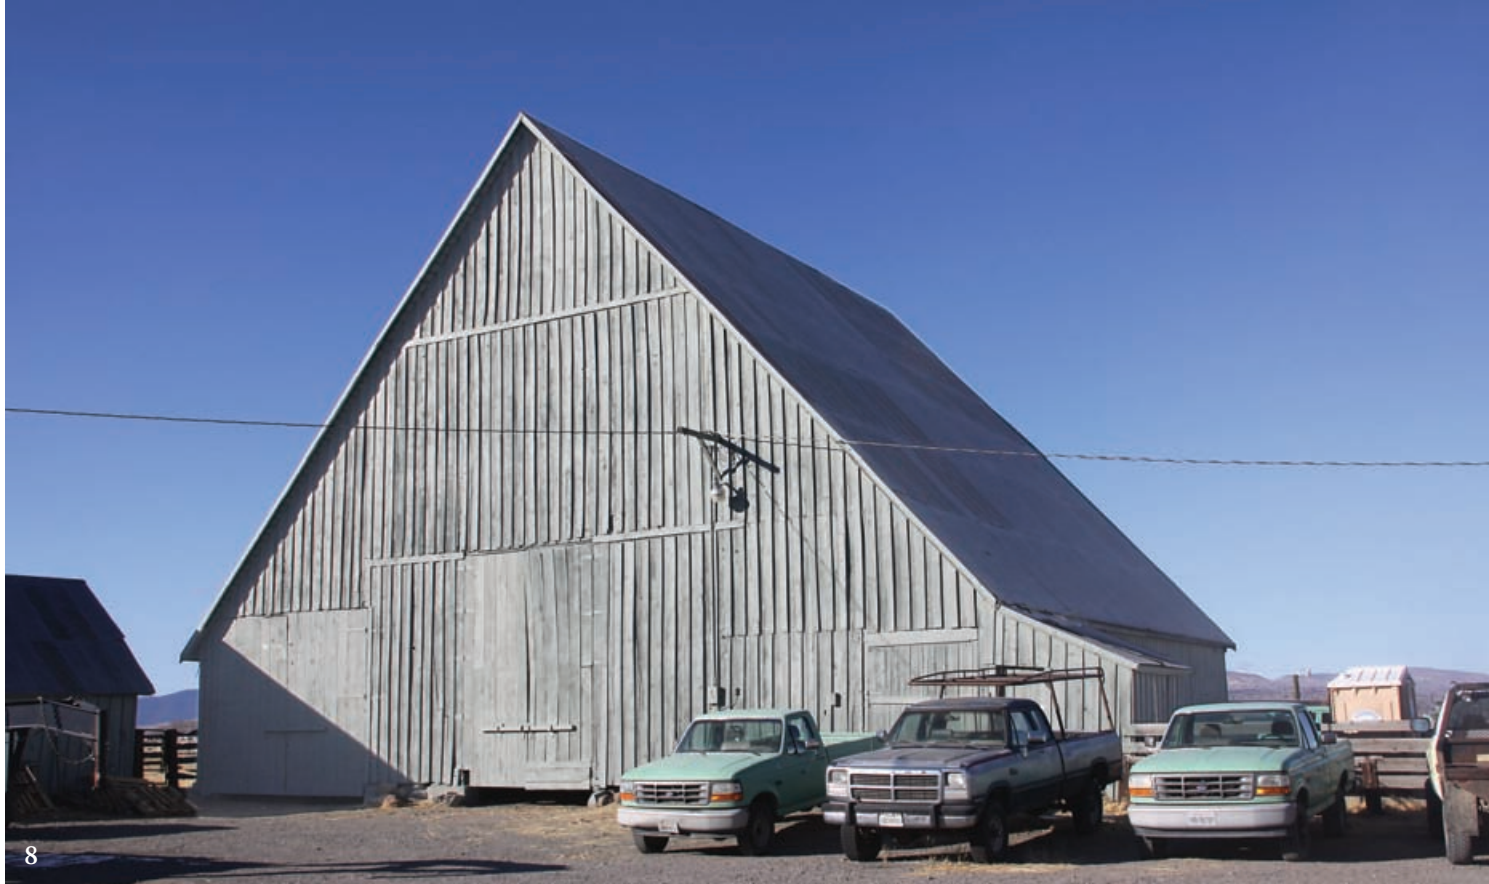
8 Facing page, Five Dot meatpacking barn at Standish, California.

East of Susanville on US 395 toward Standish stands another substantial barn with sill-to-plate bracing (Fig. 8). Today it's owned by Five Dot Cattle Co., meatpackers. This late 62x60-ft. barn is built with sawn 8x8 timbers and nailed connections, in six equal bays. Long 2x8s nailed to the undersides of the rafters stiffen the skip-sheathed roof membrane (Fig. 9). The main aisle is 30 ft. wide, the side aisles 16 ft. The first and last 10-ft. bays use inverted V-bracing that clasps the tie beam while the other bays have standard head and foot braces. Aisle purlins are supported by brackets (some incomplete) from the purlin posts (Figs. 9 and 10). Front and rear gable walls have modified A-braces (they don't meet at the peak) along with standard head braces. Originally the Five Dot barn also had long braces running from the cross sills into the posts, which will be illustrated in the next example.

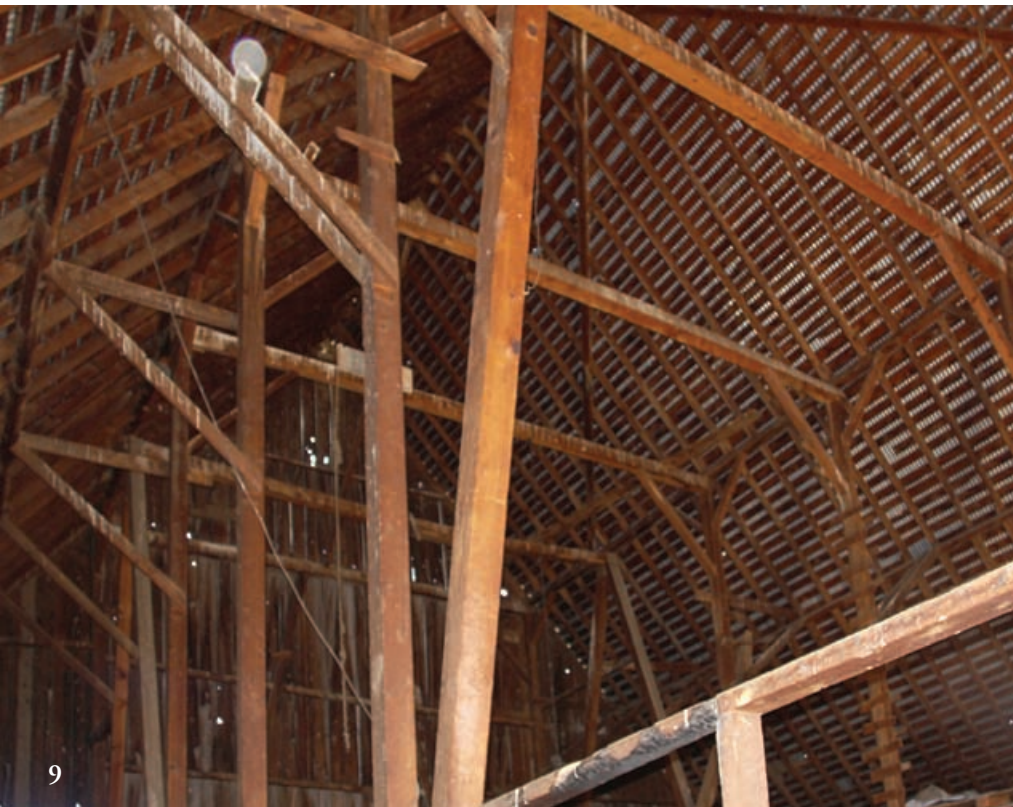
9 Five Dot central aisle. Note under-slung nailed roof bracing and brackets to purlin in aisle roof.

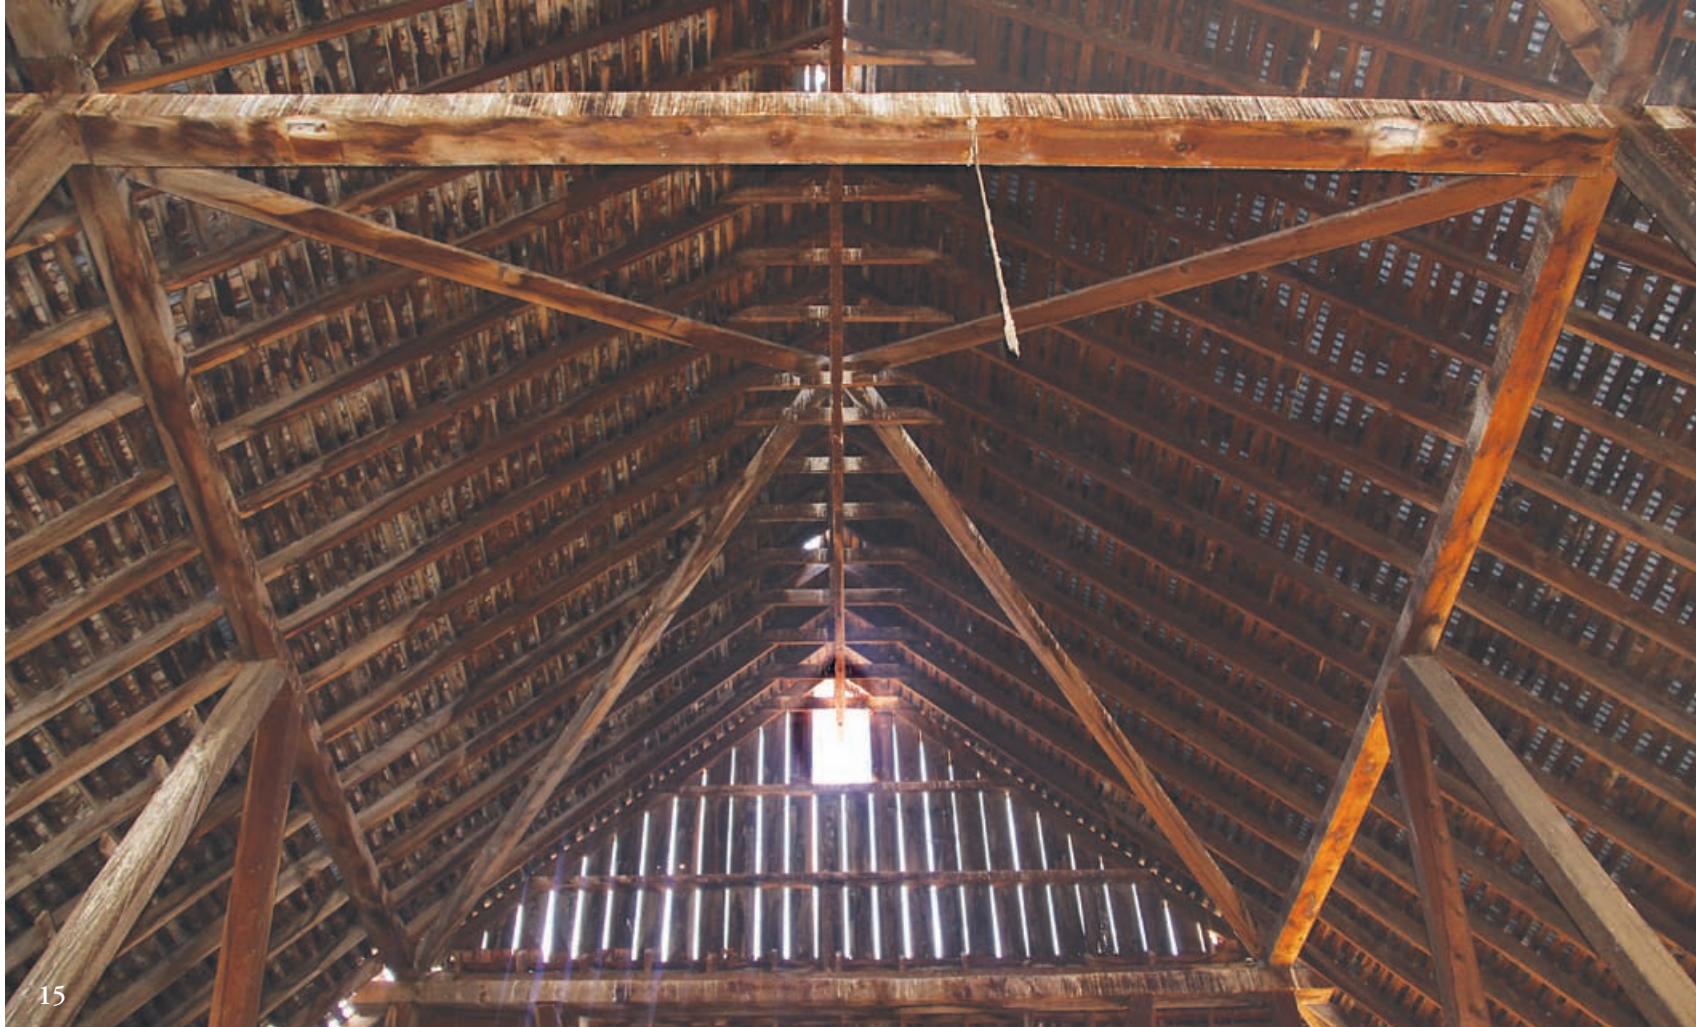
15 Big Sky Road barn, Susanville, California, one of two 28x30-ft. bays showing heavy pyramidal roof bracing rising from purlin plates. Paired aisle braces descending from purlin plate stand in plumb plane.

Bracing the 30-ft. bays lengthwise is accomplished by four giant A-braces, one in each bay along each side of the central aisle (cover photo and Figs. 19 and 20). The end bents use transverse V-bracing to the sills. I was perplexed to see empty mortises on the underside of the central tie beam but none on the posts—had the builder recycled a timber?—until from the middle of the central aisle I noticed empty mortises in the cross sill for the feet of the missing braces. Yet the most amazing framing is in the roof. Pyramidal 8x8 roof beams notched into the purlin plates and rising along the underside of the common rafters form an apex in each bay (Fig. 15). The feet of these wind braces are 28 ft. above the sills and notched about 4 in. into the plates. Though I reached one of these connections via a succession of (risky) ladders at an end bent, I could not confidently determine the configuration of the purlin plate connection to the tie beam.

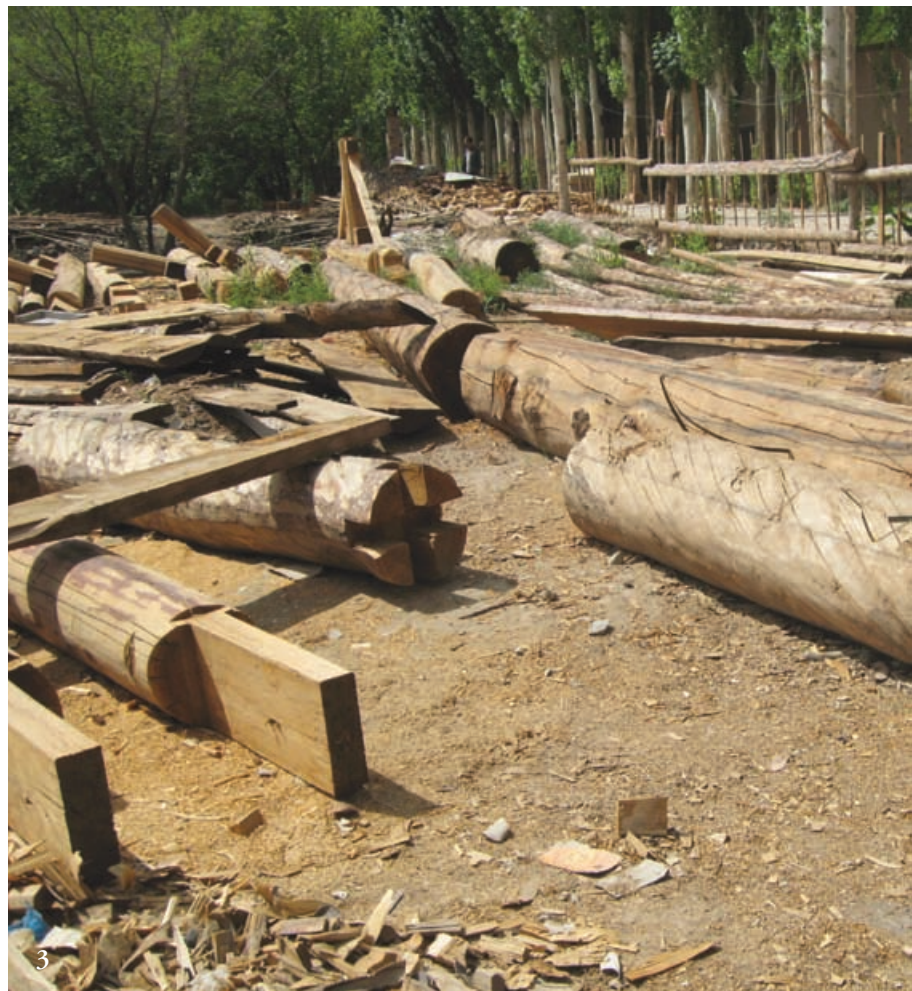
3

Material for the small common rafters was probably the local poplar, and used as found, round and irregular. The last seemed normal practice around modern and ancient Dunhuang, while elsewhere in China I had always marveled at the tendency to apply labor to hew and plane even the smallest members into a more regular form. The average larch log was 30 to 50 ft. long and, often enough, 18 to 24 in. dia. at the butt. With the notorious tendency of larch to move, particularly in these conditions of extreme dryness (Dunhuang averages 3200 hours of sunshine per year), and its hardness, heaviness and spiral grain, these must have been formidable objects to frame (Fig. 3).

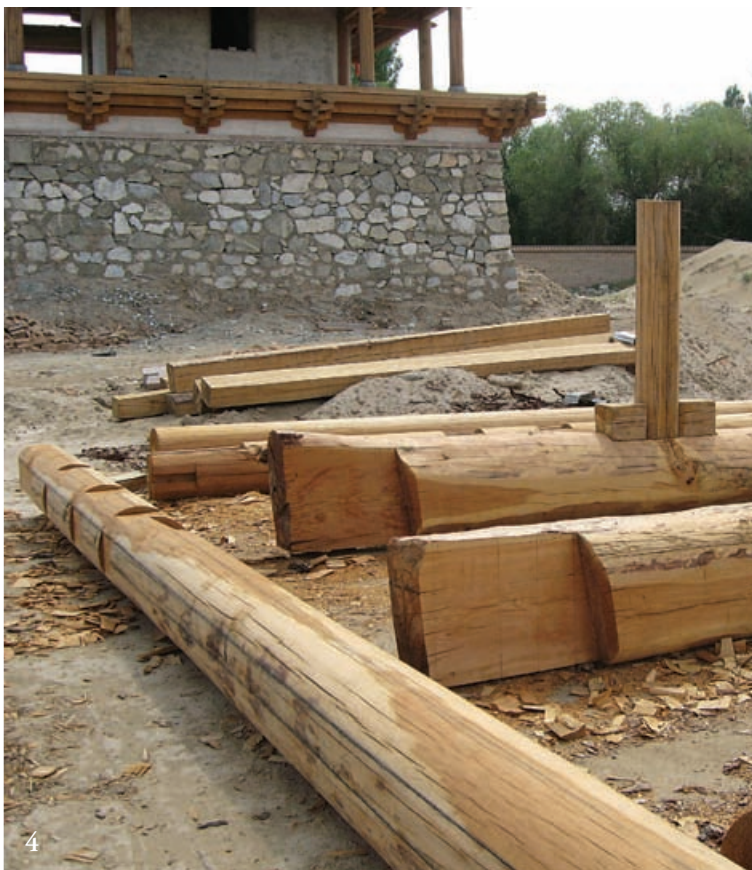
4

The typical tie beam or girt was sawn to 14x14, but many of the higher and larger horizontal ties were sawn or hewn on two sides only and left tapering and irregular on the other faces (Fig. 4). This was a characteristic, I was assured by the foreman, of late Sui–early Tang (618–907) framing, abandoned in favor of more extensive conversion of all timber during following dynasties. The same distinction apparently applies to the decorative carving of architectural elements such as brackets: minimal in Tang structures, extremely elaborate 1000 years later (Fig. 5).

No one in the *Lu Ban Jing* is seen using a *beng*, but rusty ancient examples show up in museums in western China. Since the *beng* carries out most of the functions of the axe, the carpenters building Da Soong used the small handaxe only to drive chisels and nails and to pare. I saw evidence of juggling or scoring for hewing, but didn't see how it was done (Fig. 4, far end of long timber).

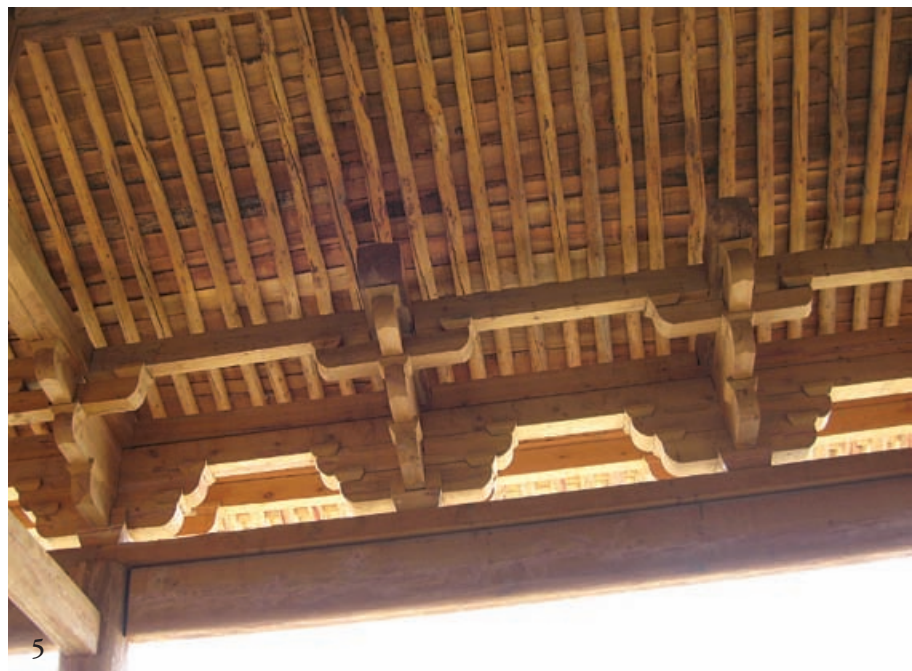
5 Above right, roof bracket sets without decorative carving.

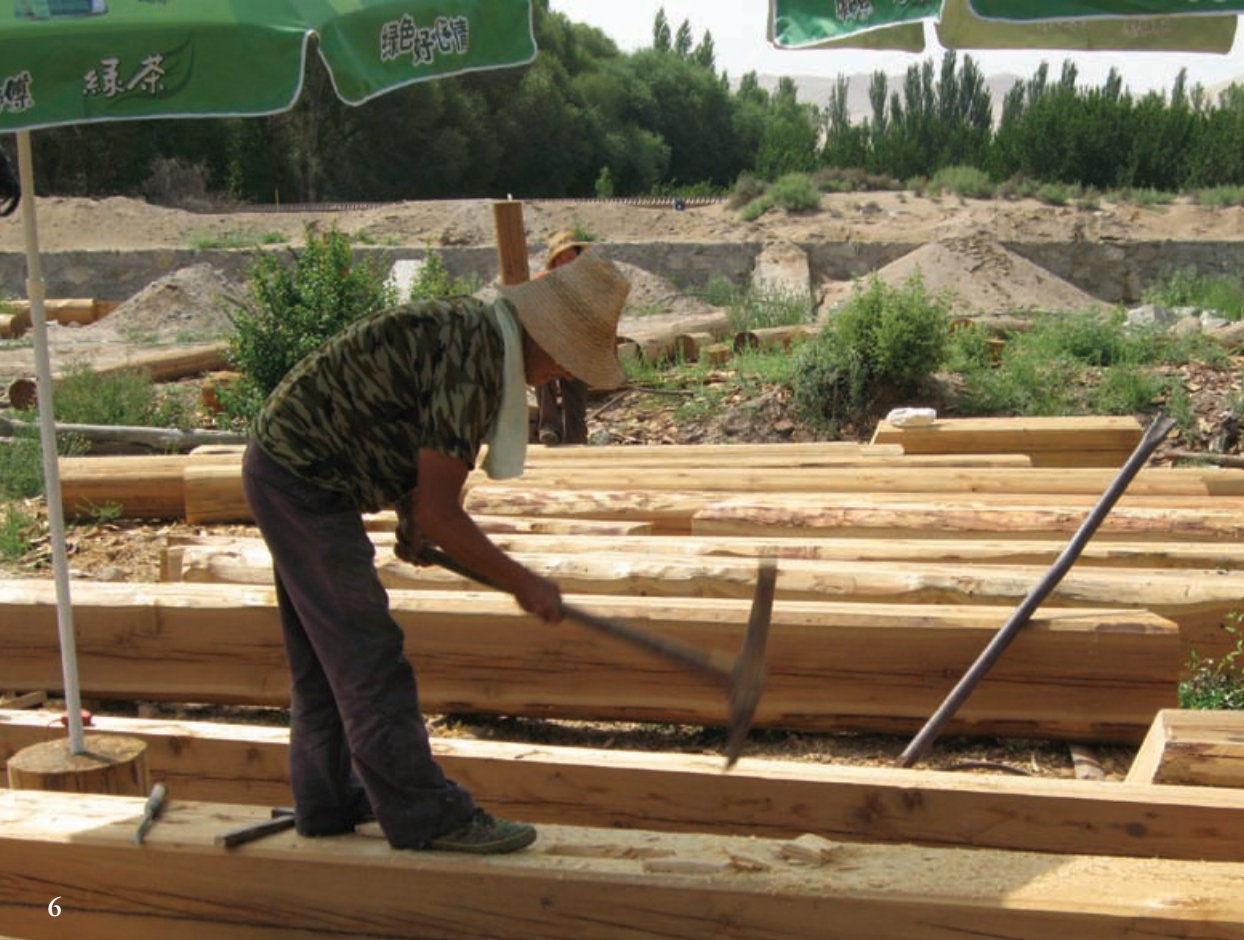
6 Chopping out the bulk of a mortise with the *beng* after starting cheeks with chainsaw.

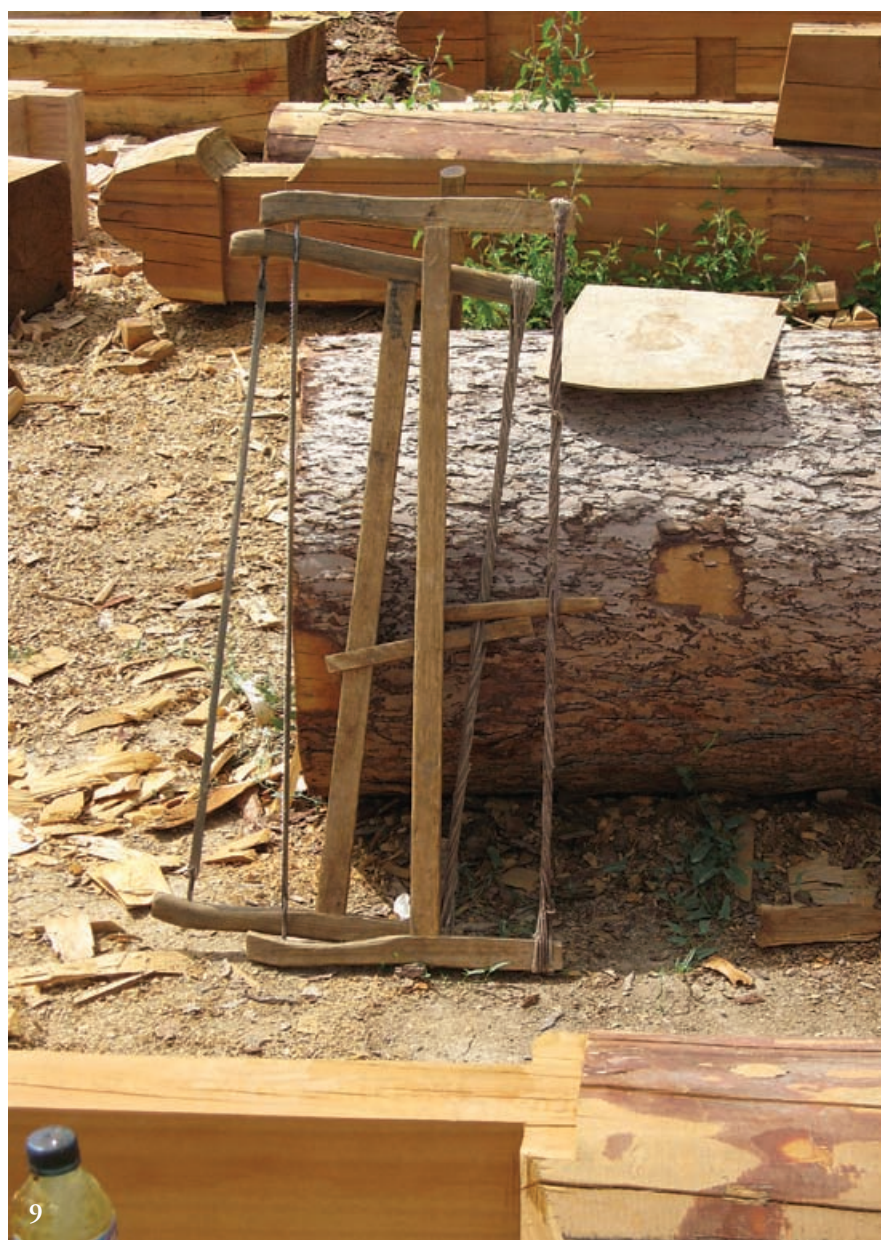
9

Tenon shoulders, meanwhile, were cut with frame saws (Fig. 9).

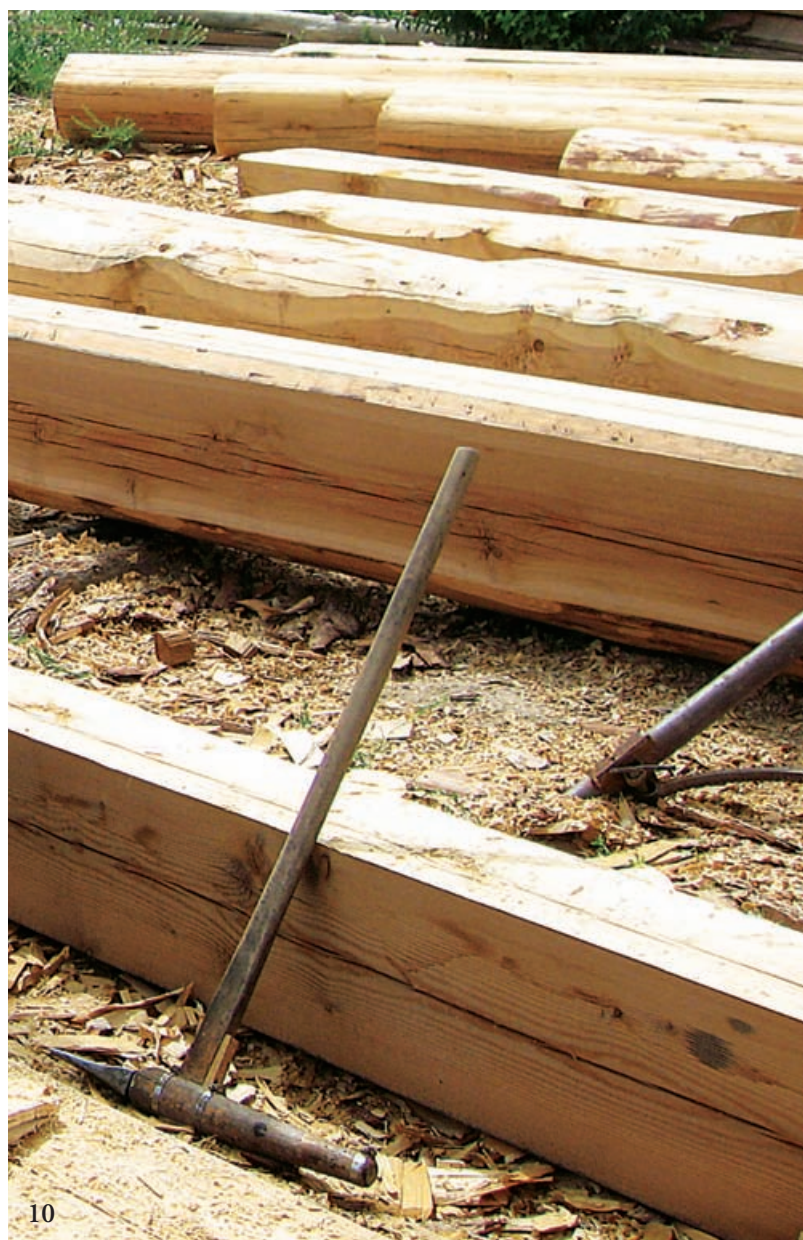
10

The *beng* has a straight wooden handle about 3 ft. long carrying a socketed heavy chisel at one end of its wooden head. The opposite end of the wooden head is round and bound by an iron ferrule, suggesting its use to drive wedges and to drive joinery together. The *beng* is swung in front of the body like an adze or mortise axe to debark logs, hew between scorings, waste deep mortises (Fig. 6) and trenches, round protruding ends of beams and do perhaps a thousand other tasks. In function it is related to the English twybil or French *bisaigue* except that it has only the one blade, about 2 in. wide in the examples I saw (Fig. 10).

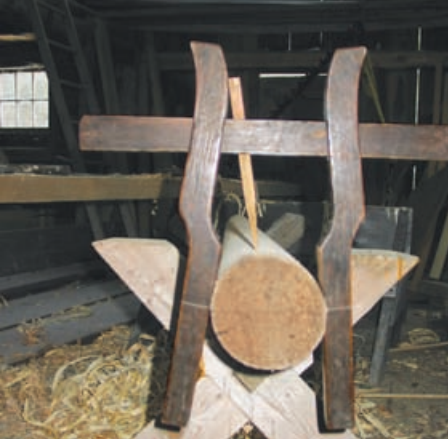
11 *Zhu jia-zi* posed at author's US workshop.

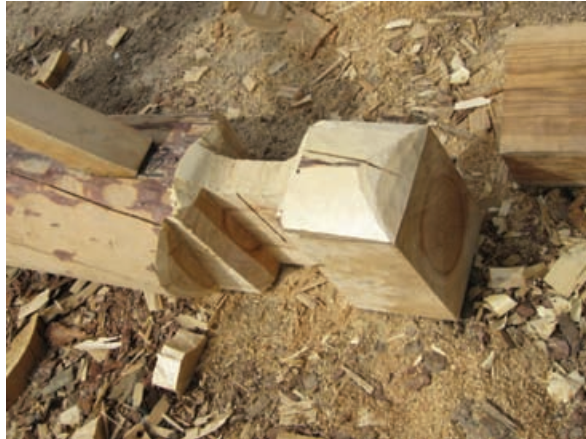
12 Reduced shoulders and tie beam end for bridle joint roughed out by the *beng*.

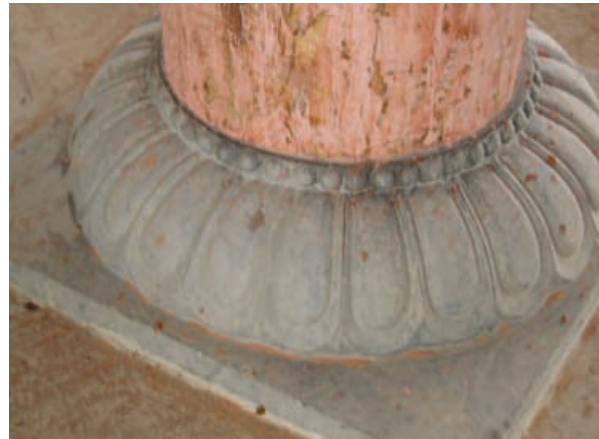
13 Limestone column base. Larch column has been sized and scraped, first of many painting steps.

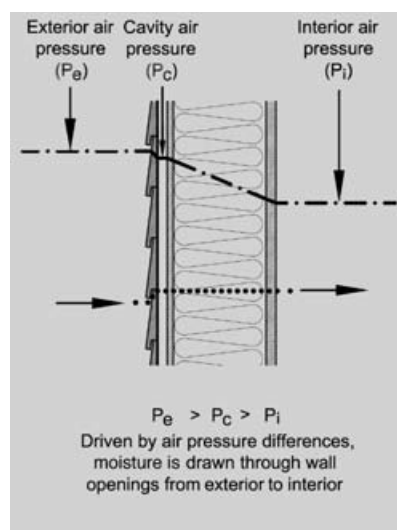
1 Air pressure differences alone can move moisture.

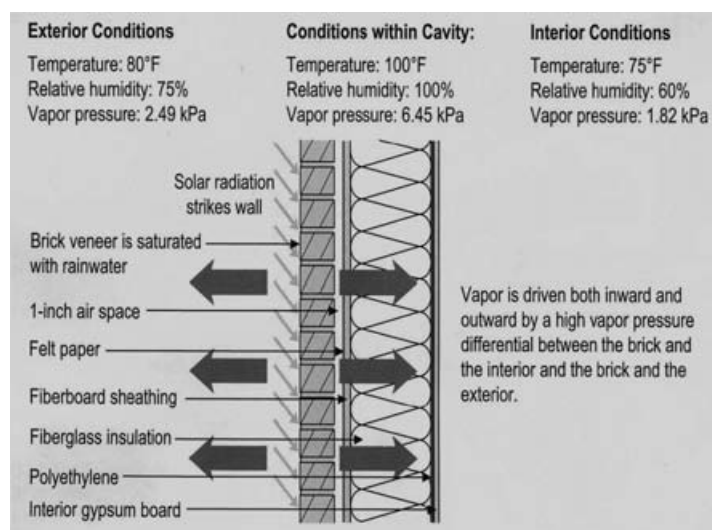
2 Solar radiation, vapor pressure and resulting movement of water through wall cavity. 1 kPa (kilopascal) = 20.89 psf.

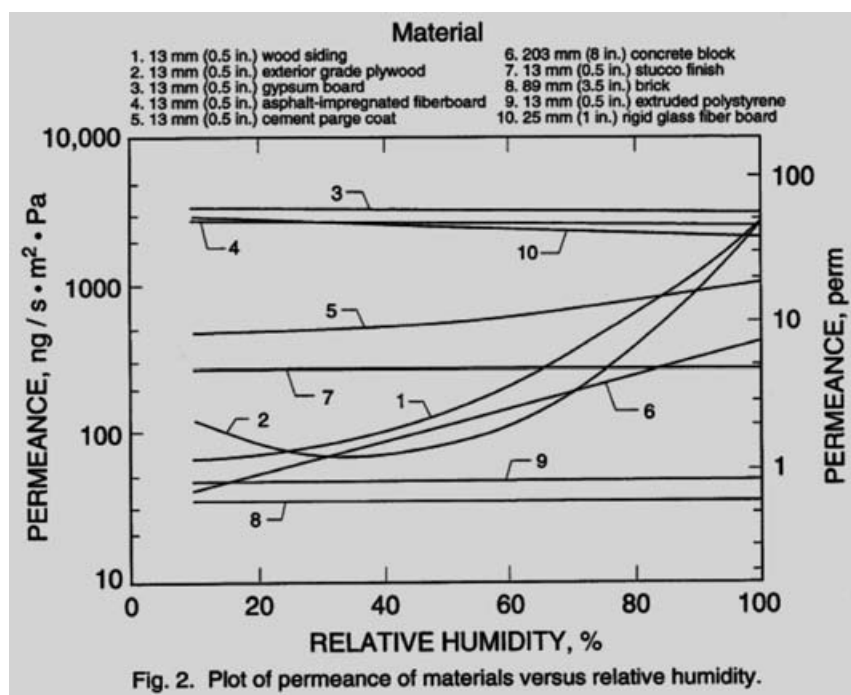
4 At right, generally direct relationship between relative humidity and permeance. Each line represents a particular material numbered in key at top.

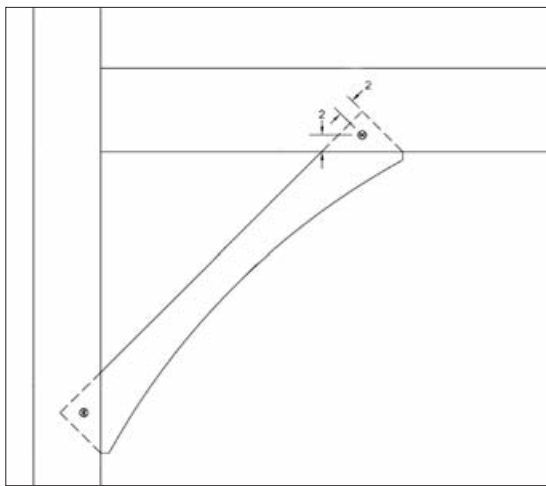
5 Draining brace mortises for exterior use.
