JOURNAL OF THE TIMBER FRAMERS GUILD

Number 93, September 2009

Restoring a Queenpost Truss Covered Bridge

The Abyssinian Meeting House

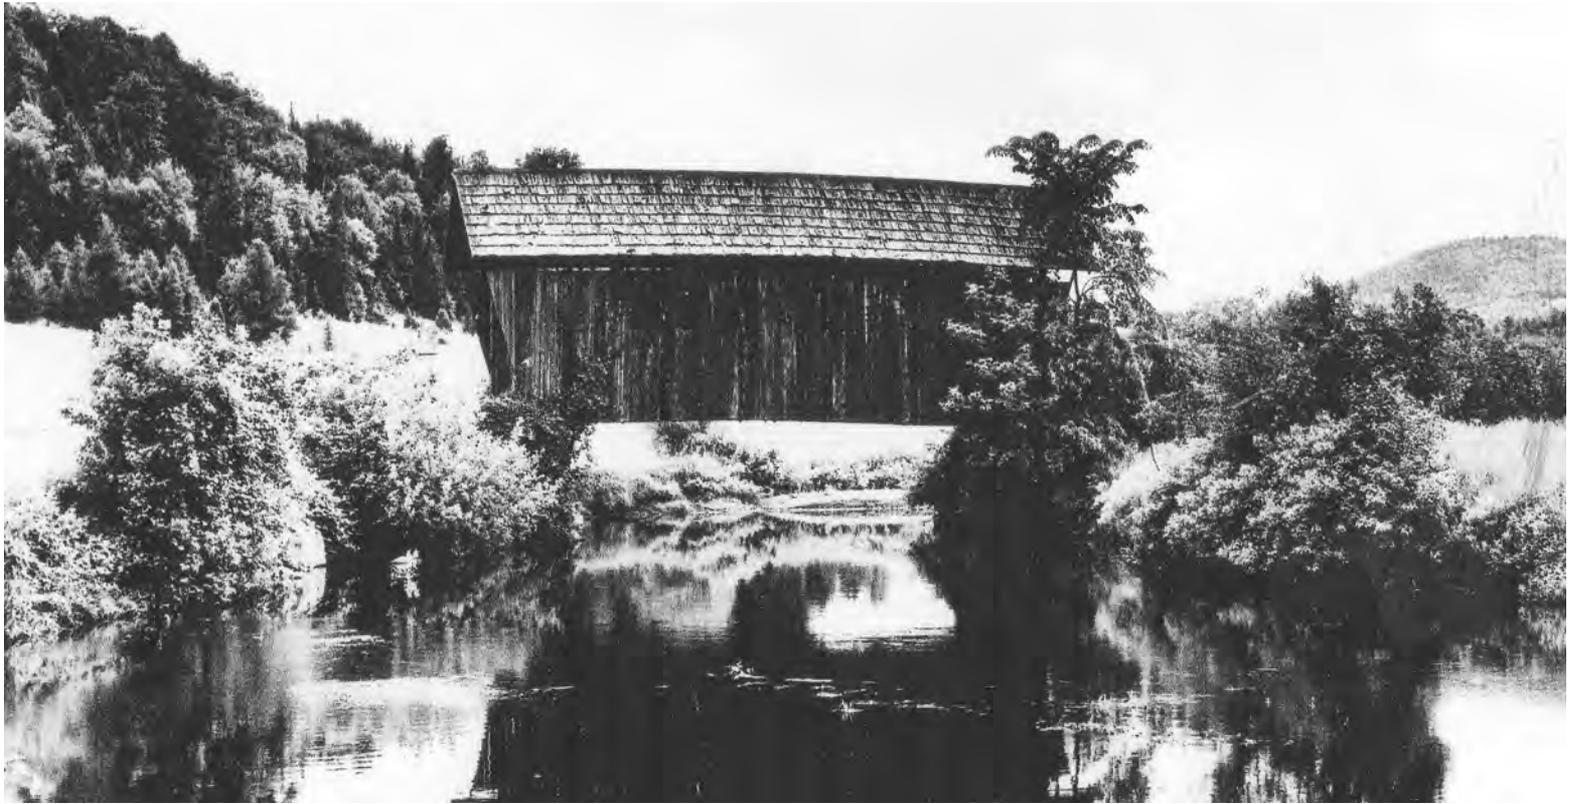
Fig. 1. Historic photo of the Martin bridge over the Winooski River, Marshfield, Vermont, ca. 1890.

BY most accounts, the Martin covered bridge, which spans the Winooski River in Marshfield, Vermont, was built by Herman Townsend for Harry Martin, circa 1890 (Fig. 1). Townsend was primarily a barn builder and there is no record of other bridges built by him. The Martins owned a farm along the Winooski, with rich soil and pastures on both sides of the river, and used the bridge to gain access to their fields. It is believed to be one of the last remaining agricultural bridges in Vermont.

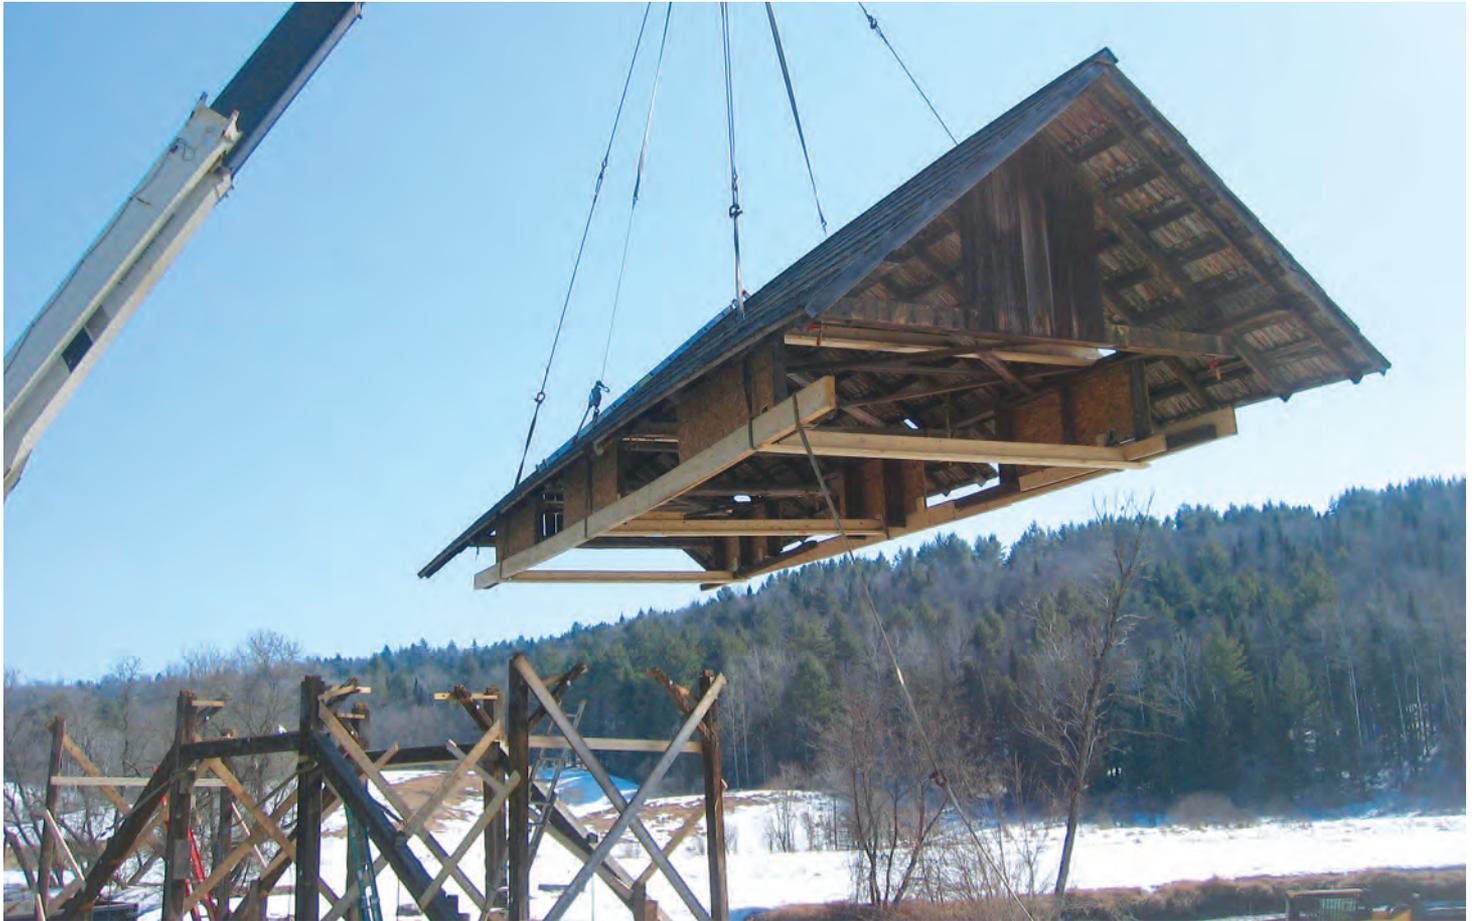
Fig. 2. Removing roof frame after bracing and reinforcement in place.

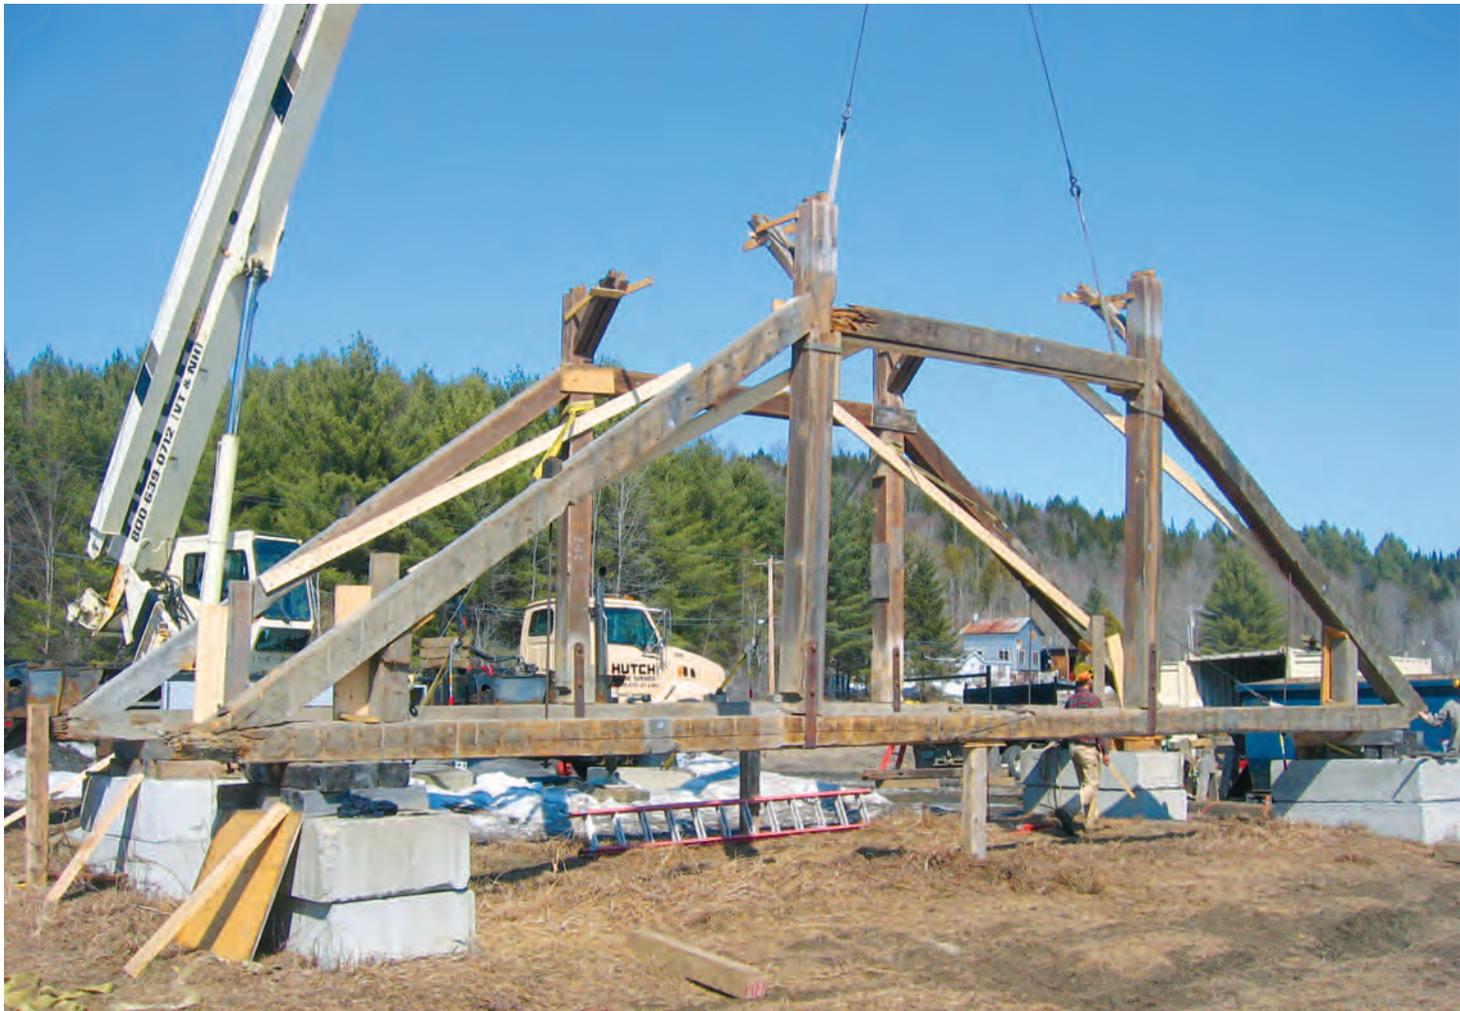
Fig. 4. Trusses exposed. Note heavy stirrup straps at bottom of queenposts and short, twinned braces at top. Struts between main braces and queenposts have been removed. Original camber in scarfed bottom chord has disappeared. All timbers tagged with disks.

WITH the trusses exposed, we tagged all the members (Fig. 4). Once all of the timbers were apart, we were able to fully inspect everything. Both bottom chords as well as one of the queenposts and a main brace were in need of replacement. The other three main braces were mostly good and only needed simple repairs at their feet. We replaced the upper 5 to 7 in. of thickness of each main brace for a distance of approximately 30 in., using a bladed abutment at the top end. The new wood was bolted to the rest of the main brace using traditional cast-iron ogee washers between the fasteners and the wood. The pair of bolts that fastened the main brace heel to the bottom chord would also capture the new wood (Fig. 5).

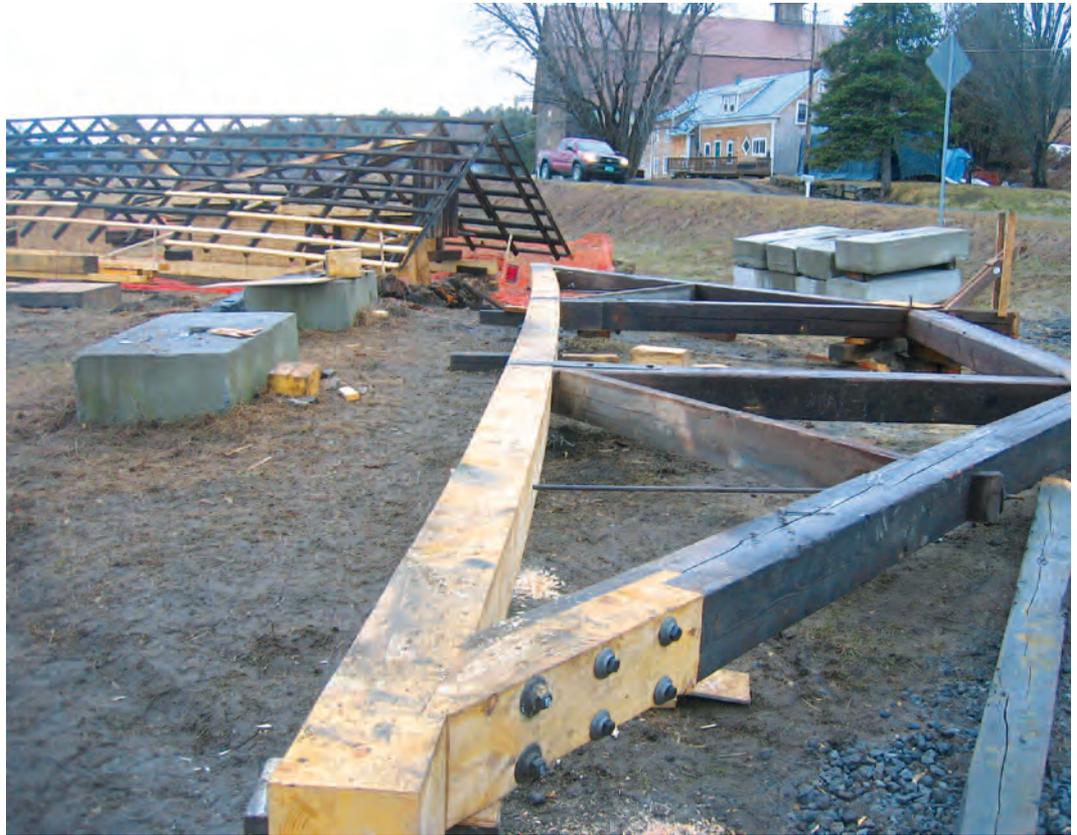
Fig. 5. New cambered chord and repaired main brace in reassembled queenpost truss.

After adding the two portal bents, we brought in the roof framing skeleton (seen in the background of Fig. 5), which by this time had had any rotted material stripped and replaced. One unforeseen obstacle was that we had locked the rack into the roof frame with all of our temporary bracing, which made it impossible simply to lower the frame back down onto our six posts now forming a square and level plan. Instead we had to engage one side first, lowering it just enough until the tie mortises on that side registered on their post and brace tenons. We then pulled the second side of the roof horizontally, until its mortises lined up with the posts and braces on that side, and lowered it down.

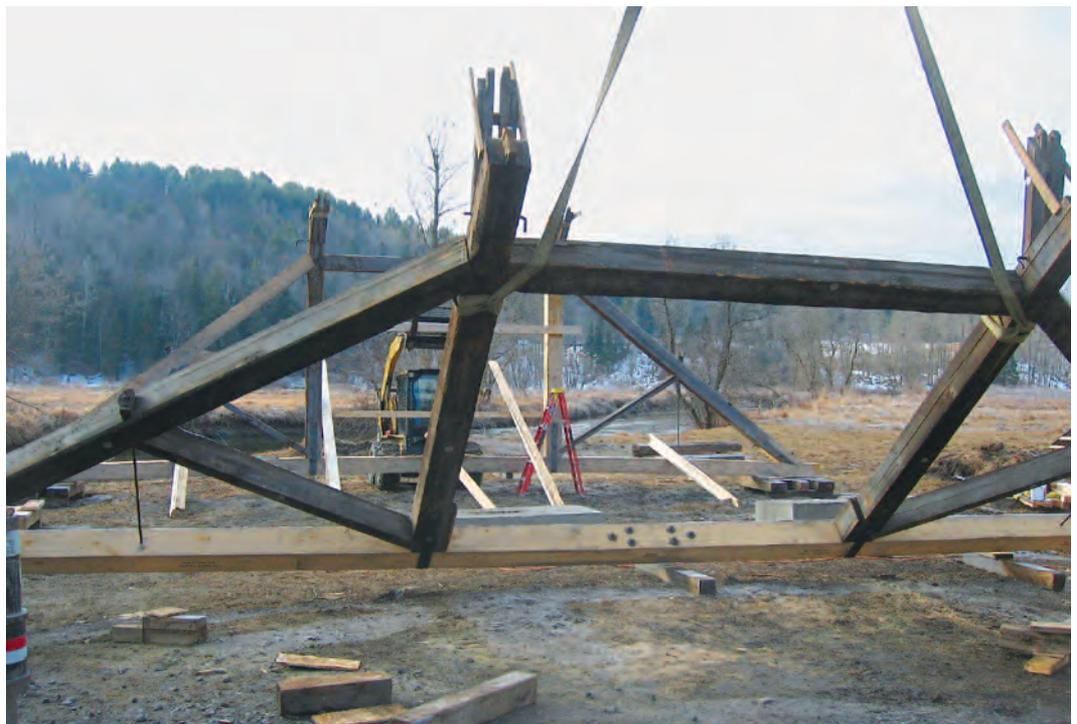
Fig. 6. Truss rising on blocking. Twinned braces prepositioned and strapped to top of queenposts, ready for tie beams. Portal bents will be added, then roof structure.

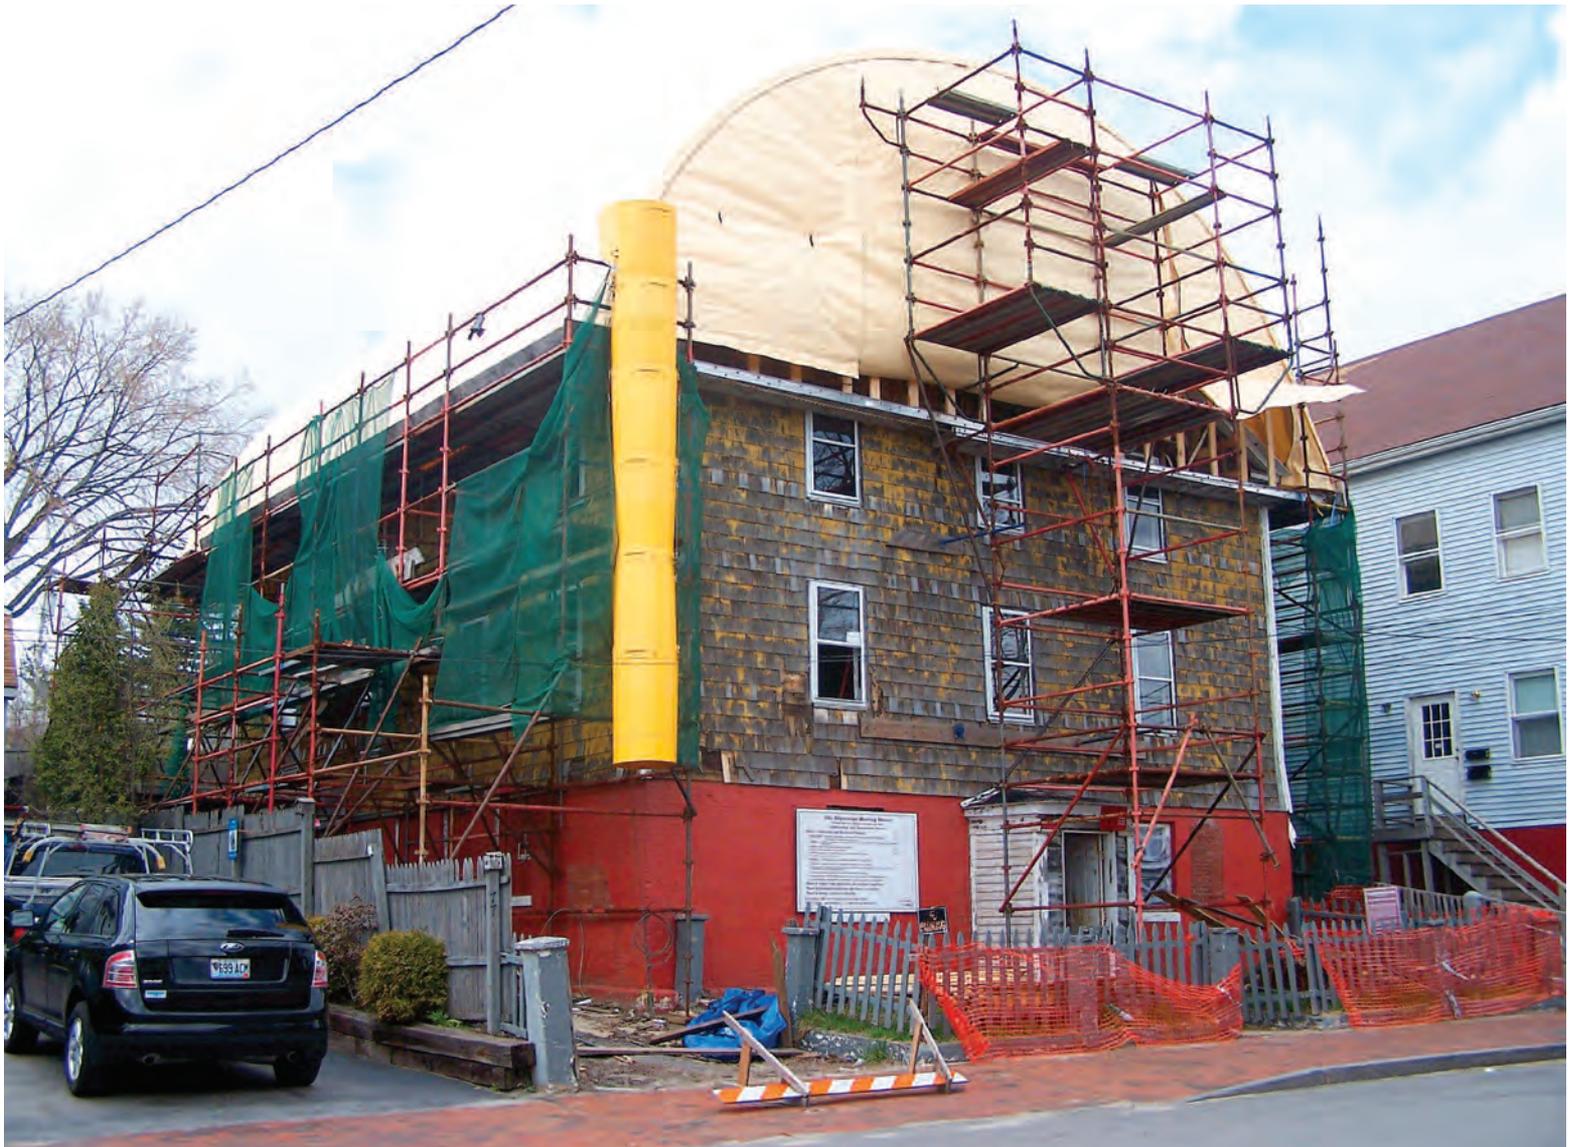
Fig. 1. Abyssinian Meeting House, Portland, Maine, 1828, under the temporary protection of a portable airplane hangar.

To assess the long-suffering building and begin accurate repairs, the restoration committee hired Arron Sturgis of Preservation Timber Framing, Berwick, Maine. To protect the structure during the complete reconstruction of the roof frame, the company set a portable steel-and-fabric airplane hangar 42 ft. wide over the top of the Abyssinian, which also allowed the necessary demolition to begin last winter, a brutal one along the Maine coast. The crew (Fig. 2) removed layers of drywall and plaster (including a dead cat found in a wall by Pete Dellea), hauling it to a dumpster in barrels, to expose the building's bones. Beholding an all-but-wrecked frame after weeks of interior demolition, members of the crew were impressed that it still stood. Foreman David Ford, who later remarked on the folly of "cutting the heart, lungs and spleen right out of the building," called it "a nightmare." Dan Boyle summed it up as "war-torn." Brian Cox wondered how it had remained square with so many structural members removed. Meanwhile, the Abyssinian's former life was slowly revealed.

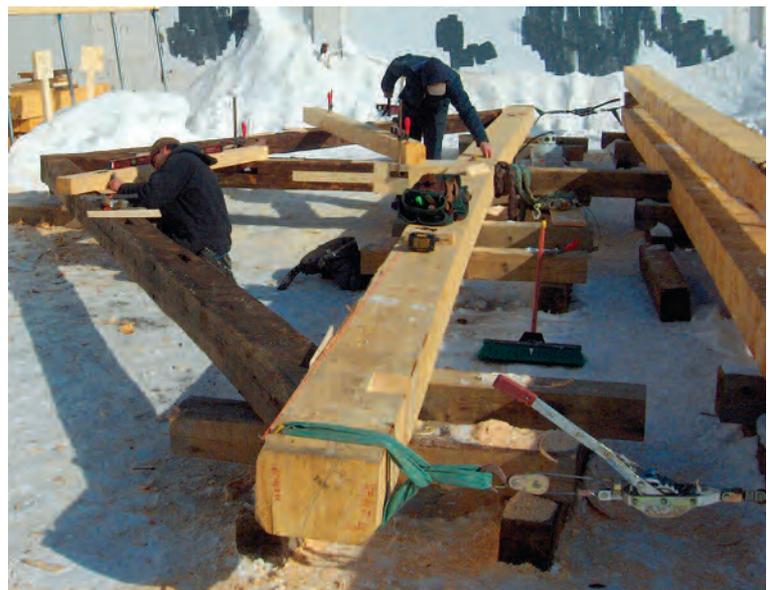
Fig. 5. Cambering lower chords for trusses and scribing struts.

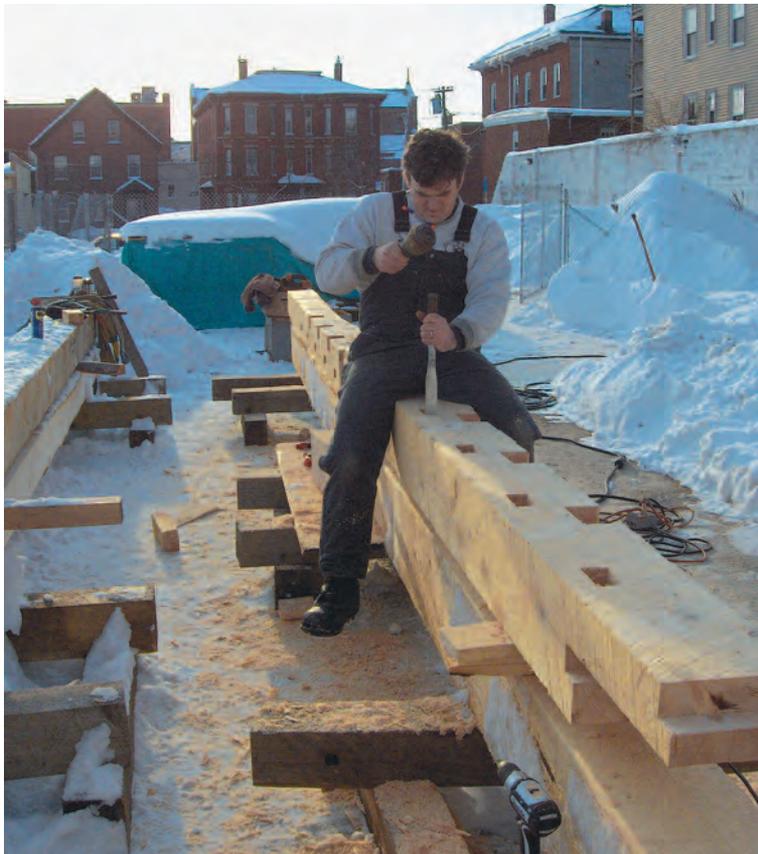
Fig. 6. Dan Boyle in the workyard mortising an end sill patch. Note joist pockets, stud mortises and bladed scarf half to join rest of sill.

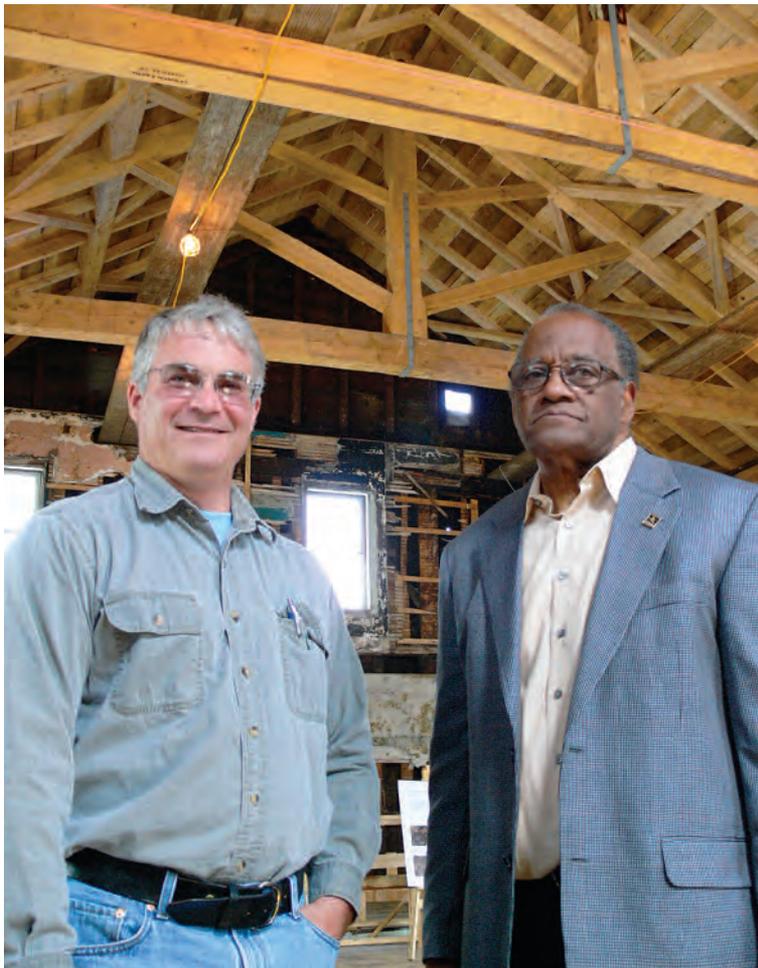
Fig. 7. Arron Sturgis of Preservation Timber Framing and Leonard Cummings of the Committee to Restore the Abyssinian Meeting House standing under the roof frame, almost all new work.

In May the initial goal was reached of stripping the building and restoring the floor plan. In a major effort, the roof frame was removed and completely rebuilt (Figs. 7–9). A wood-shingled covering has been proposed but will have to go before local code officials for a variance since the fire department has banned wooden roofs in the downtown Portland area. "We're in negotiations with them," Arron Sturgis says. "We have a fire retardant we can apply to the shingles. Because of the historic significance of the building, we're hoping for a positive result."

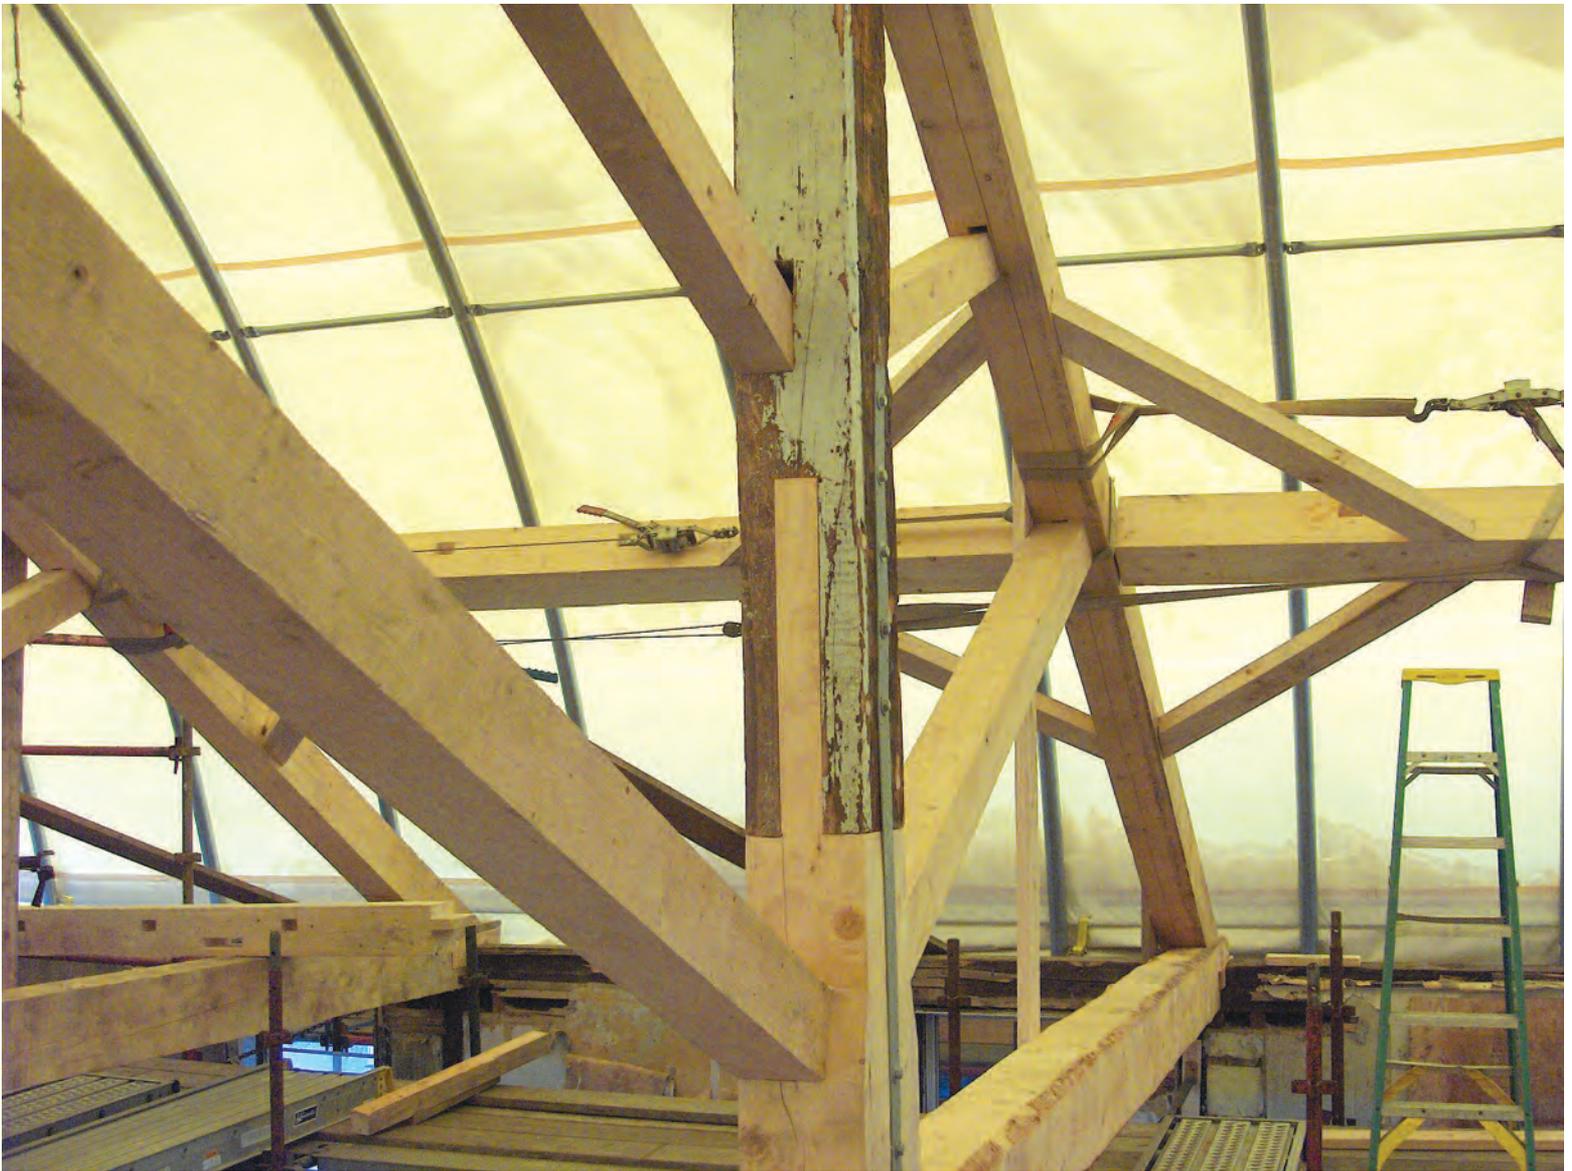
Fig. 8. Scarfed kingpost repair and extra-long stirrup strap to relieve tension at scarf. Trusses are double strutted and purlins are fully wind-braced. New timber is spruce. Translucent portable airplane hangar placed over building made work possible in almost any weather.

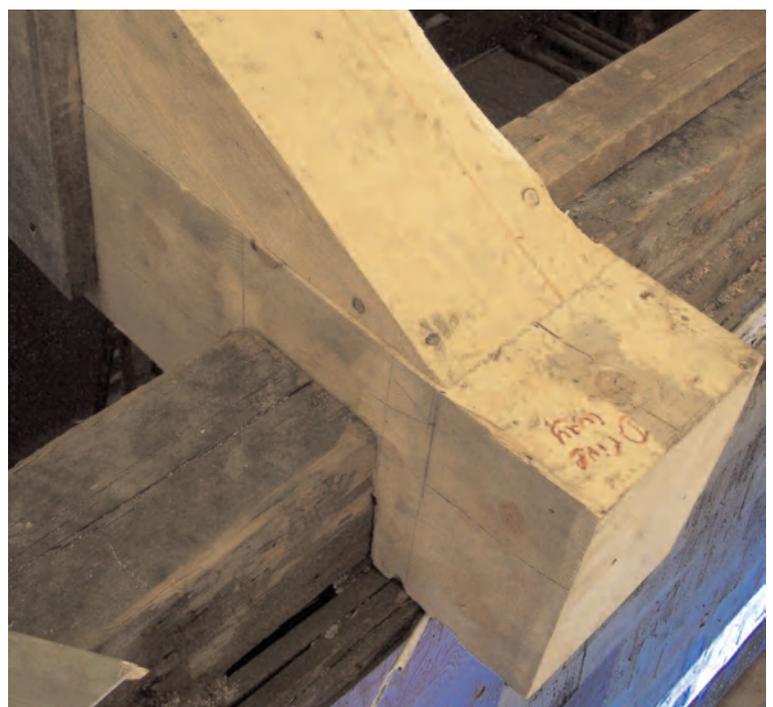
Fig. 9. Intermediate lower chords lap the continuous plate.

With the frame exposed, structural assessments were made by an engineer, who proposed unacceptable repairs such as steel bracketing that would not be in keeping with the original framing. An end wall, with its 40-ft. 10x12 ties cambered 4 in., yielded the pattern for the missing truss chords. The end wall tie beam connection to the plate proved unusual, though not surprising in context (Figs. 4 and 9).

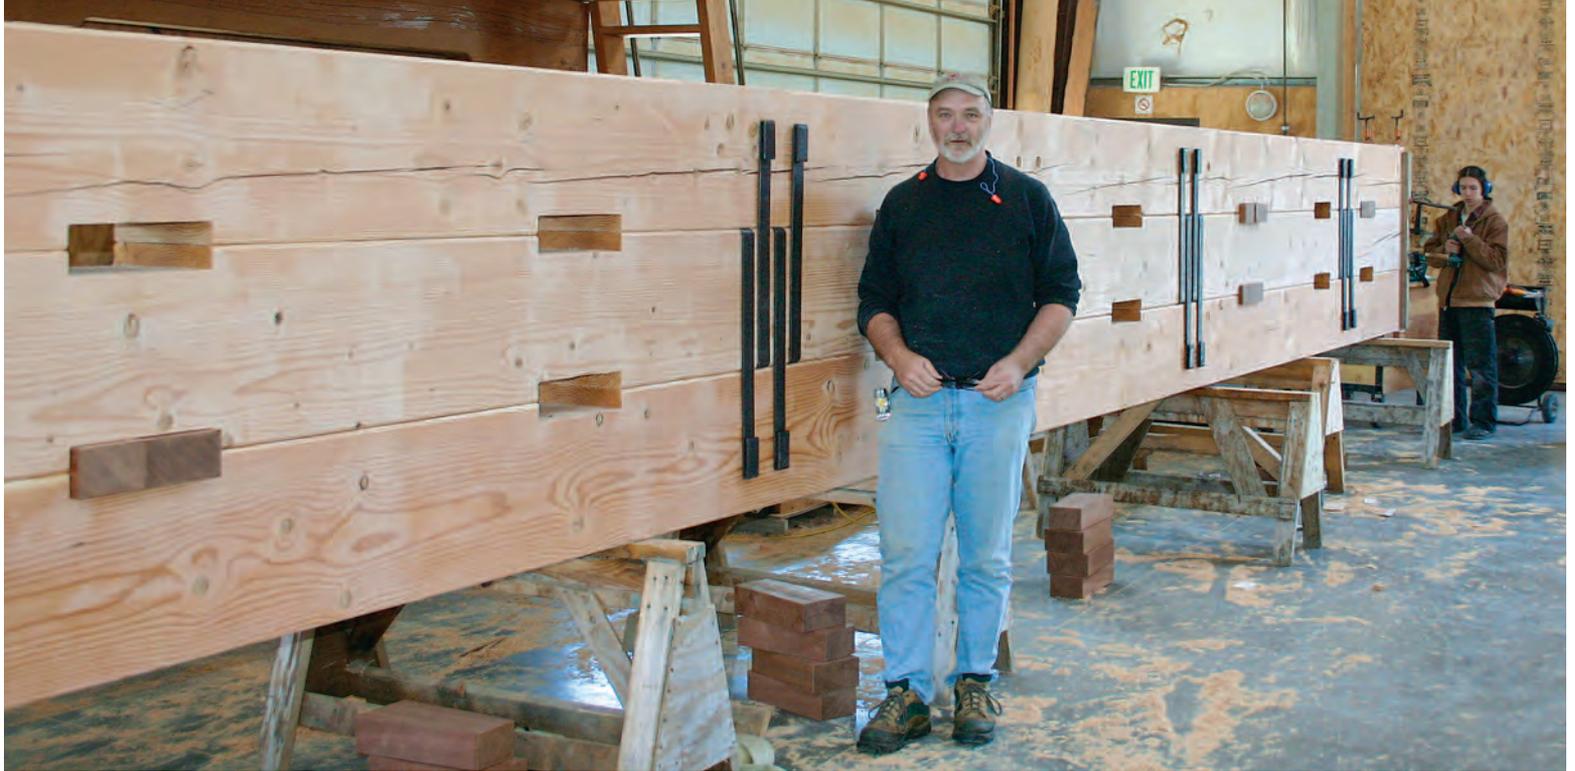
Fig. 1. Mechanically laminated beams handle unusual loads, preserve beauty of natural timber and offer decorative possibilities. Folding wedges to develop shear resistance at beam interfaces are seen partly installed and stacked on shop floor at Cascade Joinery, Bellingham, Washington. Iron straps remain to be completed to cinch assembled beam against being driven apart by reaction to wedging.

FOR many hundreds of years, builders have found needs and applications for timbers bigger than any that they could readily find within the trees from local forests. An obvious solution lies in bundling smaller timbers to make larger ones (Fig. 1). This can work well, and even ease construction, but it is not as structurally efficient as using solid sections of the same size. Builders, even early ones, recognized the value of generating some composite action between components of a bundle, with attendant gains in load capacity, reduced member sizes, or both. Modern glue technologies can yield composite action at least on a par with Mother Nature's. Before we had reliable glues, however, we relied on mechanical connections to induce composite action.

Contemporary Examples. For examples of large keyed beams, it is hard to imagine anything grander than a structure in central California framed by Cascade Joinery (Bellingham, Washington) for this “all-large project.” The clamping hardware was a celebrated opportunity, a preferred alternative to concealed lag screws, and appropriate to this amazing collection of long-span beams and clustered posts (Figs. 1 and 13).

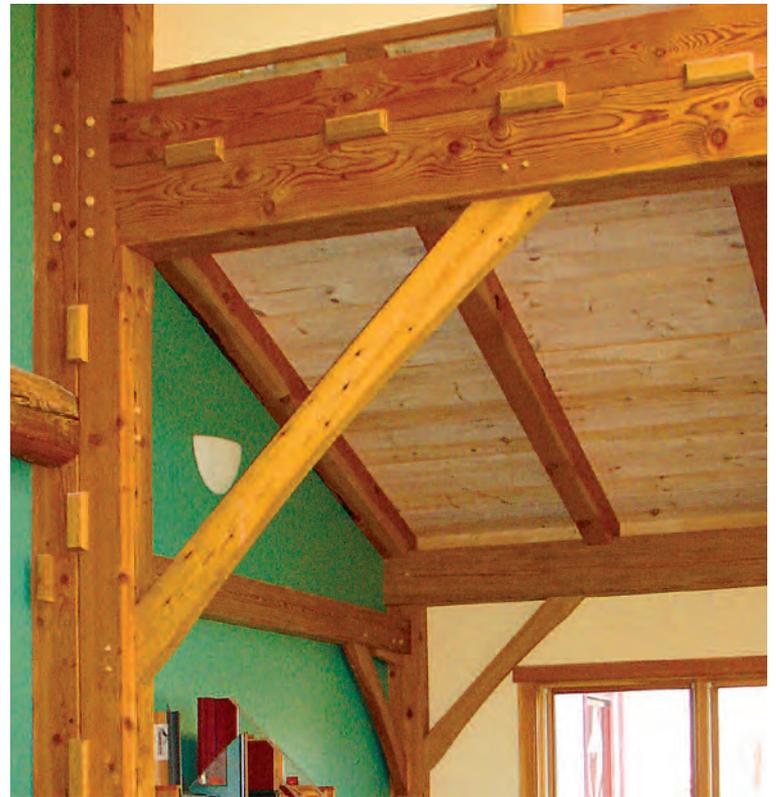
Fig. 6. If lateral loads are high, keyed posts as well as beams can be appropriate.

To the extent that posts and beams (and knee braces) are involved in resisting these lateral loads, keyed versions would be much more effective (Fig. 6). Knee braces can introduce interesting interactions among posts and beams, even as they resist simpler gravity loading. A very stiff and long knee brace, for instance, could reverse the shear in the beam between the brace mortise and the post. Again, load paths are redundant and carry load in proportion to their relative stiffness; a very limber post makes for an anemic knee brace and a braced beam that can act as though it were just simply supported.

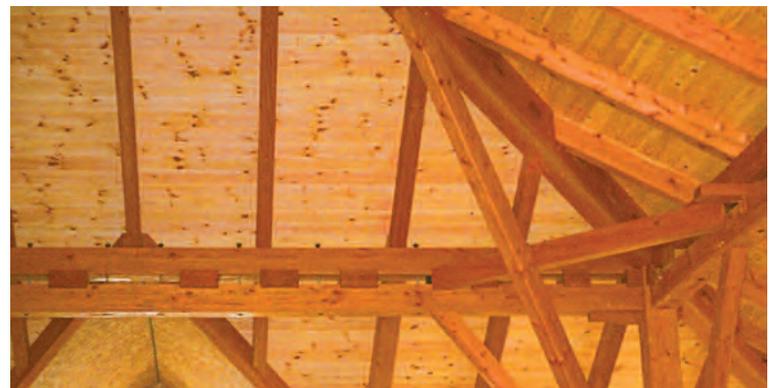
Fig. 7. Clamping bolts on keyed beam seen above are fitted with springs under their heads to take up shrinkage in keys and members.

Finally, it can be tempting to use heavy springs under the heads of through bolts used as clamps, in an effort to maintain prying resistance even as the timbers shrink (Fig. 7).

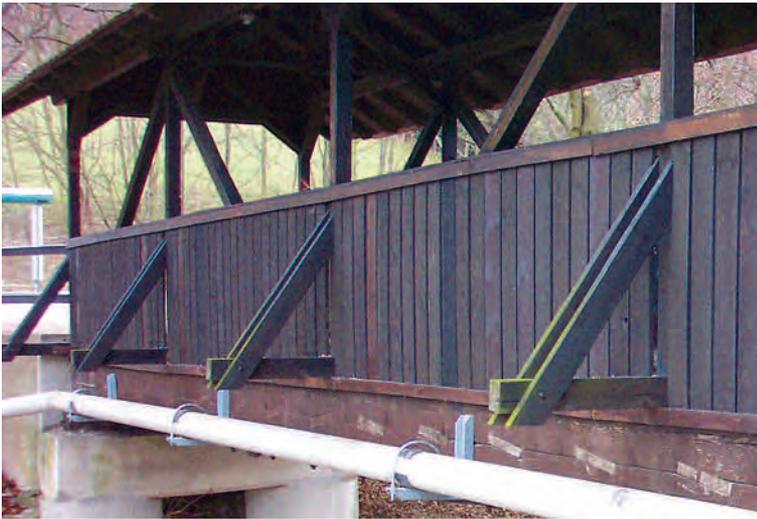
Fig. 8. Bridge in Austria relies on sloped-key-laminated girders for load bearing. Diagonal members in “truss” brace roof structure only.

Historic Examples. Keyed beams have a long and varied history. Cases of keyed beam usage have been documented over the last 300 years in Europe, many in bridges (Fig. 8).

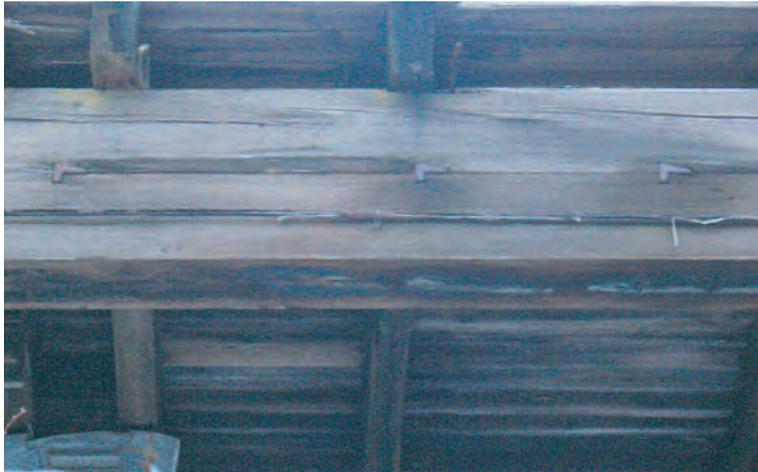
Fig. 12. Directional iron keys in built-up beam, West Lebanon, N.H.

At the same time Kidwell was using keyed beams for mining timbers, railroad engineers were using them for bridge girders and roof structures. As railroaders were already keen to use metal, cast-iron keys were commonly employed, to the point that certain cast-iron keys were commercially available to anyone for use in built-up beams. Such keys can still be clearly seen in a railroad service building in West Lebanon, New Hampshire (Fig. 12).

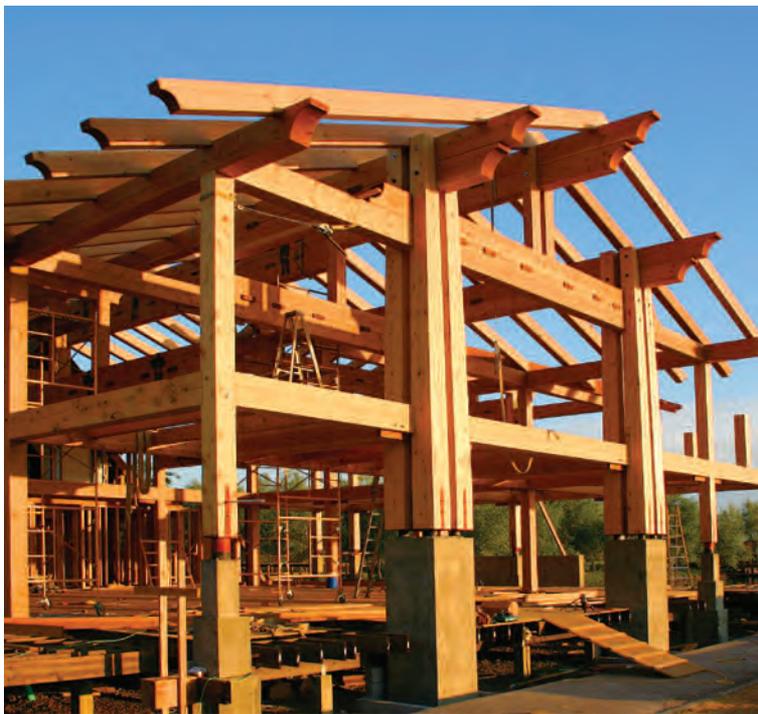
Fig. 13. The “Birdhouse,” a 2000-sq.-ft. addition to a private duck-hunting lodge in California, with clustered posts and keyed beams.

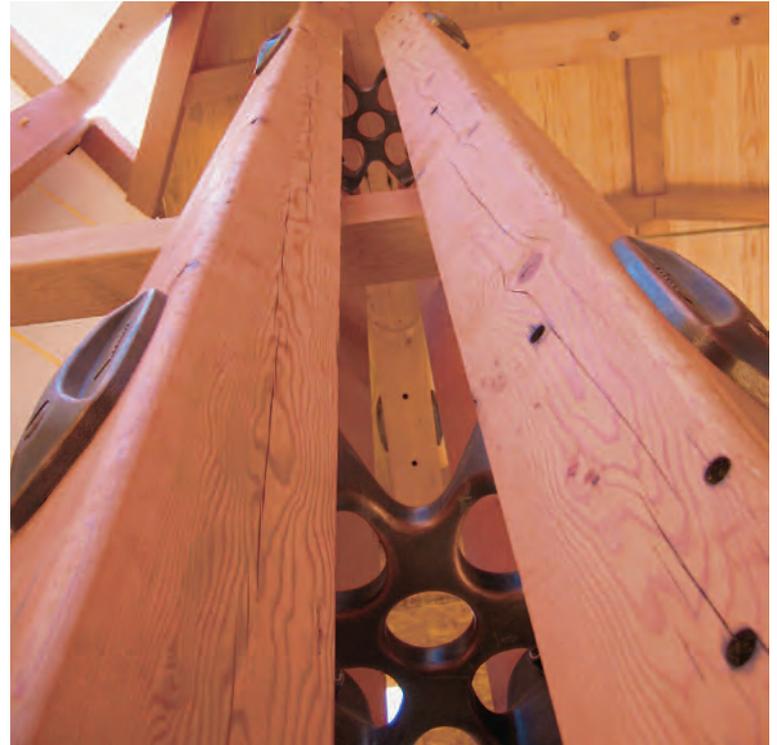
Fig. 14. At Wawona, California, cluster columns use housed decorative cast keys bolted through timbers to produce composite action.

Clustered posts appear again in the work of Randall Walter AIA of Benson Woodworking in Walpole, New Hampshire, who used a copse of heavy keyed posts to support keyed beams in a house in Wawona, California. As large and spectacular as the recycled timbers may be, the keys are in a class unto themselves. The client, who builds high-end auto components, used his own facilities to cast and plate the keys, which are housed and bolted to the timbers (Figs. 14–16).

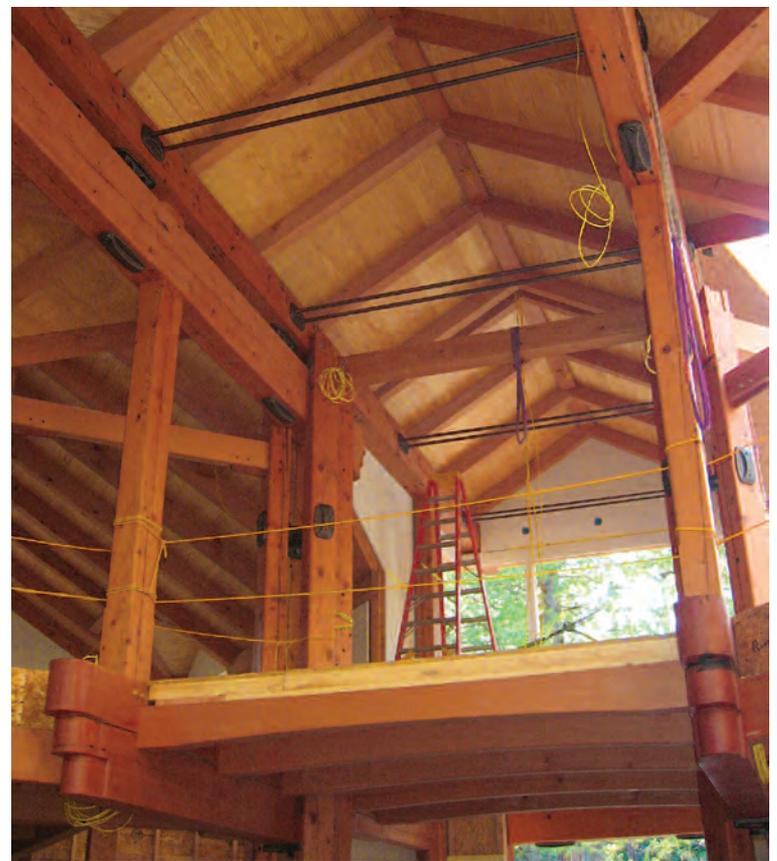
Fig. 15. Elaborate washers seen on keyed beams and posts are cast in same style as keys. Decorative ends are cut on solid recycled beams.

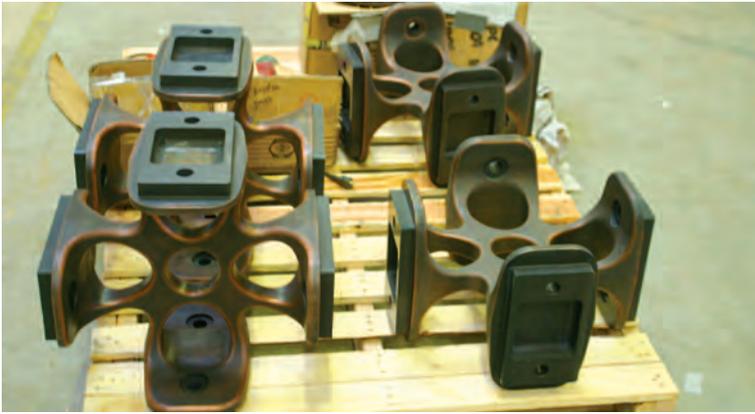
Fig. 16. At Wawona, through-bolted cast-aluminum keys electroplated with copper and bronzed fit rectangular housings. Bolt heads lie flush.

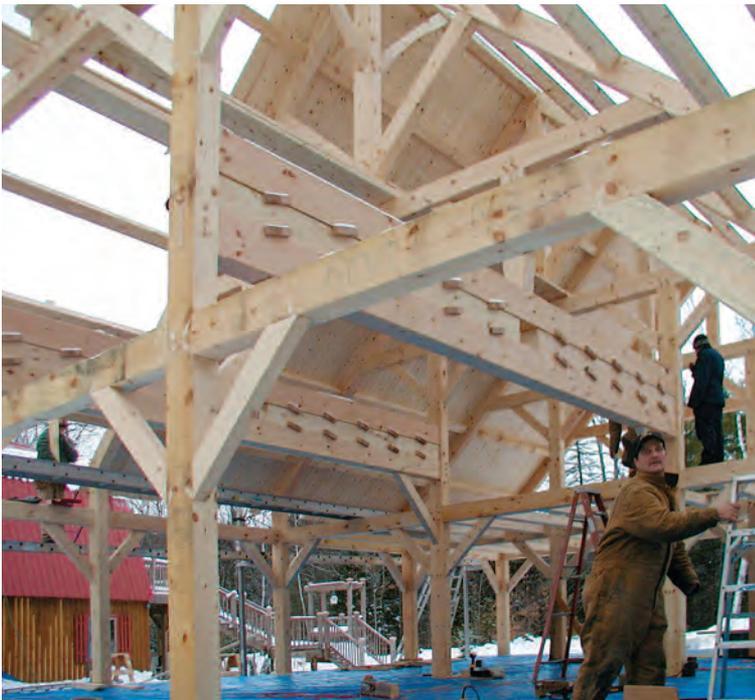
Fig. 17. In New Hampshire, triple-laminae white pine beams with sloping, folding-wedge keys. Gaps in central lamina fall at area of no stress and will be occupied by a tie beam joining the keyed beams.

On a smaller scale are the keyed beams in a simple bent building in New Hampshire's Lake Country, built by Hunter Timber Frame Structures in Alton for an owner who wanted a post-free great room. Rather than using yet another hackneyed transverse hammerbeam, author Ben Brungraber designed two decoratively striking longitudinal keyed beams, big enough for an interesting effect and set high enough not to feel oppressive. Two interior posts supporting the roof are simply cut off and land on the keyed beams. Note that the single point load, arriving from above at midspan, makes for simple uniform key spacing (Fig. 17).

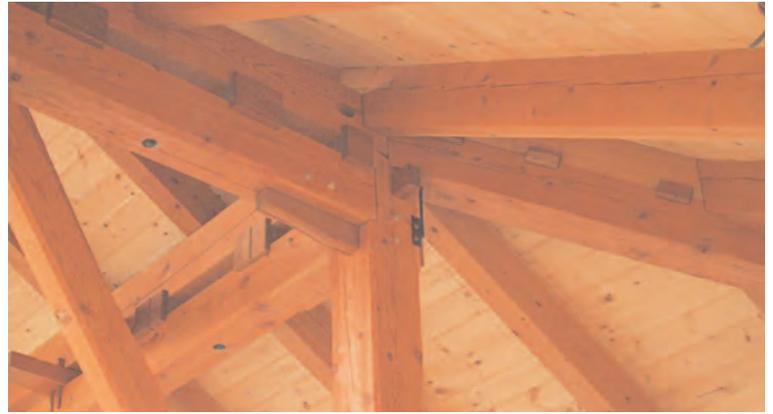
Fig. 18. Keyed hip and purlins meet at top of post at Massachusetts' Tewksbury Country Club. Purlin clamping bolts are spring loaded.

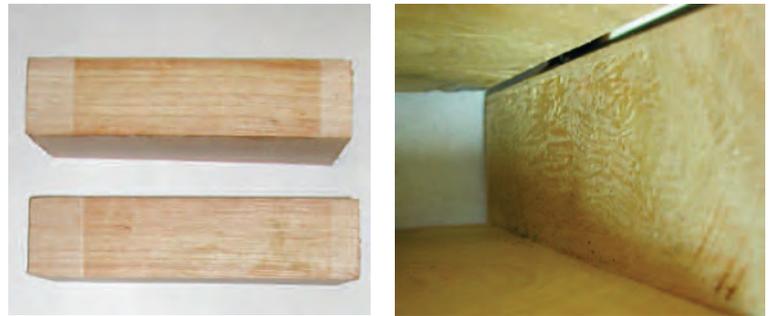
Figs. 21–22. At left, side-grain crushing in sloped white oak shear keys. At right, end-grain interpenetration of PSL key in poplar housing.

Once adjusted for timber and key moisture content and specific gravity (both of these affect the element's stiffness), the analytical model quite accurately predicted actual beam behavior. As expected, the keyed beam behaved somewhere between how simple stacked beams would behave and how a full-depth solid beam would behave. Predictions were borne out that hardwood keys loaded perpendicular to the grain would crush before the end grain of the corresponding timber notch, and that, when keys were installed with end-grain to end-grain bearing, the fibers would interpenetrate. Both of these phenomena were regularly observed during our keyed-beam testing (Figs. 21–22).

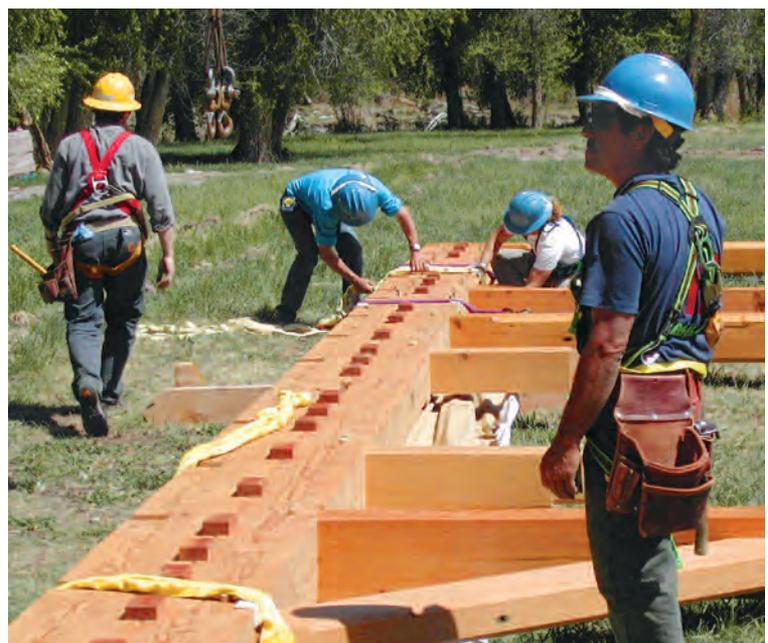
Fig. 25. Many small keys produce desired composite action in Douglas fir beam in contemporary timber frame.

Conclusions. We continue to design, fabricate and install key-laminated beams and posts, convinced that they offer aesthetic, structural and inventory benefits (Fig. 25). We have learned much about the realities of fabricating these surprisingly sophisticated structural elements. The fabrication tolerances can be daunting, even without considering the dimensional changes wrought by new timbers shrinking in place, while “dry” recycled timbers can be quite waterlogged and unexpectedly deteriorated, causing problems if assembled into keyed beams. We expect and hope to continue developing our expertise in their use. There are compelling aesthetic, structural, economic and green justifications for using mechanical lamination. We wish the very best to others in their beam-keying efforts.

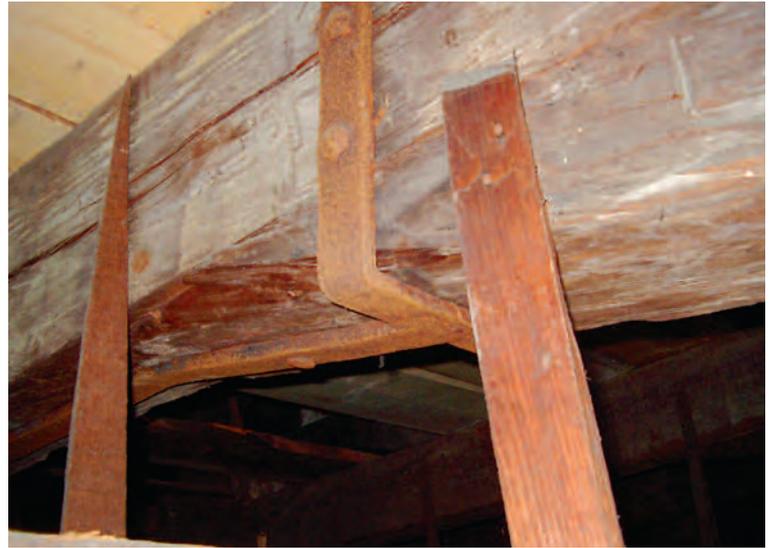
Iron strapping at principal truss joins lower chord, tension leg and princepost (drawn at right below). Wood sticks carry ceiling.

In addition to identifying and repairing obvious local failures, we identified the connection among princepost, tie beam and tension leg in the common trusses as a design weak point of the roof structure (drawing, lower left). Together with engineer Janet Kane, of Burlington, Vermont, we designed a reinforcing bracket that we were able to install in full on the four outside trusses and in part on the trusses adjacent to the ceiling dome rising into the church attic, where clearance was limited.

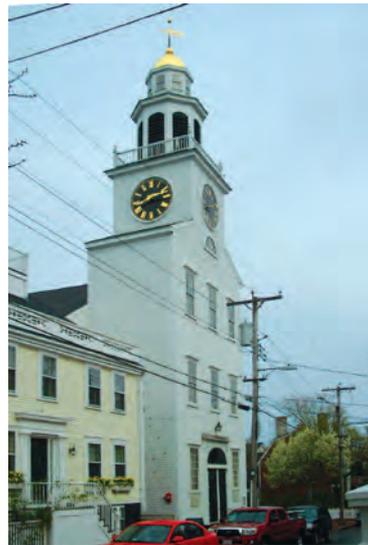
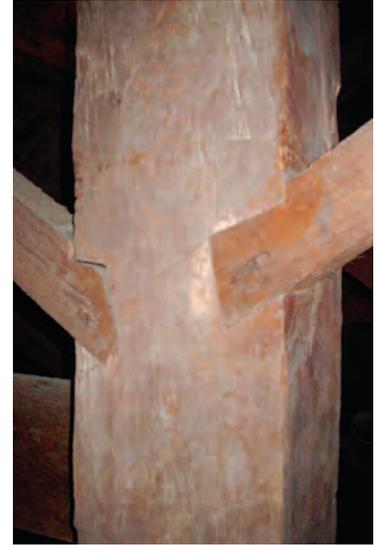
Meeting house obscured behind pavilion with tower, added 1830. Lap joinery at kingpost. Notched lap at left resists tension.
