JOURNAL OF THE TIMBER FRAMERS GUILD

Number 93, September 2009

Restoring a Queenpost Truss Covered Bridge

The Abyssinian Meeting House

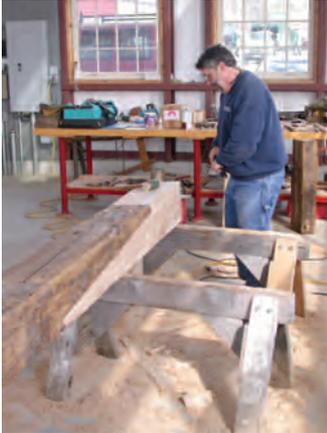
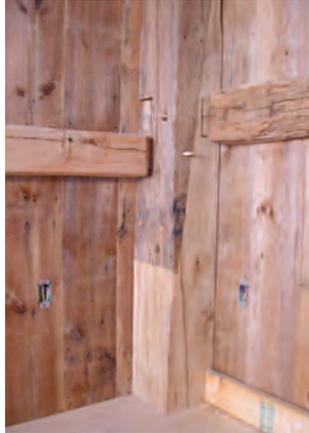
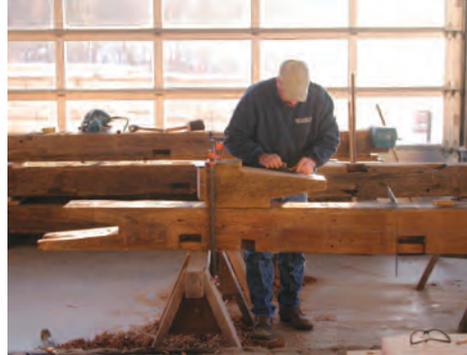
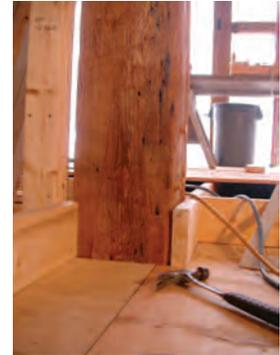
Post repairs in shop and installed in restored frame.
 Gerard Laflamme at left, Mike Fountain above.

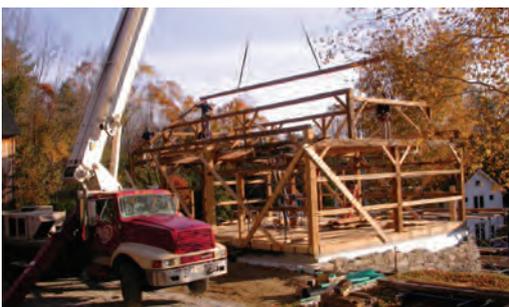
Purlin posts, purlins and roof ridge added.

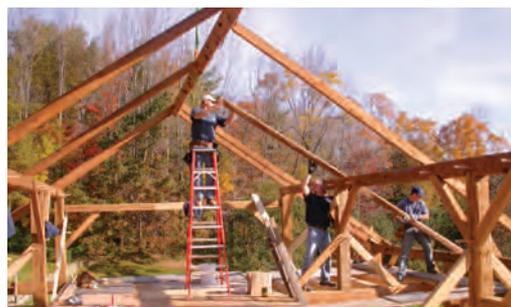
Tenoned rafters brought up one by one.

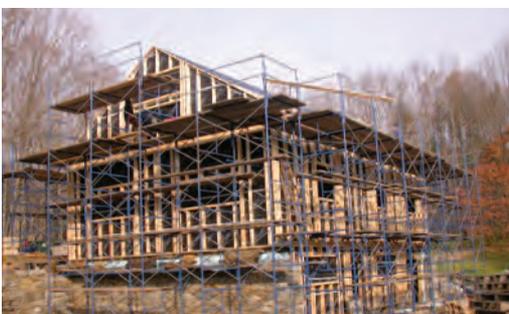
Staged up for roof boarding.

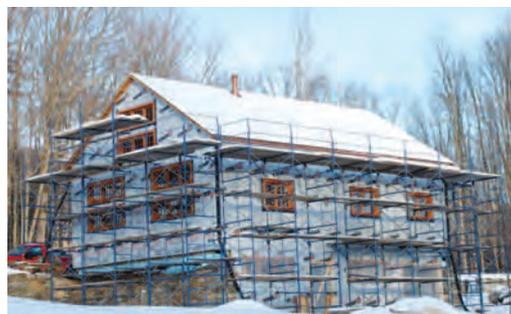
House frame built over barn frame.

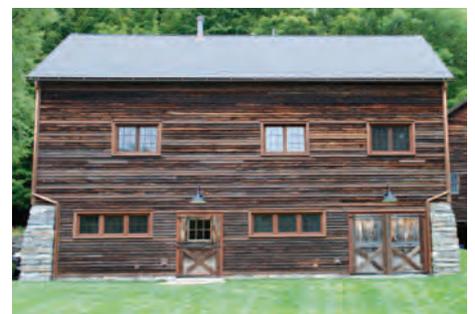
Sheathed and wrapped. Winter again!

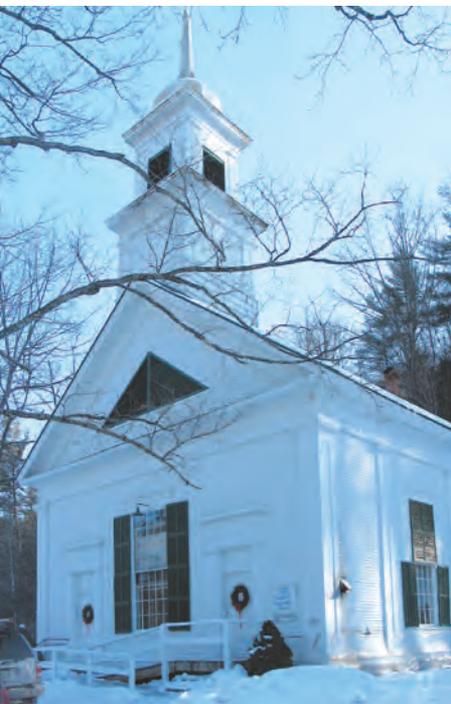
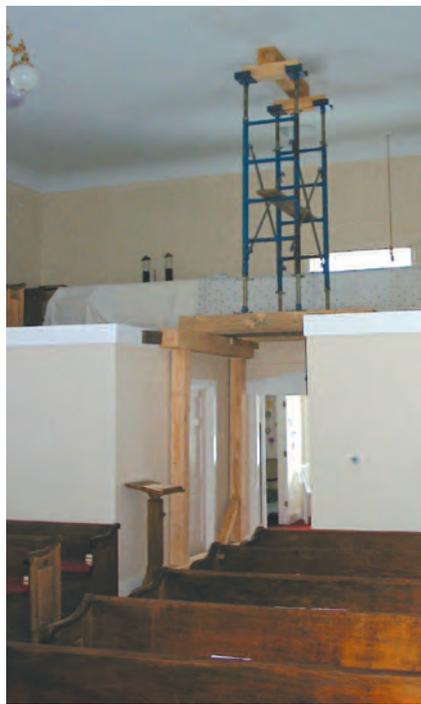
Figs. 1–2. Gaysville Community Church, 1863, and interior staging to carry loads from damaged area in attic above.

First we supported the damaged tie beam all the way from the ground, using timber cribbing in the crawl space, a timber frame structure that churchgoers could walk through in the lower part of the main room, and structural scaffolding at two different locations above (Fig. 2). We then dismantled the inner truss, dovetailed a repair section into the plate, scarfed a repair end on the tie beam and scarfed a new 8 ft. section of round spruce pole into the common rafter, tenoning it into the new tie beam end. At this point everything was restored within its original form, but the scarfed tie was not strong enough to bear the inner truss rafter.

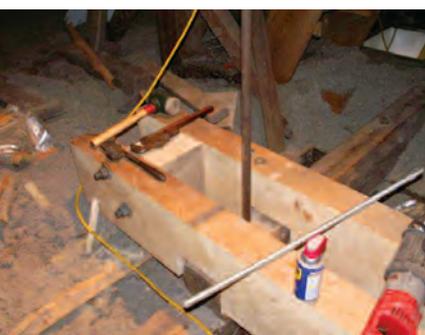
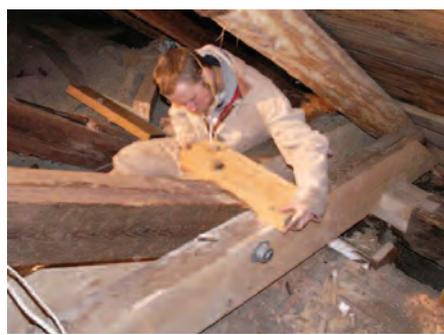
Figs. 3–4. Inner end of paired 5x12s, carried on lengthwise 8x8. At right, Chris Patton fits housed thrust block against truss rafter.

Consequently we brought two 5x12 spruce timbers 24 ft. long in through a decorative louver in the attic, and notched them so they would hook over the central longitudinal timber at one end (Fig. 3) and over the plate at the other (Fig. 4). These secondary or upper tie beam segments were spaced to clasp the inner truss rafter and actually take its main thrust. The inner truss principal rafter was still tenoned into the tie beam, now repaired, but before allowing it to bear fully there, we intercepted it with restraint at the two 5x12s. A 1½-in.-dia. bolt clamped the three together and picked up both vertical and horizontal loads, and a 3-in. white oak shear block, shouldered into the 5x12s and shouldered as well against the inner principal rafter, also picked up that rafter's horizontal thrust (Fig. 5). The great strength of the paired 5x12s was also used to hang the repaired tie beam on suspension rods at two points and to strut to the scarfed common rafter above.

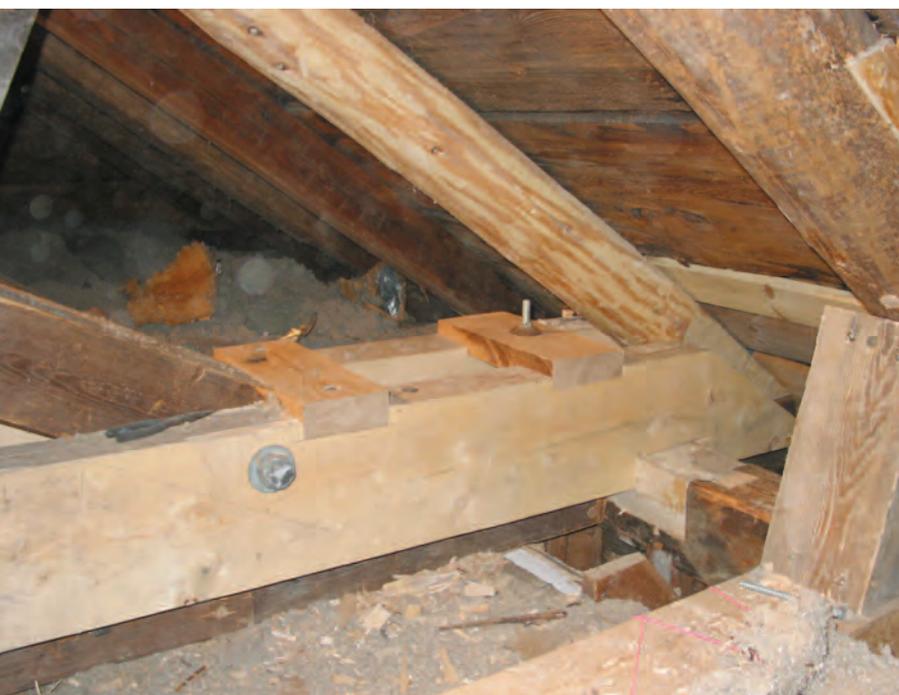
Fig. 5. Heavy bolt clamps paired 5x12s to truss rafter, shares thrust with housed oak block. New shaved end for round common rafter, dovetailed patch for plate just visible under nearer 5x12.
