# TIMBER FRAMING

JOURNAL OF THE TIMBER FRAMERS GUILD

Number 109, September 2013

# Capacity of Load-Bearing Housings

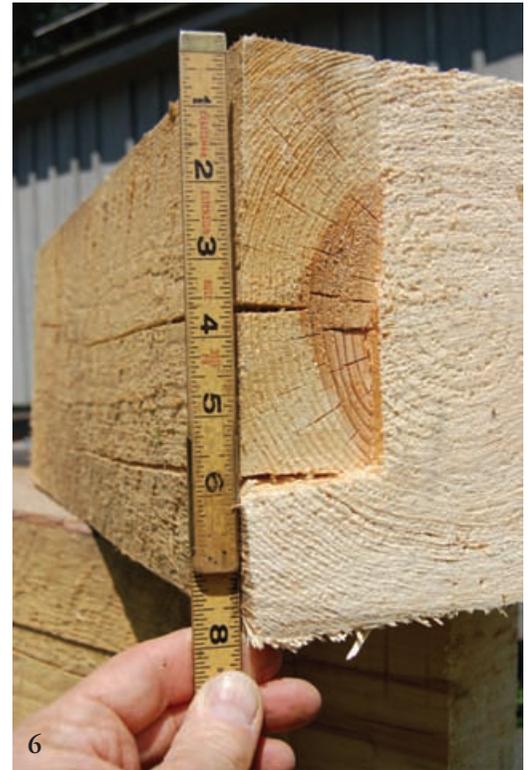
5 Fracture surface is compound, coplanar with bearing but also downward on diagonal toward beam center.

**Fracture configuration** The characteristic fracture that developed as the tests proceeded comprised a compound surface, both a horizontal extension from the bearing surface, parallel to the length of the beam, and a diagonal sloping surface extending from the bearing surface at the back of the housing down and toward the center of the beam (Fig. 5).

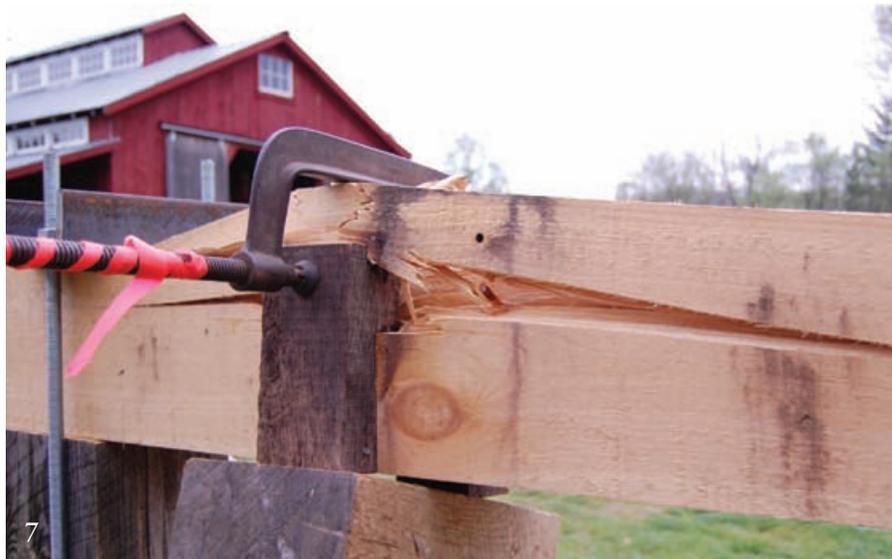
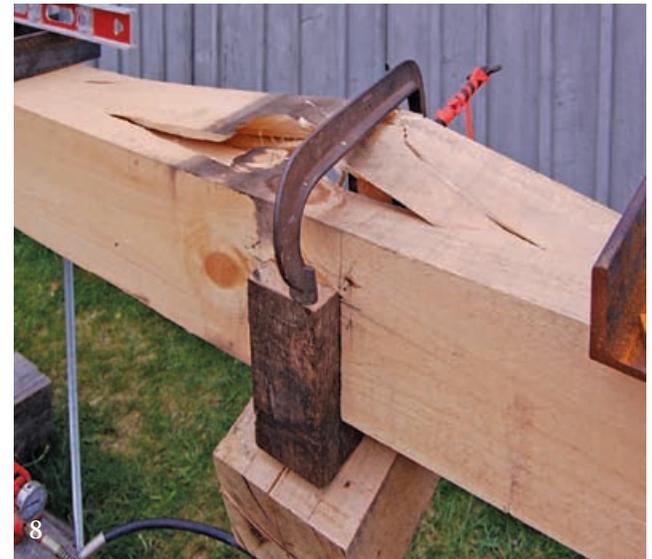
7, 8 Below left, terminal condition of white pine 3-in.-bearing test, with complete rupture on one side displacing thrust block clamp. Below right, top view.

As the width of the fracture increased, the direction of the horizontal fracture surface tended to change from parallel to the length of the beam to sloping toward the tension face. This characteristic form was repeated in virtually every test performed. The general form illustrated in Fig. 5 was typical of the 2-in. and 3-in. bearing depths, while the 4-in.-bearing-depth specimens tended to fracture straight across between housings. The fracture shown represents a snapshot during the testing. The actual shape and length of the fracture at peak load varied with species and bearing depth (Figs. 6–8).

ductility (or toughness), suggesting that higher-strength woods have both higher load-bearing capacity and increased toughness (Figs. 6–8). Whether this behavior is a species-dependent characteristic or can be related to specific gravity remains to be explored.

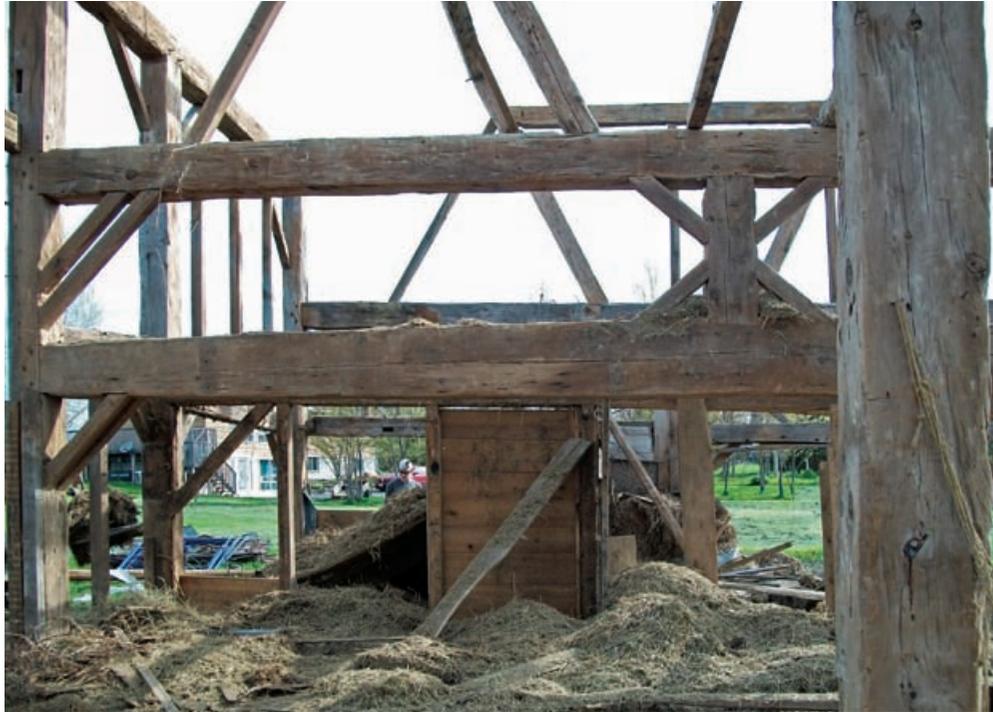
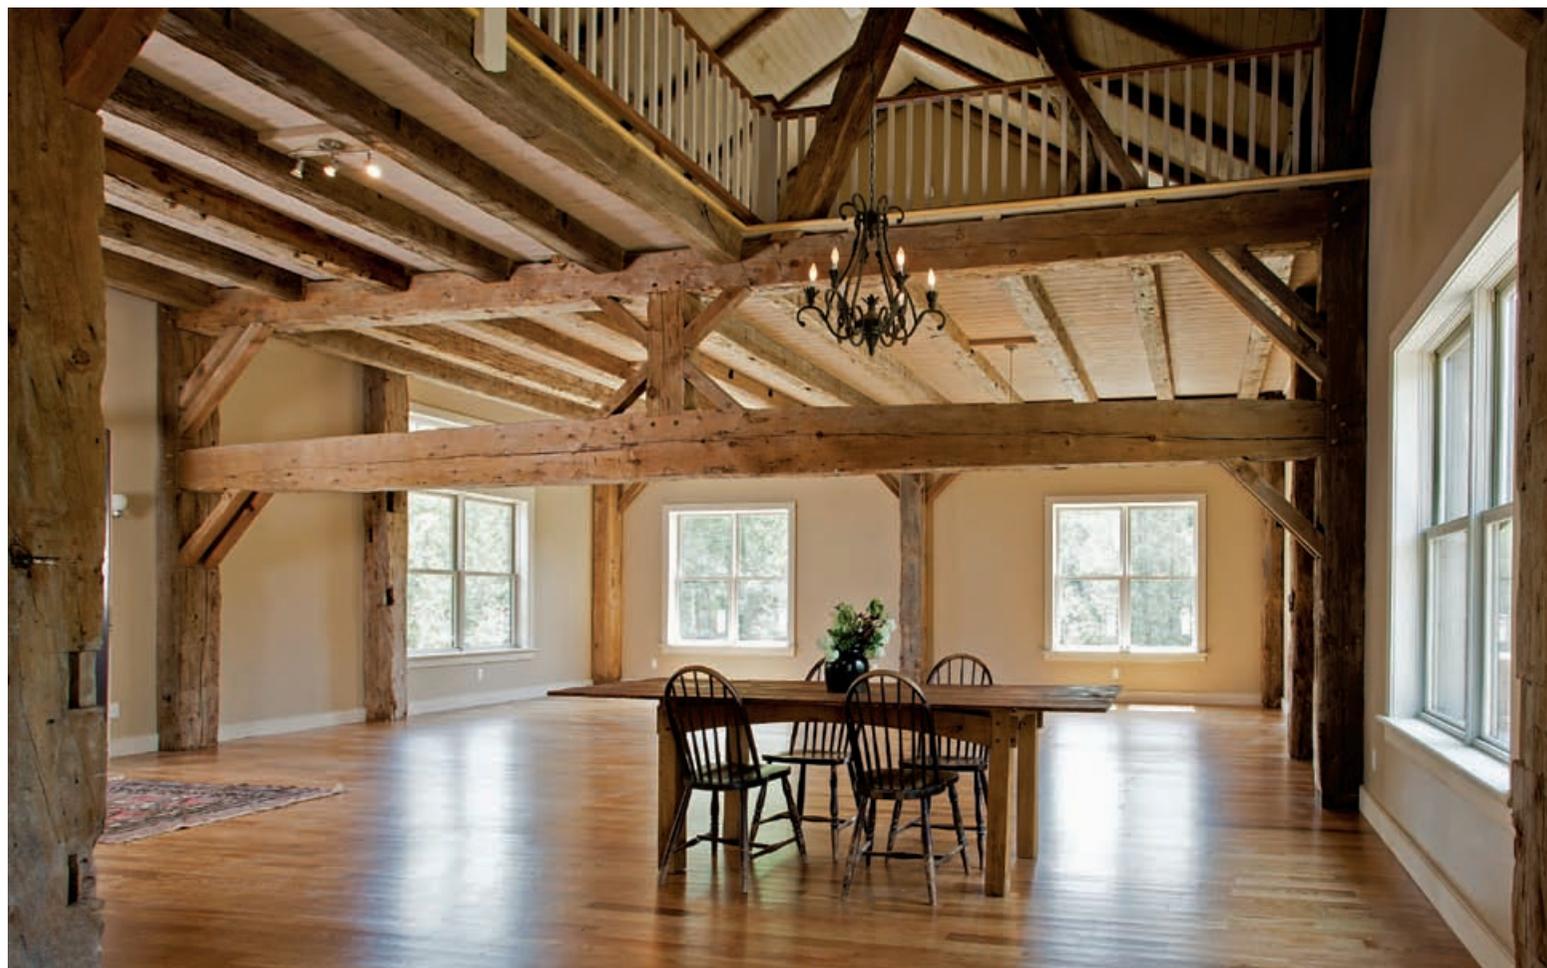
Below, frame cleaned, modified and reerected in Perth, Ontario, finished as show house for timber framing company. Swing beam measures 10x17 at midpoint, 10x10 at ends, and tie beam 10x12. Note doubled and twinned 4x4 braces from tie beam and swing beam, respectively, to wall post.

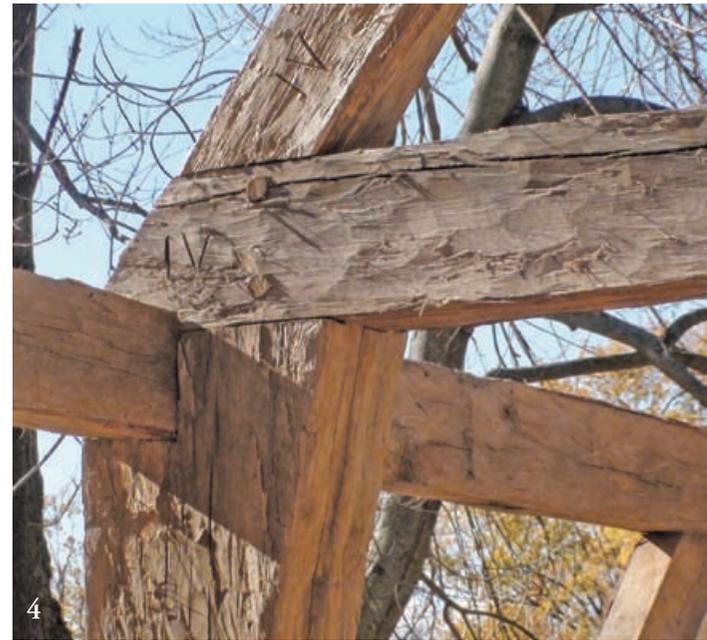
3 Plate assembled to post on blocks in shop, showing teazle tenon and half-dovetail housing for tie beam in English tying joint.

Whidden used scribe rule to lay out the joinery. The layout, cutting and trial fitting of the main frame was done at his shop (Fig. 3). The raising took place in September 2010, with many hands to help (Figs. 4, 5). Volunteer Dick Chapman fashioned white oak trunnels as needed during the raising. The raising crew set the principal rafters by the end of the day. Temporary siding and flooring served as we awaited finish materials. Since much secondary framing remained to do for the walls, roof and chimney, work continued through the following summer and fall. We each cut a few mortises, sawed a few studs or fashioned a tenon in the ever-hardening oak.

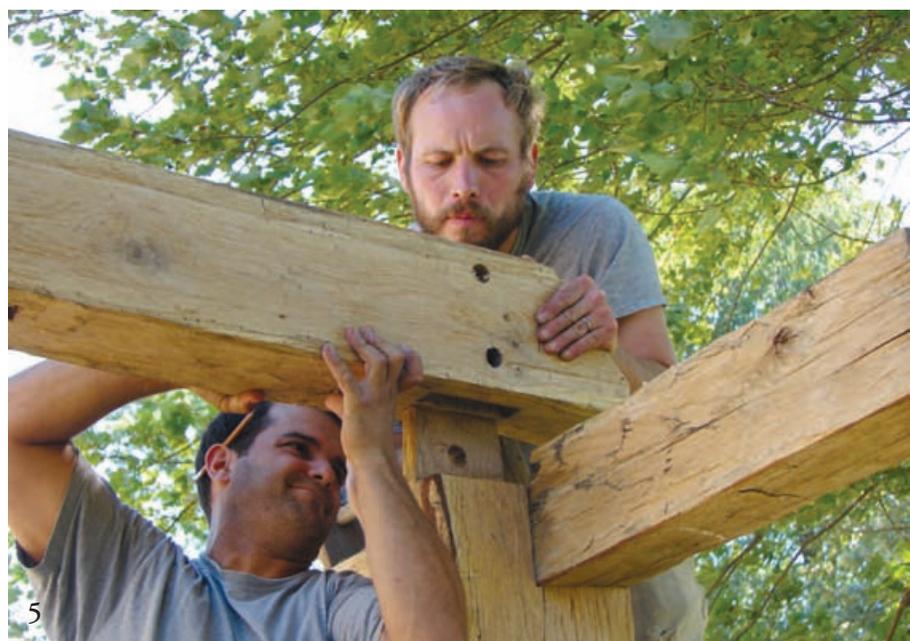
5 Matt Diana, left, and Jesse Brown assembling tying joint during raising. Dovetail flare is on far side of tie beam. Crushing on near face likely resulted from previous test assembly.

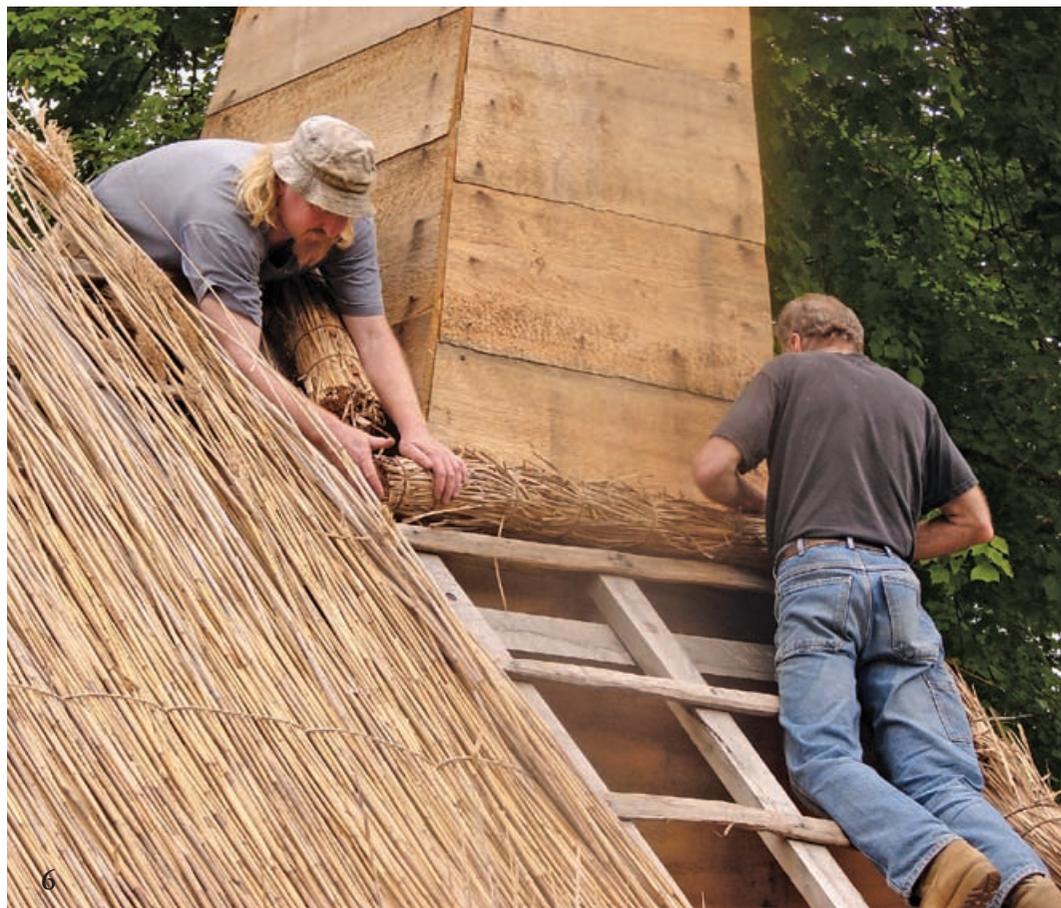
6 Thatchers Michael French of Plimoth Plantation and Lorin Johnson, a friend of the Knight House team, place bundled rolls at chimney base to hold next layer. Bundled rolls surround chimney and roof perimeter.

We met with artisans from Plimoth Plantation, who came to Ipswich and showed us how to harvest thatch from the Ipswich marshes and prepare it for the roof. In the spring of 2012, the team collaborated with Plimoth Plantation's Michael French and Justin Keegan, who agreed to thatch the roof (Figs. 6–8). Along with their expertise, instruction and considerable time, they supplied appropriate tools and additional necessary materials. We prepared long bundles of reed and tied them around the edges of the roof to hold the thin *fleeking*, a mat of tall grasses, then a thick layer of wet tangled hay. Another row of long bundles around the edges held the finished courses begun at the bottom, laid and dressed and worked up to the ridge. Spars held the dressed bundles in place, woven onto the riven lath using a large needle and cord. Thatching in progress often brought traffic to a stop along South Main Street in Ipswich.

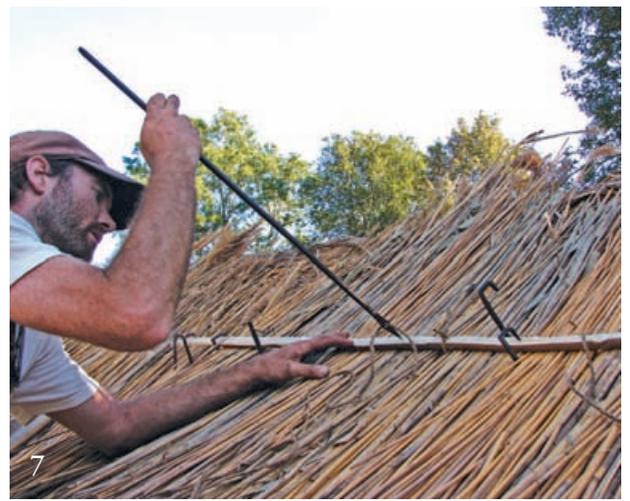
7 Using giant needle, Justin Keegan of Plimoth Plantation weaves hemp cord back and forth through thatch down to roof lath to secure transverse spar.

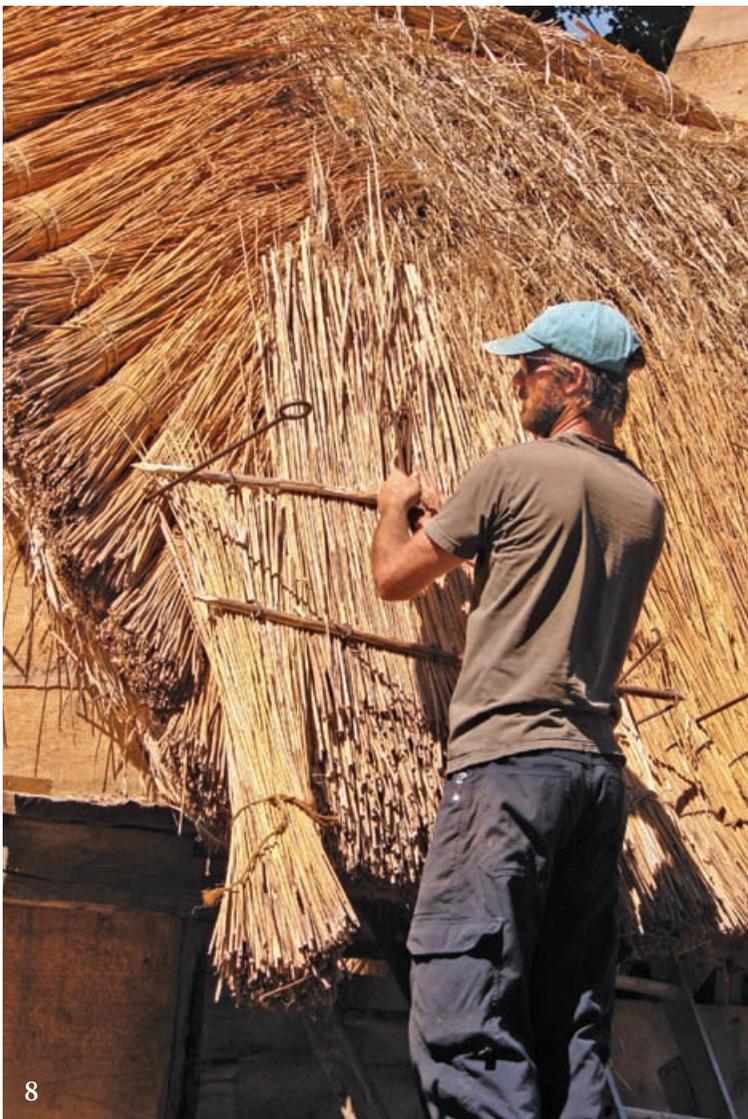
8 Justin Keegan affixes first course of final layer of dressed bundles. Final treatment of thatch remains to be determined at and near ridge (Fig. 1), with several styles under consideration.

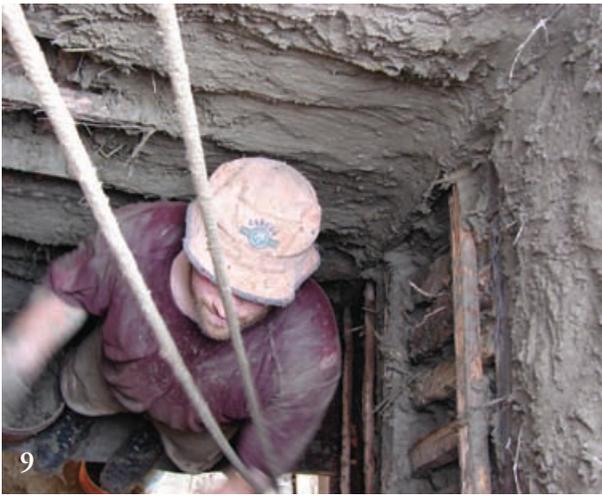
9 Jeremy R. Brown applies daub to framed, heavily lathed interior of spacious wood-framed chimney wetted down in Fig. 10, starting at top.

Meanwhile, the chimney frame was fitted with riven white oak lath in preparation for plastering with a daub of local clay, straw and sand. Mason Jeremy R. Brown applied the daub to the wet interior of the chimney, hauling buckets to the top and working his way down (Figs. 9 and 10), the daub having been mixed in frames by barefooted volunteers directed by Richard Irons (Fig. 11, left). In 1657, home fires would have burned year-round on a broad, deep hearth, for cooking and to heat water for washing.

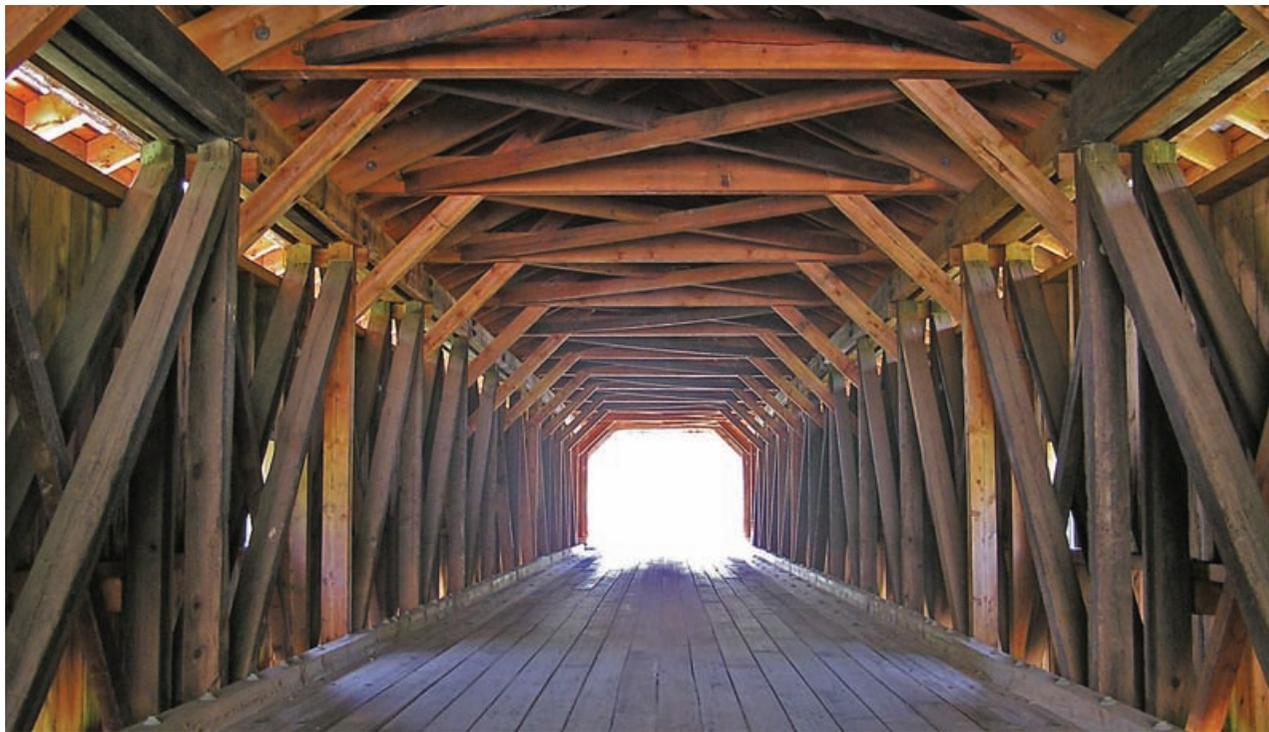
Hamden Bridge, Delaware County, New York, 128-ft.-span Long truss built over Delaware River in 1859 and propped midspan by pier in 1940s. During rehabilitation in 2000, pier was removed and bottom chords replaced by glulam because of theoretical weakness of chord splices, even if in good condition, in original design.
