BYU Civil & Environmental Engineering

Performance Criteria for Free-Standing Timber Frames with Knee Braces

November, 2022

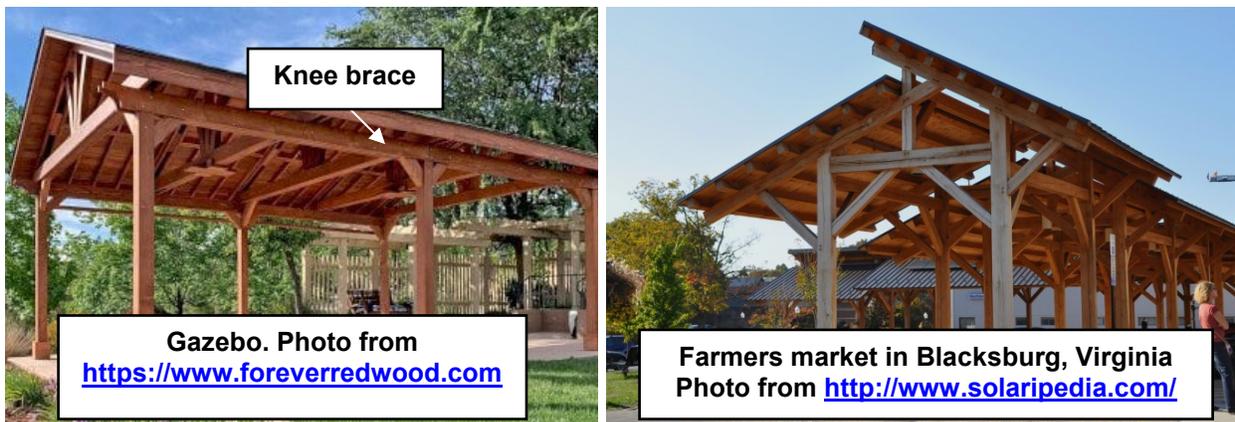
Timber frames that use large-dimension wood members with mortise and tenon connections and wood pegs are a traditional construction method that has been successfully used throughout the world for centuries. Examples of timber frames include ordinary structures, such as residential structures and free-standing structures, especially gazebos, and pavilions (Fig. 1.1).

Fig. 1.1. Examples of free-standing timber frame structures.

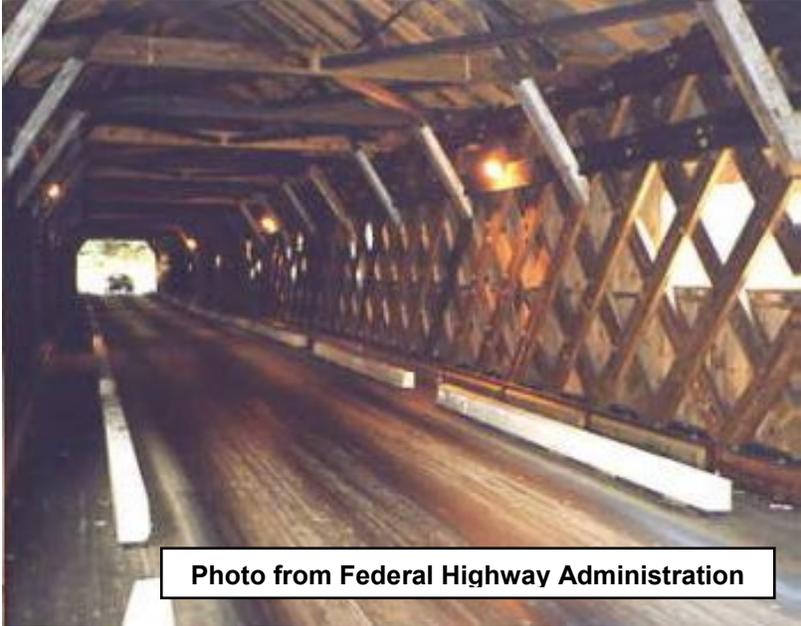
Other examples of timber frames include more notable structures, such as covered structures for bridges (Pierce et al. 2005), as shown in Fig. 1.2, and roof trusses, such as the roof of the Notre Dame cathedral (Courtenay 2022) shown in Fig. 1.3.

Fig. 1.2. Typical covered bridge with timber frames.

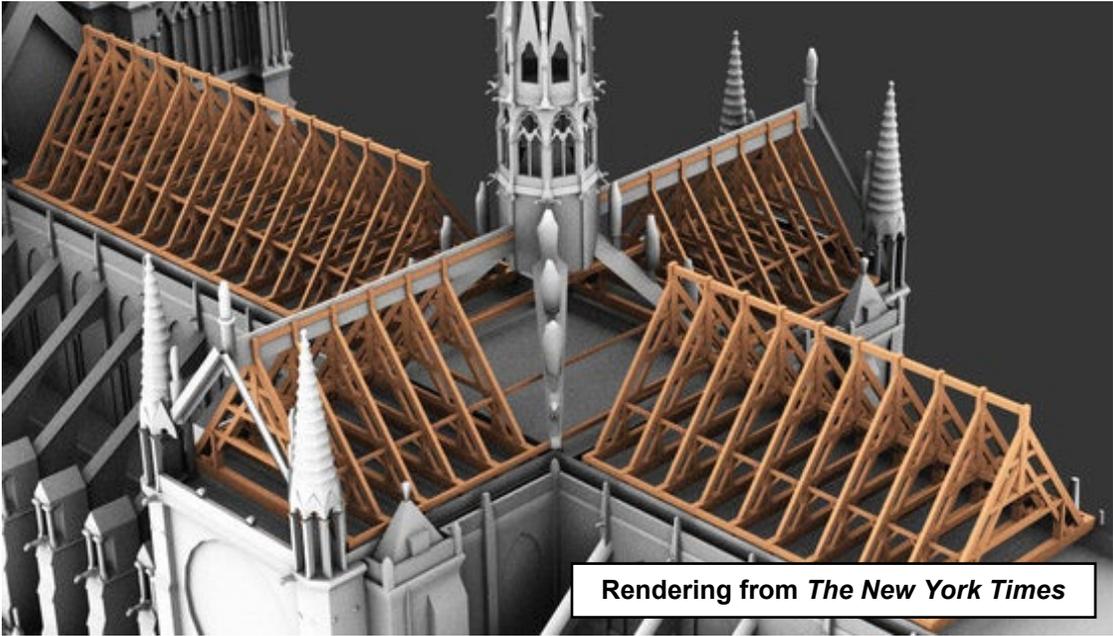
Fig. 1.3. Timber frame roof in the Notre Dame cathedral.

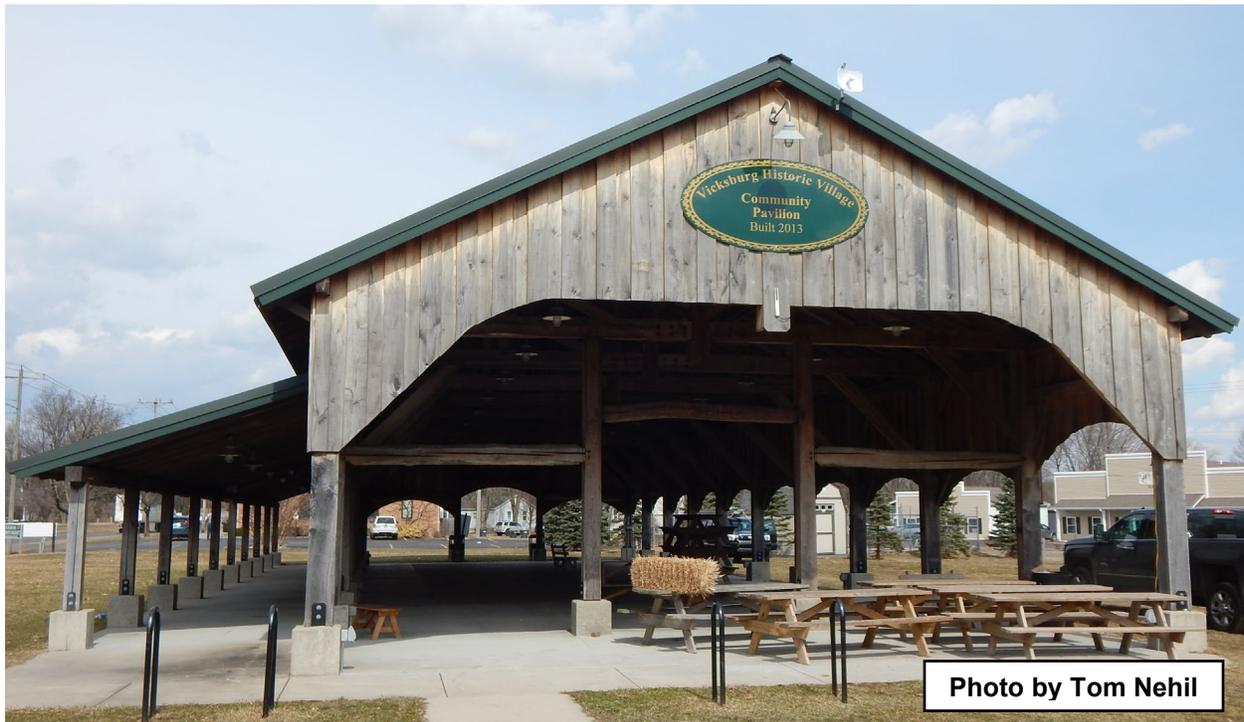
In addition to existing structures, timber frames are also used in new construction. For example, Fig. 1.4 shows a free-standing timber frame for a farmer’s market that was built in 2013. Although modern innovations in building, including structural composite lumber, connector hardware, and mass-produced steel fasteners, have led to efficient light-frame wood construction methods that are ubiquitous in North America, there has been a resurgence in traditional timber framing (Heitz 2016).

Fig. 1.4. Free-standing timber frame built in 2013.

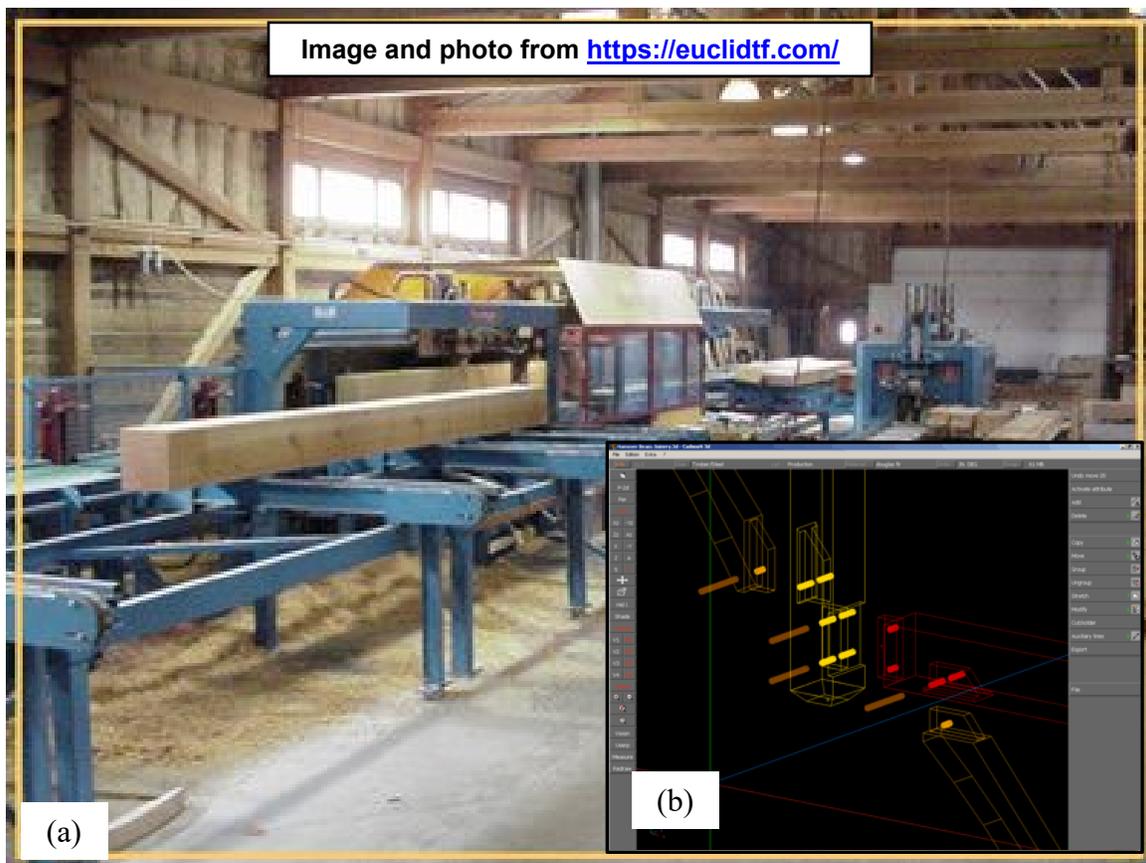
An important contributor to this revival of timber framing is that the complex and time-consuming process of crafting precision timber joinery by hand has been largely automated in recent years by advancements in tooling and machinery (e.g., Wu et al. 2019, Pedersen et al. 2023). For example, Fig. 1.5 shows typical computer automated drafting (CAD) software and timber milling machinery that can be used to design and fabricate a timber frame. This automation has the potential for higher precision construction compared to hand-constructed frames. For builders, this can lead to greater productivity. For owners, this can lead to lower cost. As a result, these advancements have greatly reduced the labor required for traditional timber frame construction and made possible more widespread adoption of timber frames in aesthetic and structural applications.

Fig. 1.5. Typical (a) timber milling machinery and (b) CAD software.

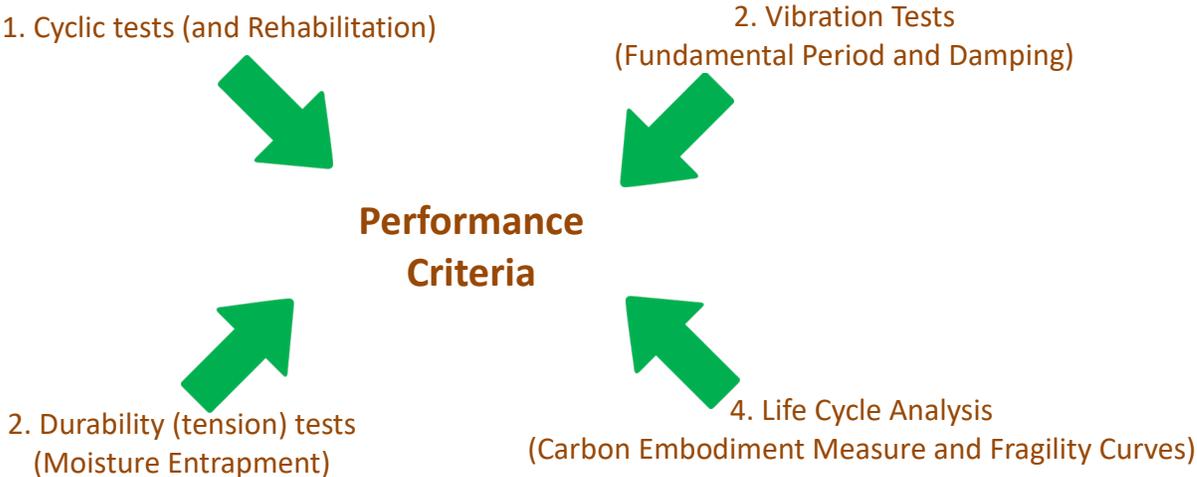
To accomplish the research objective, four tasks (Fig. 1.6) were created to determine performance criteria: (1) cyclic tests of timber frames were conducted to determine hysteretic behavior and to explore rehabilitation schemes for improved performance after damage due to a lateral-loading event; (2) durability tests of brace connections were conducted to determine the effect of joint details on the tensile strength and behavior of typical knee-brace connections; (3) vibration tests of timber frames in the field were conducted to determine the fundamental period of vibration and modal damping; and (4) a life-cycle analysis was conducted to determine the embodied carbon and the damage states for knee-brace connection and to establish component fragilities for performance assessment.

Fig. 1.6. Diaphragm of research approach.

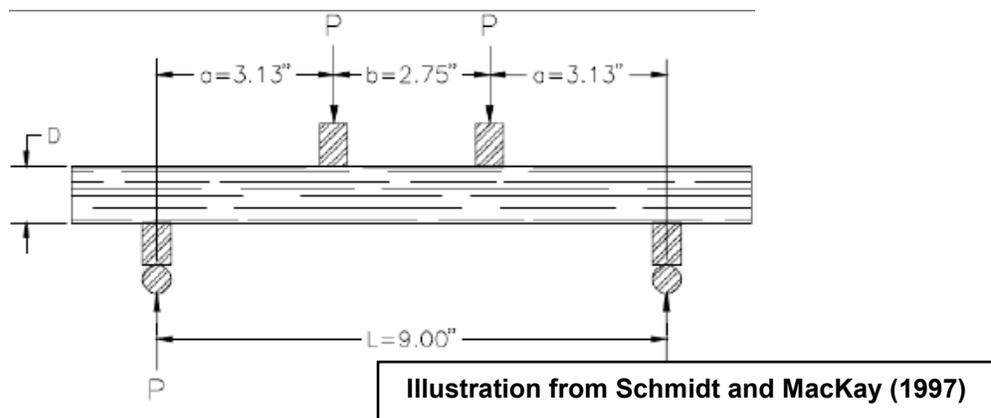
Schmidt and Mackay (1997) were among the first to truly apply the EYM to wooden-peg dowels in testing with traditional frame connections. Tests were performed in peg bending, shear, and dowel bearing in order to confirm that the existing yield model equations from the latest NDS were applicable to wooden pegs. Concluding results indicated that the EYM was applicable, as well as improving some areas of knowledge within this specific connection. One such example was the conclusion that tenon splitting/relishing could be prevented by ensuring an end distance from the peg center to tenon end of at least three times the peg diameter. However, at this point, researchers did not fully understand which failure mode was preferable for design recommendations.

Fig. 2.1. Peg bending test.

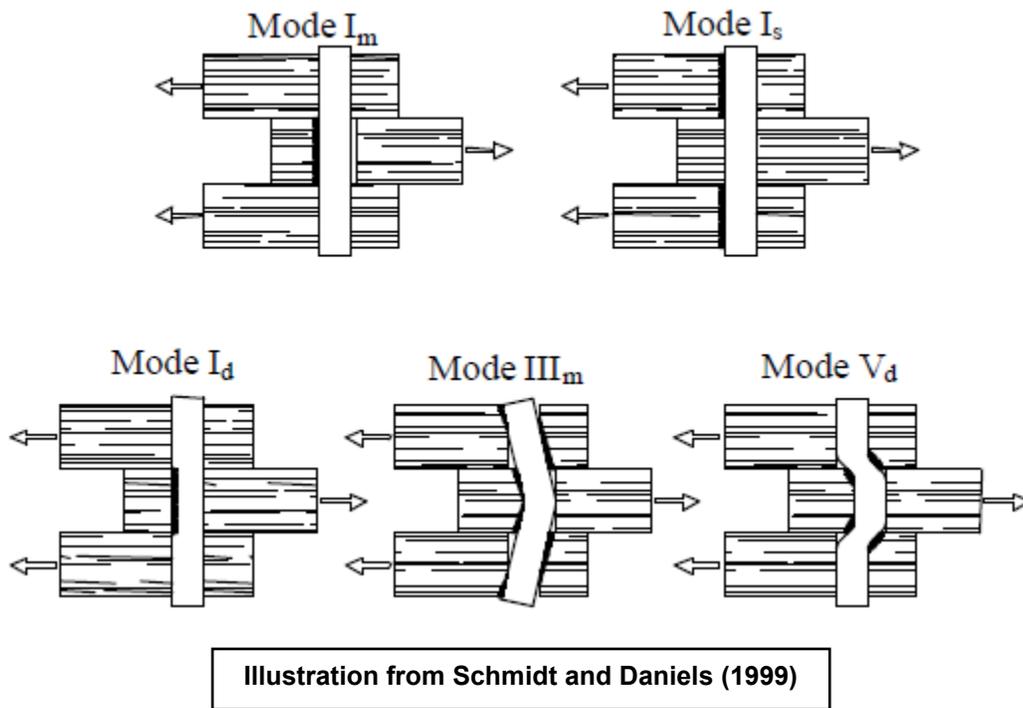
Two years later, Schimdt and Daniels (1999) performed a variety of tests in order to better summarize failure modes, verify allowable stress values, and determine proper joint design recommendations. They determined that the preferred failure mode at these connections is peg failure, due to the ductile nature prior to ultimate failure within the dowel. Their findings indicated that there were in fact five possible failure modes for pegged mortise and tenon joinery. Bearing failure of the main and side members is specified, along with bearing failure of the peg. Both shear and bending failure are possible in such pegged connections. These connections are more likely to fail in shear when the base material of the peg has a relatively high bearing strength. Fig. 2.2 below shows the revised list of failure modes.

Fig. 2.2. Proposed failure modes for joints.

The same research performed by Schmidt and Daniels to summarize these failure methods also produced strength equations for four of the five failure modes based on factors such as the diameter and number of fasteners, as well as dowel shear capacity and bearing strength. However, an analysis of stiffness characteristics for pegged joints was not produced until Sandberg et. al (2000). They developed a linear model based on specific gravity of the joint members to estimate overall joint stiffness. From this, an empirical equation for joint stiffness based on peg and member flexibility was derived.

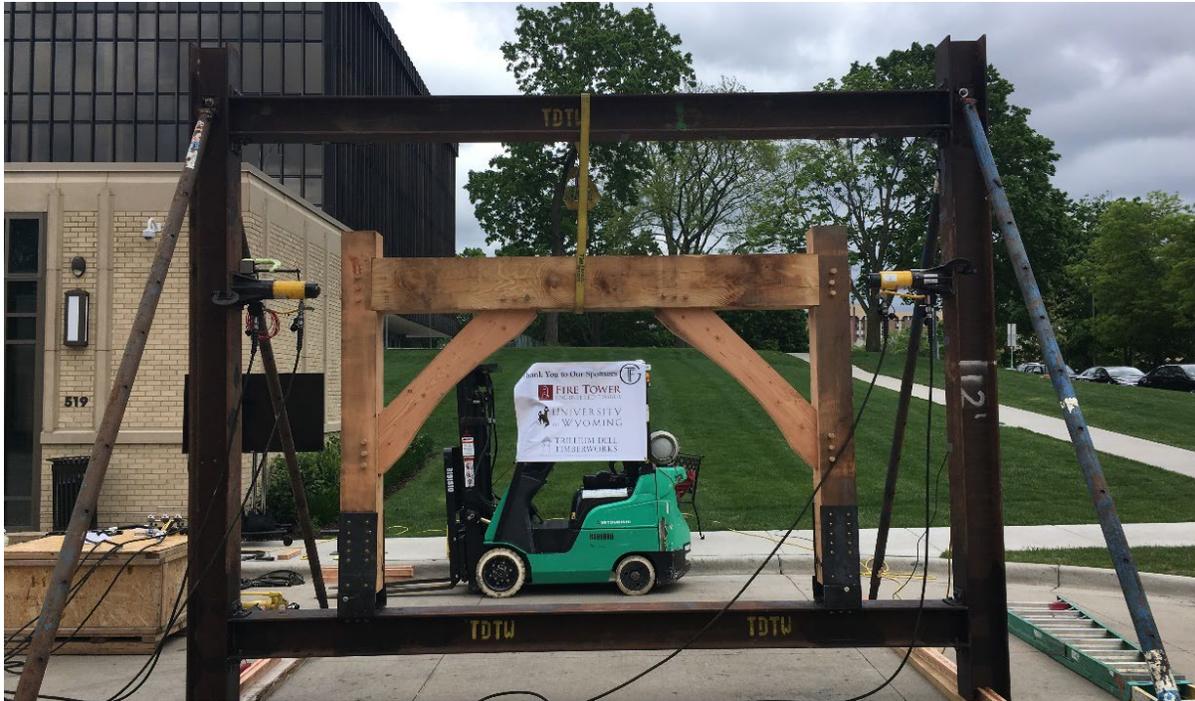
Prior to the tests mentioned in this report, the two timber frames were previously tested in a field demonstration under a cyclic load in order to determine (1) the hysteretic behavior and (2) the probable damage states. Fig. 3.1 shows a photo of the field demonstration. Both frames were retained their respective field tests and the braces which had failed originally were replaced with newly manufactured members.

Fig. 3.1. The 3-peg frame originally tested in the field under cyclic loading.

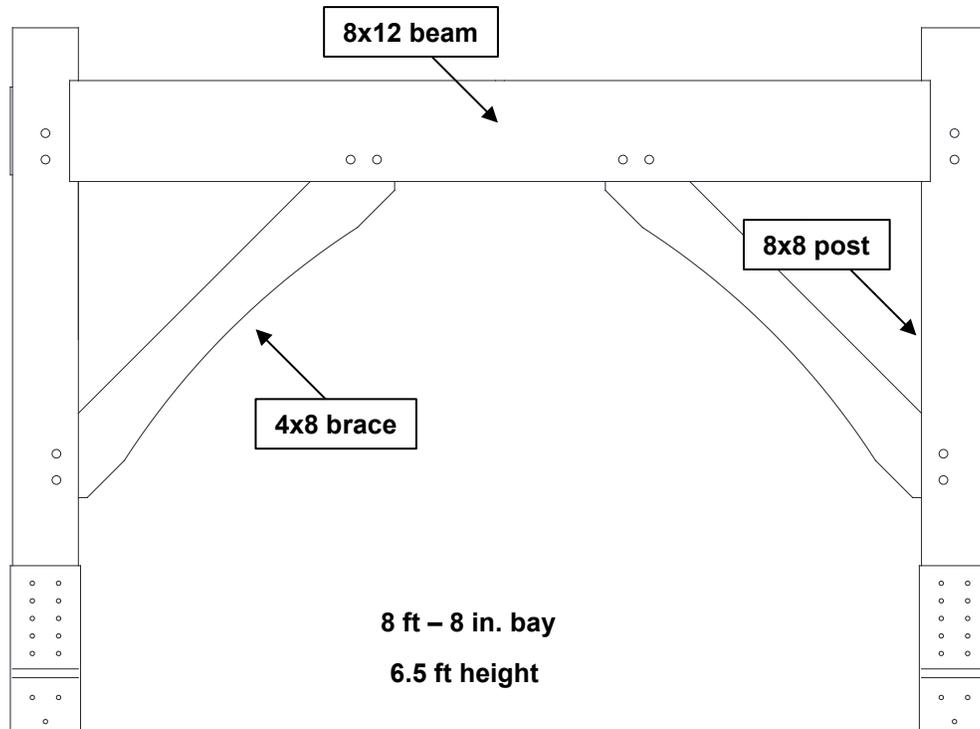
Fig. 3.2 shows an elevation view drawing of the frame. Each frame had two nominal 8x8 posts connected by an 8x12 beam. The posts and beam were Douglas Fir. White Oak was used for the 1-inch diameter pegs. 4x8 braces (also Douglas Fir) connected each post to the beam. One timber frame used 2-peg connections and 4x8 knee braces, and the other frame used 3-peg connections and 4x10 knee braces. The connection details for these braces were based on a previous study sponsored by the TFEC (Judd et al. 2018). Fig. 3.3 shows a rendering of the 3-peg connections. The original timber frames were constructed by Trillium Dell Timberworks.

Fig. 3.2. Drawing of the 2-peg frame.

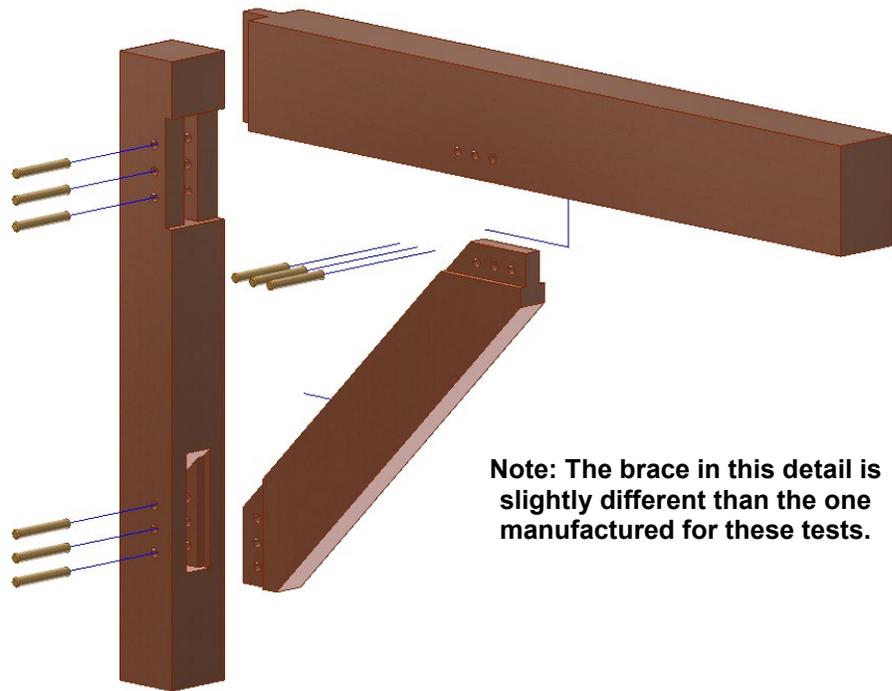
Note: The brace in this detail is slightly different than the one manufactured for these tests.

Fig. 3.3. Rendering of the 3-peg frame connection details.

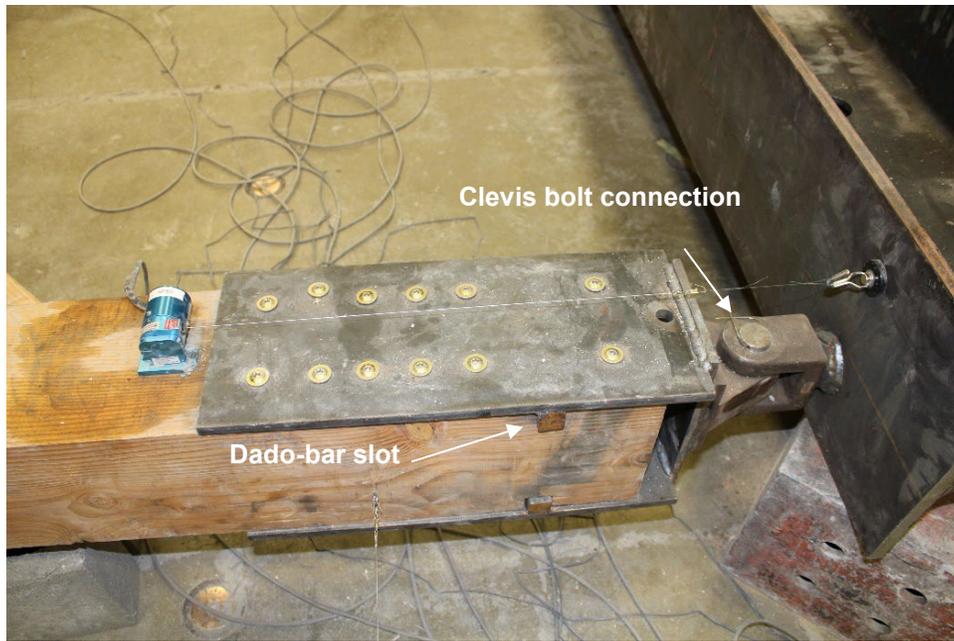
An apparatus was designed in order to properly fit both the two-peg and three-peg frames for support and testing. The base of each post was connected to a pin support via metal plate connections fitted into the dado slot on the front of the leg. Both supports were welded to a wide flange beam which was anchored to the floor with a DYWIDAG bar system

Fig. 3.4. A dado-slot plate connection to beam for the frame support system.

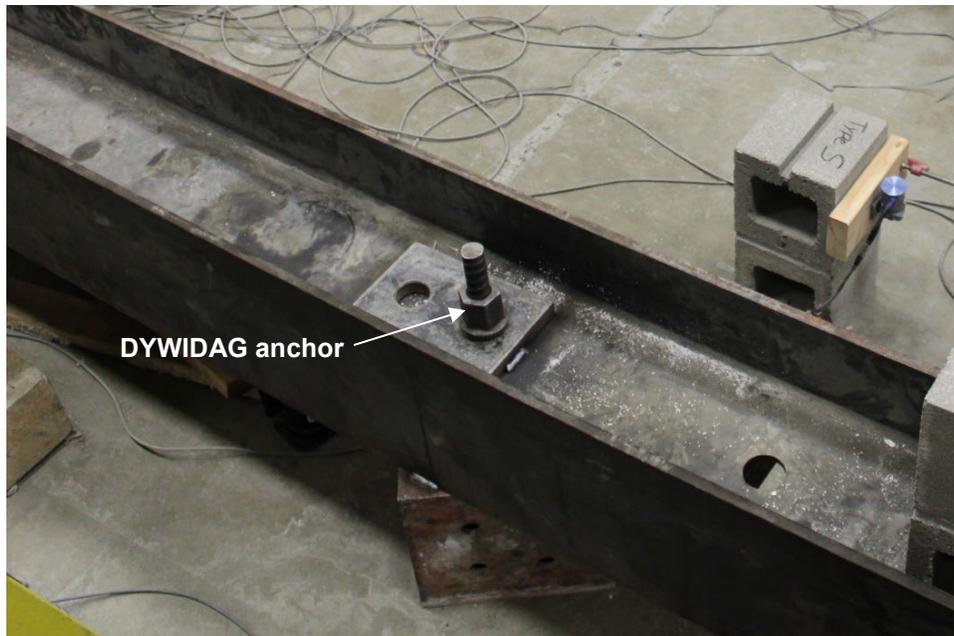
Fig. 3.5. DYWIDAG Anchors securing the support beam to the floor.

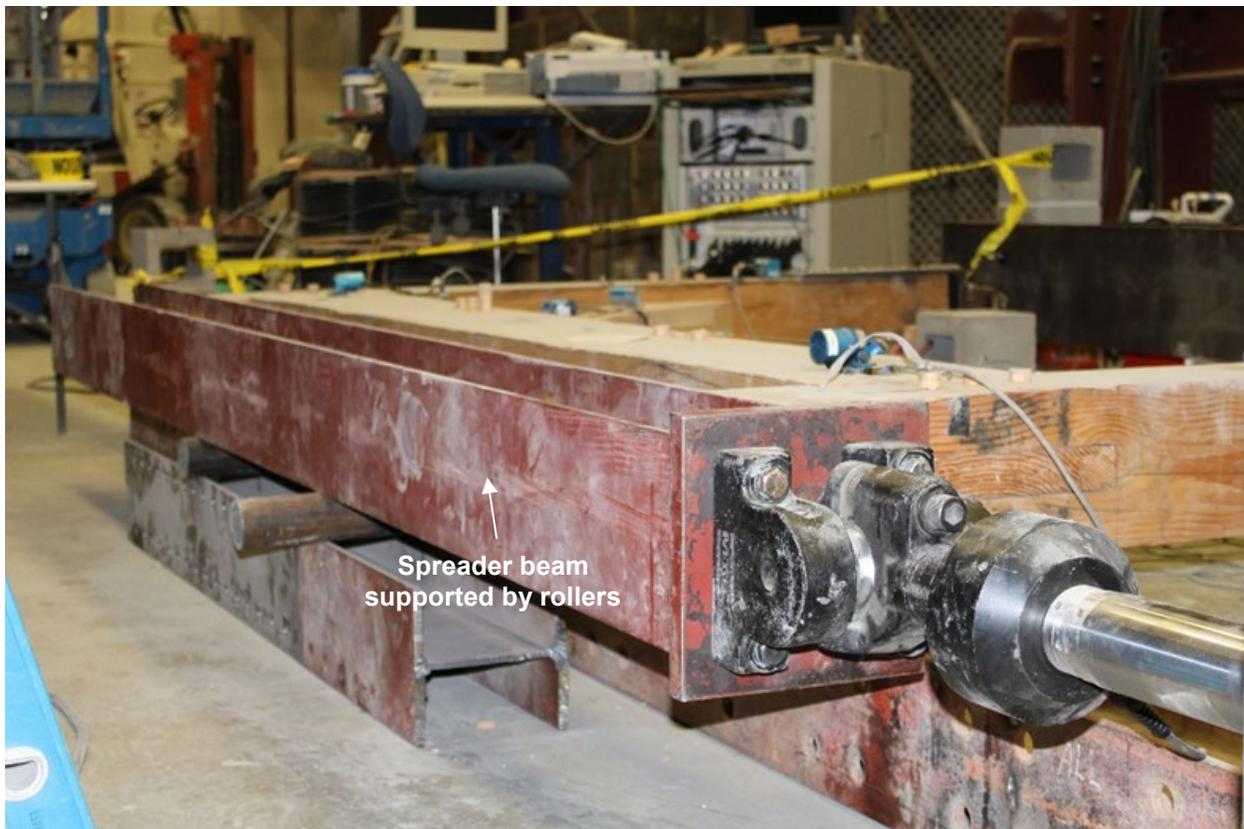
The top of the frame rested on two separate rollers that were supported by a wide-flange beam. The faces of each post were fixated between a spreader beam resting on top of the rollers at the same elevation as the frame. A hydraulic actuator was fastened to the face of the spreader beam as shown in Fig. 3.6. This provided the ability to cyclically load the frame according to the stroke of the actuator. The actuator was fastened in place by a DYWIDAG anchor system similar to that of the supports at the base of the frame (Fig. 3.7).

Fig. 3.6. DYWIDAG Anchor system securing actuator to the floor.

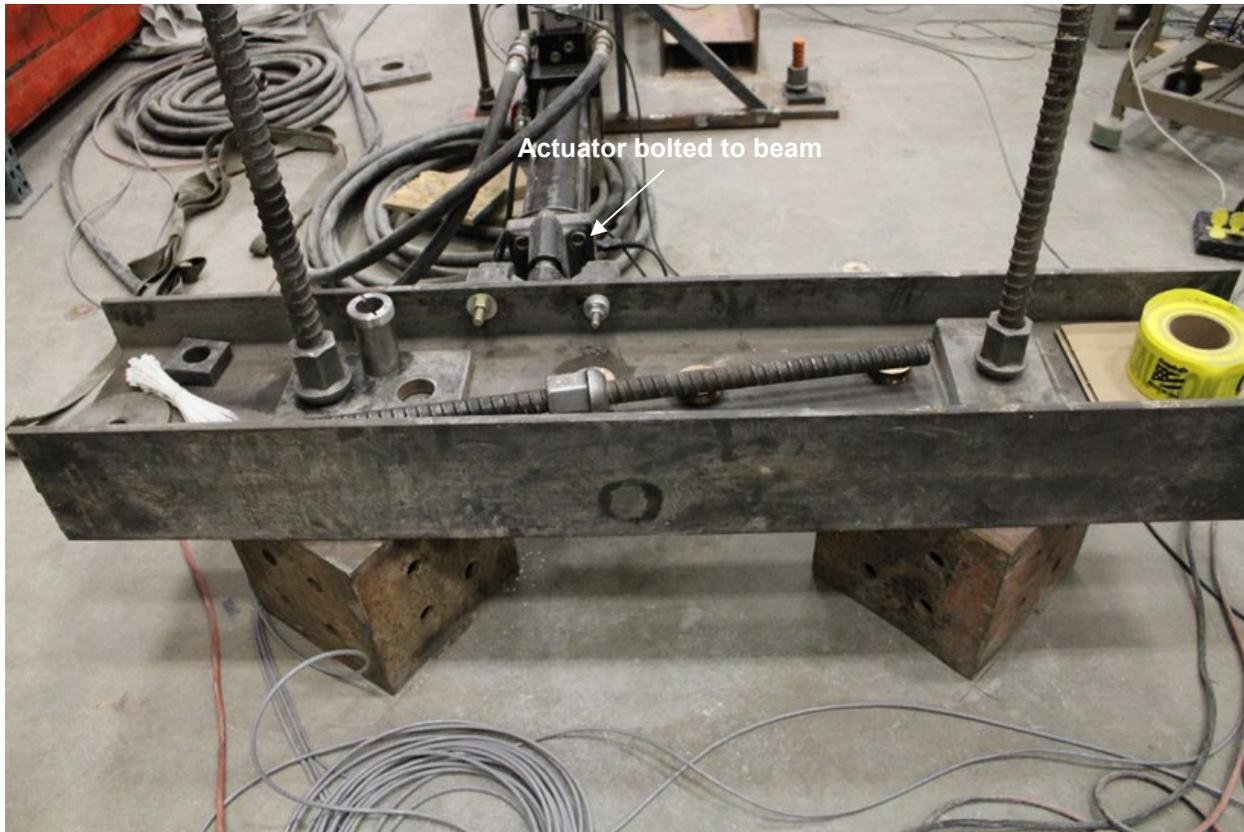
Fig. 3.7. DYWIDAG Anchor system securing actuator to the floor.

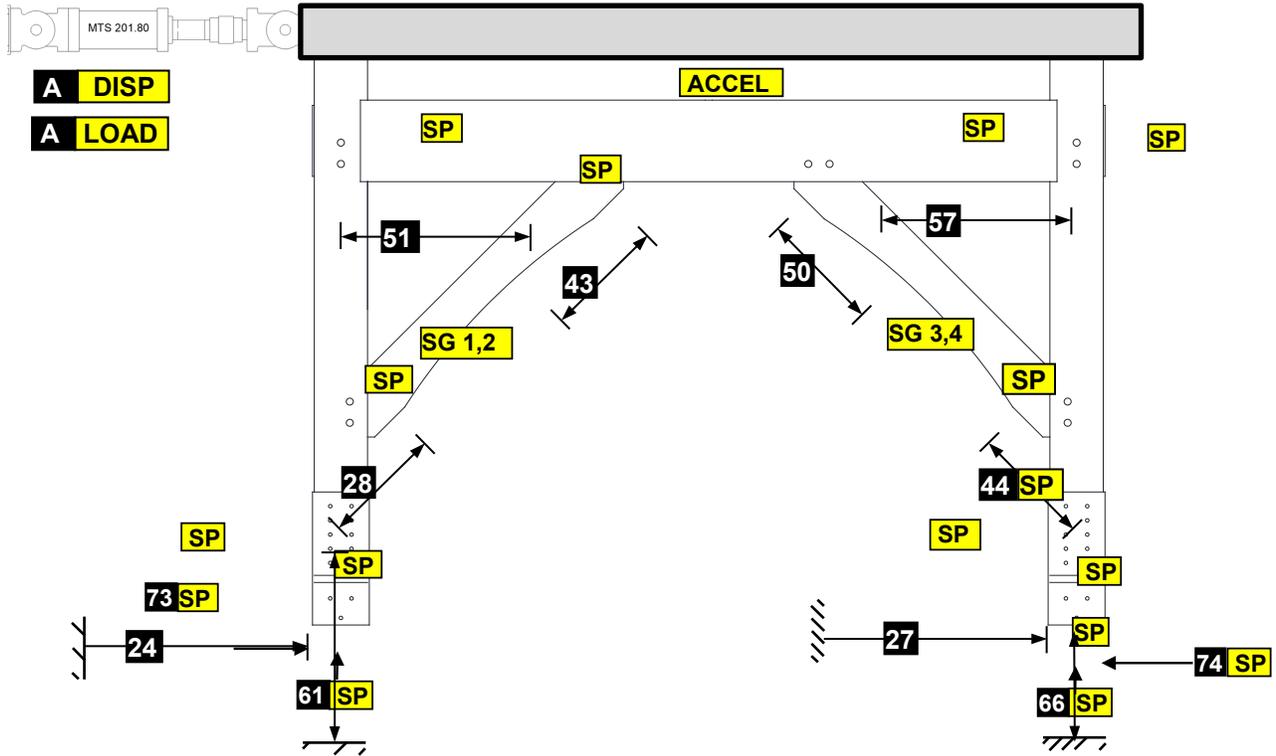
String potentiometers were secured to the frame at different locations along adjoining members and connections to the supports. Two strain gauges were placed on each brace within the frame, totaling the instrumental count to 14 string pots and four strain gauges. Each of these instruments were calibrated prior to the tests and utilized during each cycle in order to show displacement within the frame. The four string pots at the base of the supports were utilized in order to account for slippage in the DYWIDAG anchors. This slippage was first experienced in a preliminary test and addressed prior to the remaining trials in order to minimize impact on instrument readings.

Fig. 3.8. Instrumentation plan showing position of string potentiometers and strain gauges.

Label	Purpose
A1	Actuator load
A2	Actuator displacement
SP20	Frame drift
SP24, SP27	Left, right reaction displacement
SP28, SP43, SP44, SP50	Brace to post/beam connection separation
SP51, SP57	Beam to post separation
SP58, SP59	Frame uplift
SP73, SP74	Anchor support drift
ACCEL	Acceleration
SG 1,2 SG 3,4	Strain gages: top of left and right braces

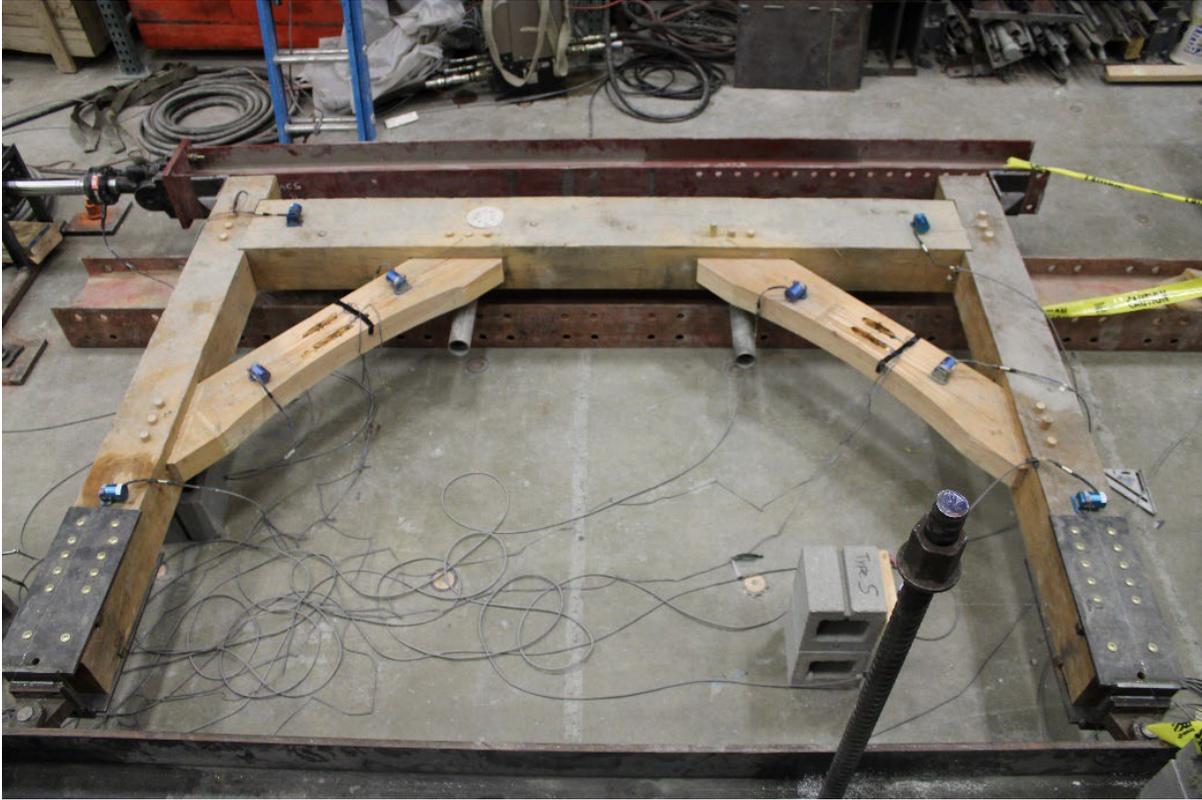
Fig. 3.9. Completed testing apparatus with 3-peg frame specimen.

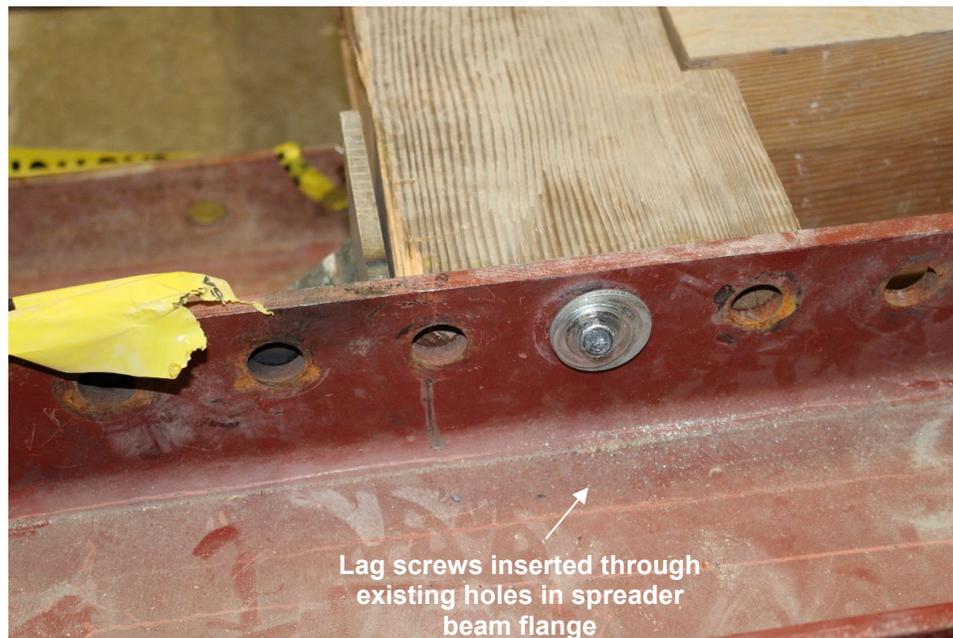
Fig. 3.10. Lag screw inserted into post to secure spreader beam.

The first test was run up to the 2.0-inch displacement mark and then paused due to noticeable slippage in the anchors near the footings. This was due to the washer used to fasten the DYWIDAG anchors through the slab giving every time the actuator reached max displacement. In addition, a lag-screw was inserted through the spreader beam flange into the top of the post (Fig. 3.10) in order to keep the spreader from drifting off the frame. After pausing and making proper adjustments, including the string pots used to measure the anchor slippage, the test was re-run on the 3-peg frame.

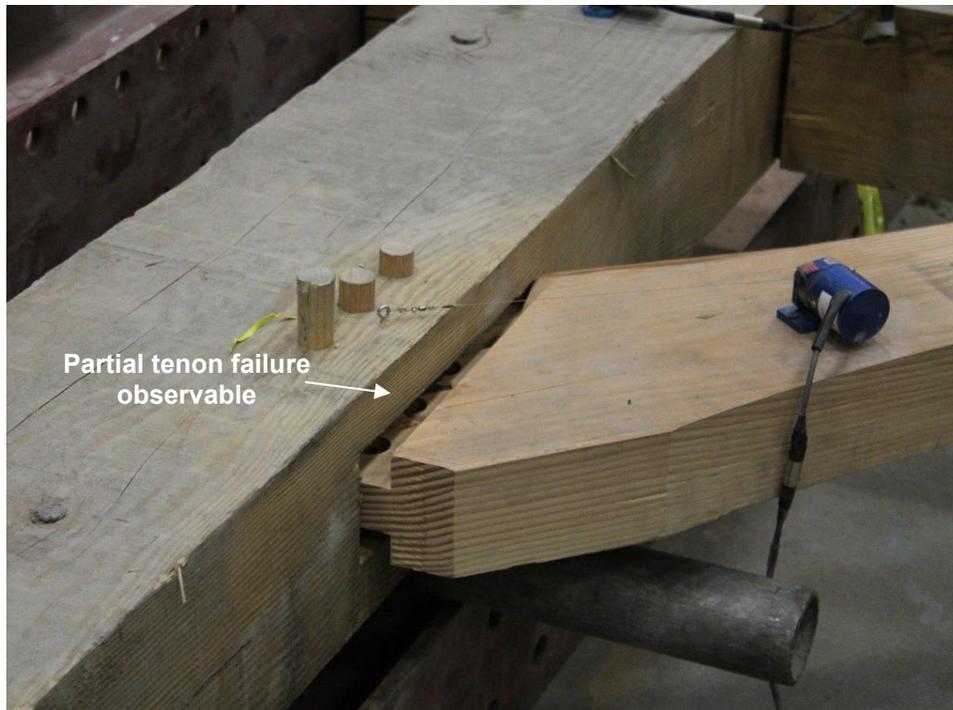
The full trial of the 3-peg frame test was run up to 3Δ (6 inches) before ending the test. At around 4 kips of force applied to the frame, noticeable crack propagation was present between the top-right post and beam connection. Following this observation, there was slight rupture within the right brace during the next cycle and the connection became loose. Fig. 3.11 demonstrates the

aftermath of the increased load on the brace connection. The increasing tension pulled the brace tenon further out of the beam as the actuator reached 4.5 kips as observed in the SP50 data. While this brace continued to give, the left brace to left post tenon gradually started to fail and had demonstrated full failure at the loading point of 6 kips. The dado slot at the bottom of the right post began to fail during the last couple cycles and was followed with connection failure between the footing plate screws and the post. At this point the test was stopped and the displacement returned to zero.

Fig. 3.11. Tenon failure in the right brace-beam connection.

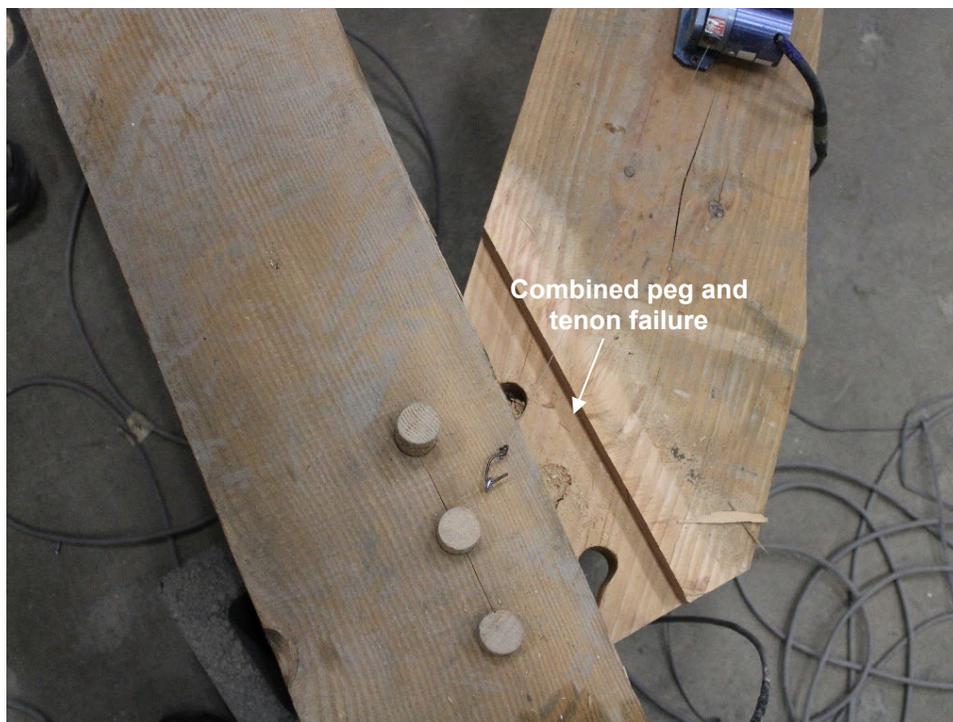
Fig. 3.12. Tenon failure in the right brace-beam connection.

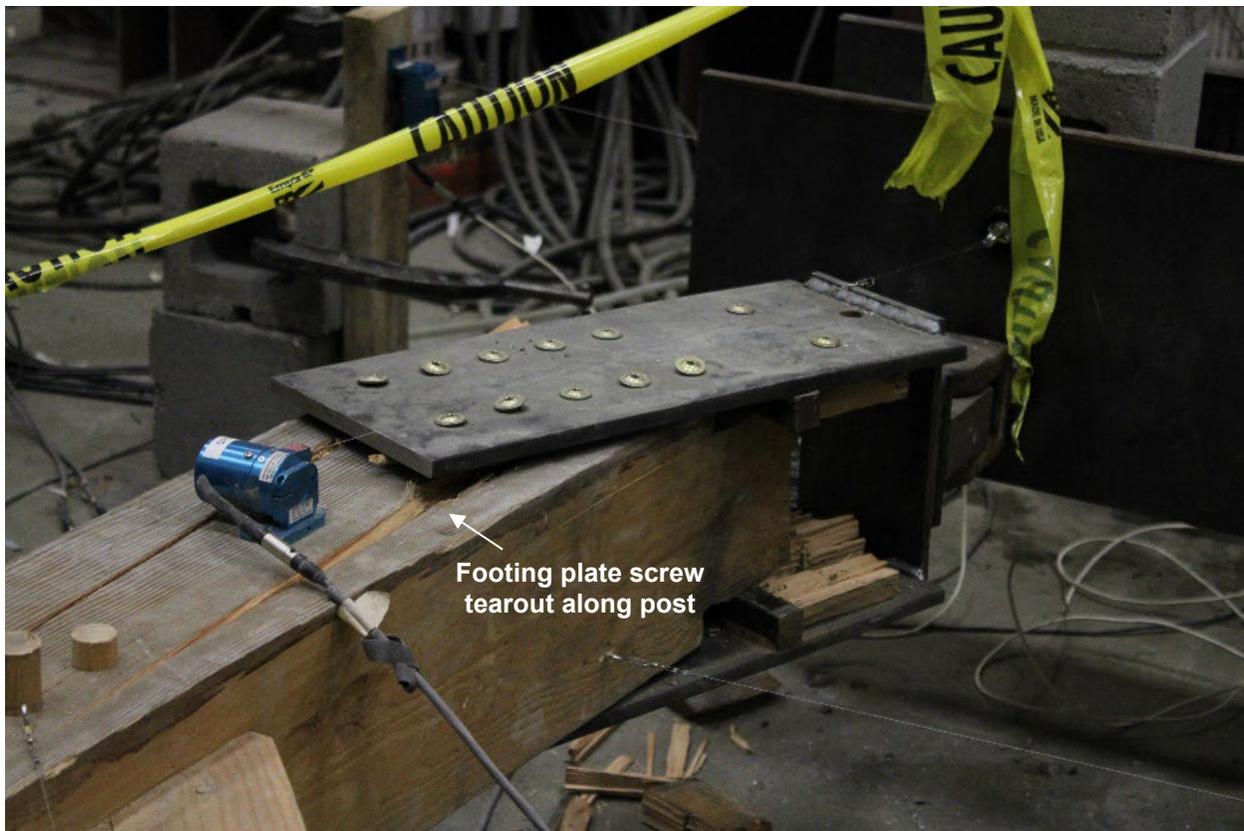
Due to the tearout failure between the plate screws and post as seen in Fig. 3.13, the plate footing was unable to re-attach to the right post of the frame. This rendered the 3-peg frame useless to rehabilitate, and the 2-peg frame was inserted next into the testing apparatus.

Fig. 3.13. Failure in the footing connection (tearout of screws and dado bearing).

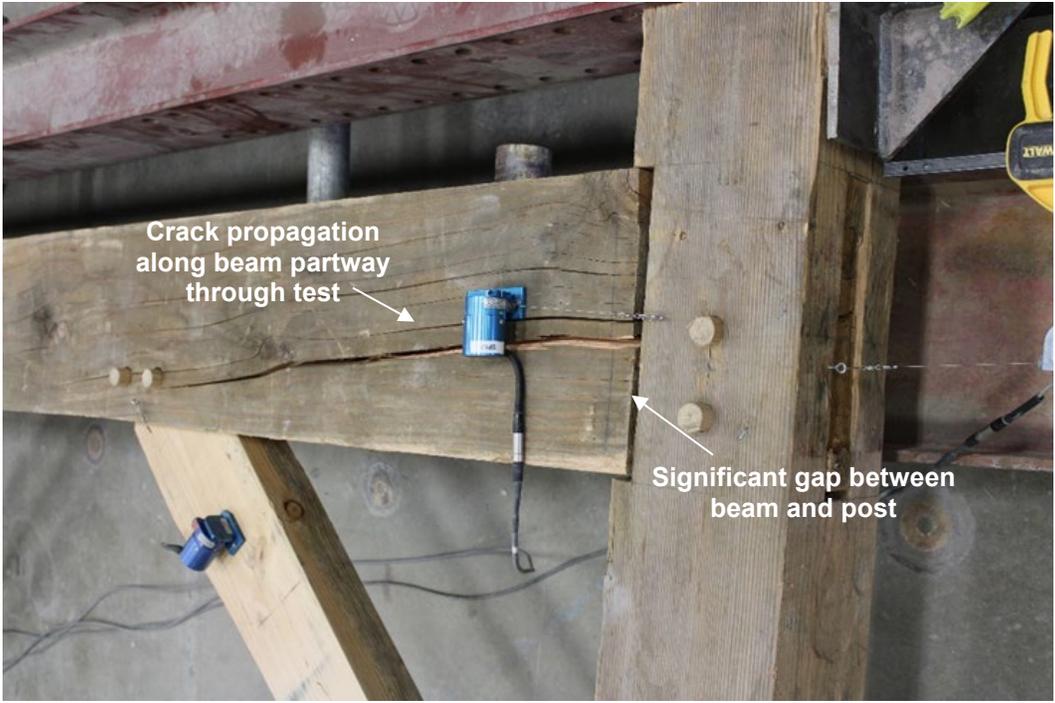
The 2-peg frame was tested and resulted in a different behavior throughout the loading regime. At 4.5 kips of load, the top beam-to-post connection had a rupture within the tenon and resulted in crack propagation from the connection on the left side of the beam. On the following cycle, the crack began to move through the beam to the center as observed in Figs 3.14 and 3.15. At this point, the test was stopped and the frame was reverted to zero displacement. Partial tenon failure in the right brace was visible as the final rupture through the beam occurred.

Fig. 3.14. Initial crack propagation in the right beam-to-post face.

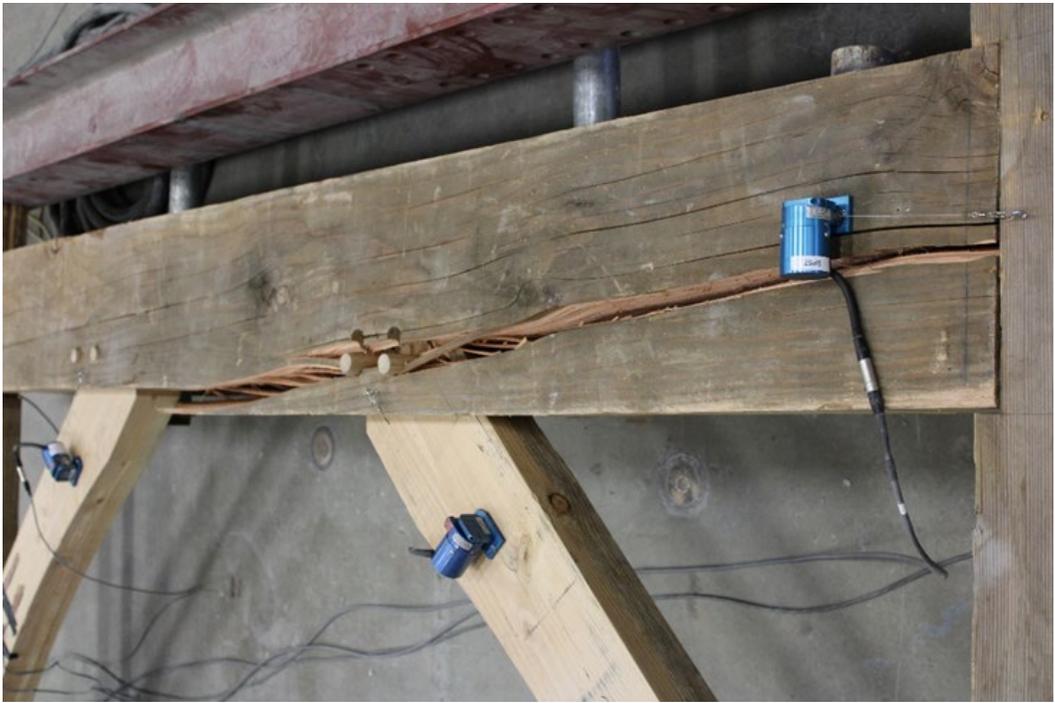
Fig. 3.15. Further cracking through the beam towards the right brace.

The condition of the 2-peg frame following the completion of the initial test was sufficient enough to warrant a rehabilitation involving self-tapping screws to reinforce the beam. CYL 5/16x11-7/8 in. self-tapping screws were selected based on length needed to reinforce the depth of the beam with sustained cracking. Screws were inserted at an embedment angle of roughly 60°. Twelve screws were inserted from the top of the beam to the right of the brace, while another ten were inserted on the bottom of the beam to the left of the brace (Fig. 3.16). This was done due to the position of the crack as it moved from the right connection towards the center demonstrated in Fig. 3.15. The finished result of the lag screw installment is shown in Fig. 3.17 and Fig. 3.18.

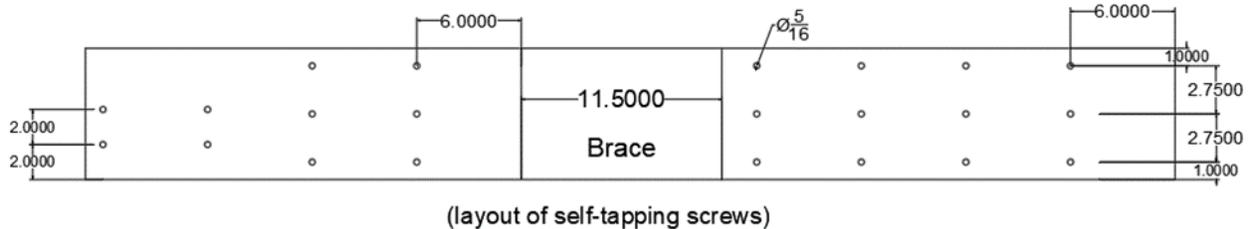
Fig. 3.16. Lag screw rehabilitation array.

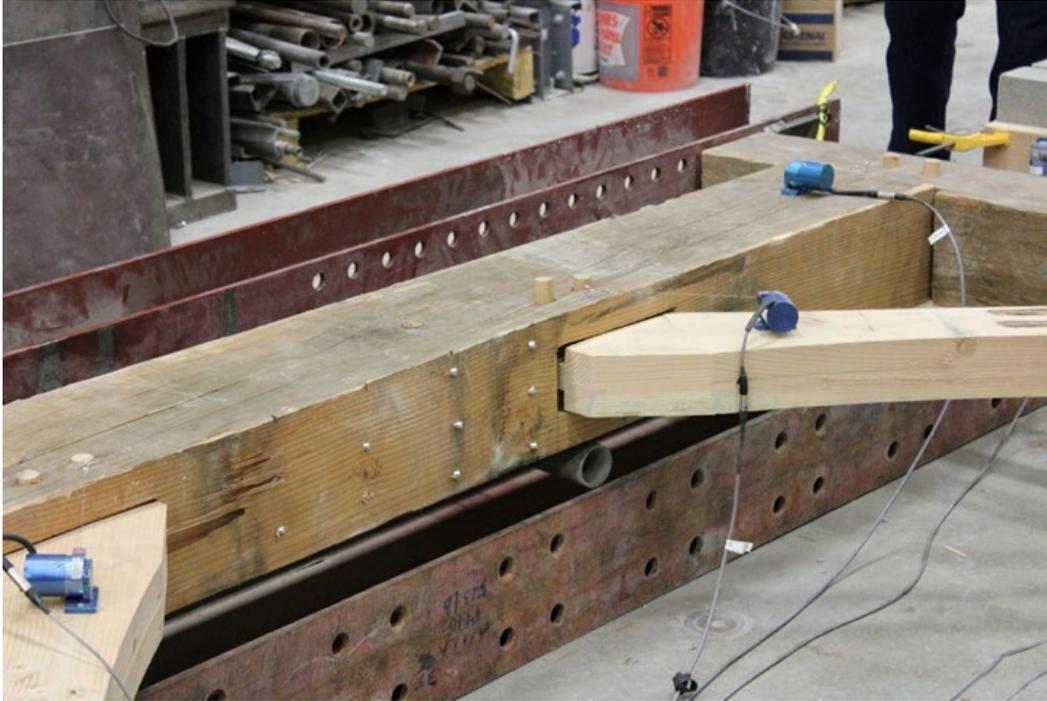
Fig. 3.17. Lag screws inserted in the bottom beam face.

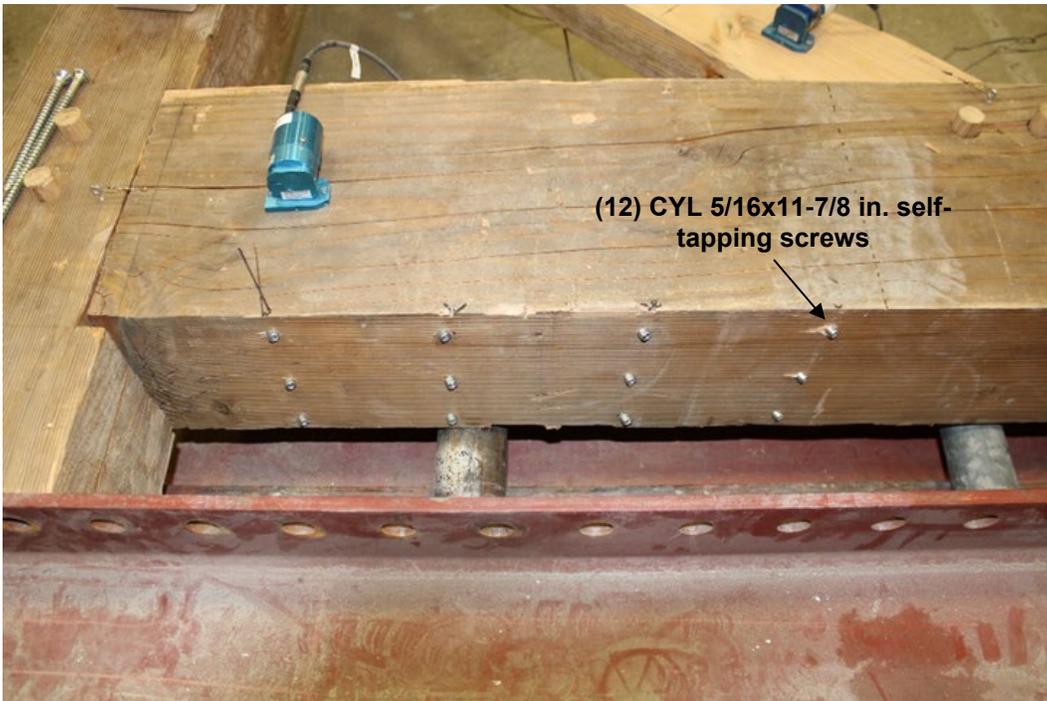
Fig. 3.18. Lag screws inserted in the top beam face to the right of the brace.
