BYU Civil & Environmental Engineering

Performance Criteria for Free-Standing Timber Frames with Knee Braces

November, 2022

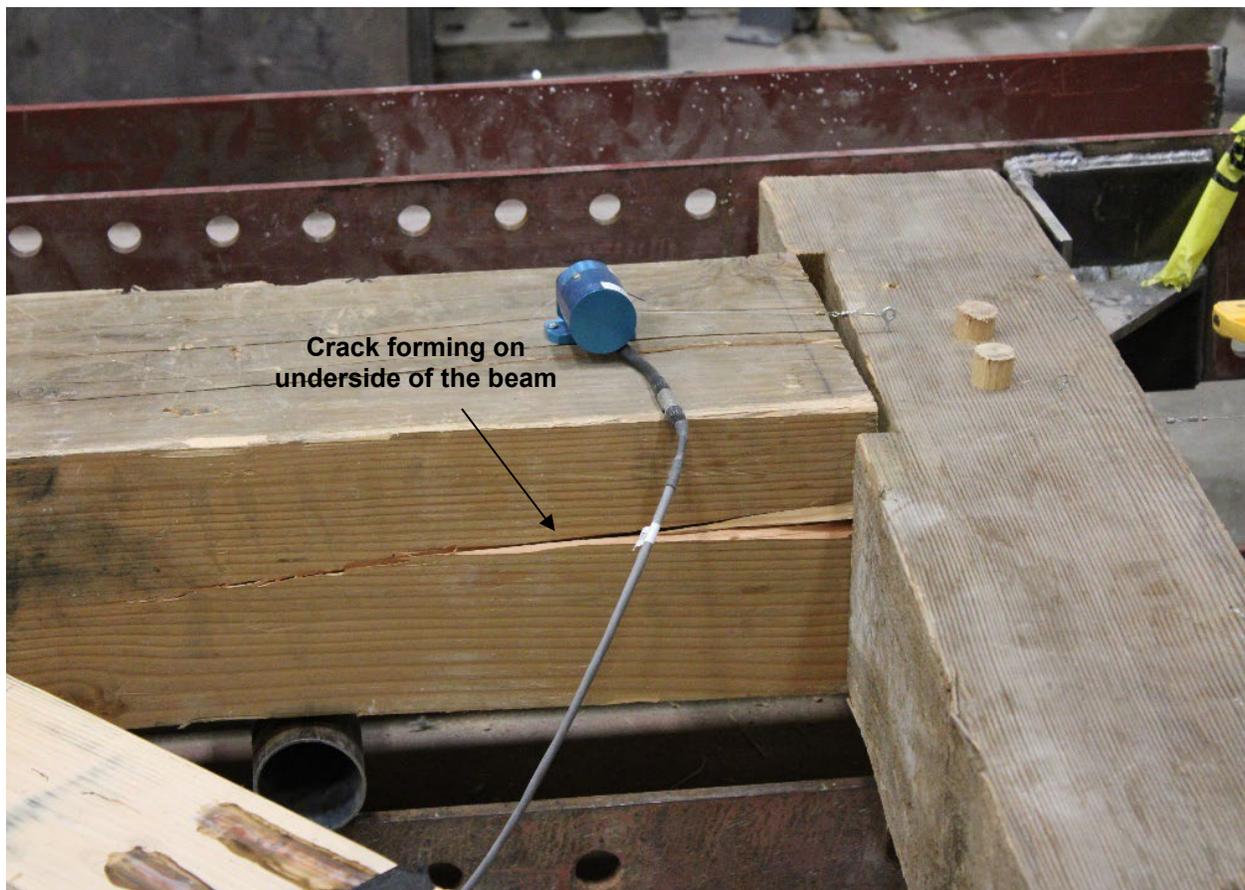
Despite part of the tenon joint being ruptured, the frame proceeded to transfer load throughout the system in a behavior similar to the original test. The tenon joint failed completely at 5 kips, yet continued to provide compressive strength to the frame when positive displacement from the actuator occurred. The beam did not experience cracking again until nearly 7 kips of applied force, in which the joint between the beam and right post also began to give as shown in Fig. 3.16. This crack continued through the base of the beam while the right brace-to-beam joint failed completely. Through the last cycle, both footings experienced bending within the plate connections (Fig. 3.21).

Fig. 3.19. Crack forming in the rehabilitated beam.

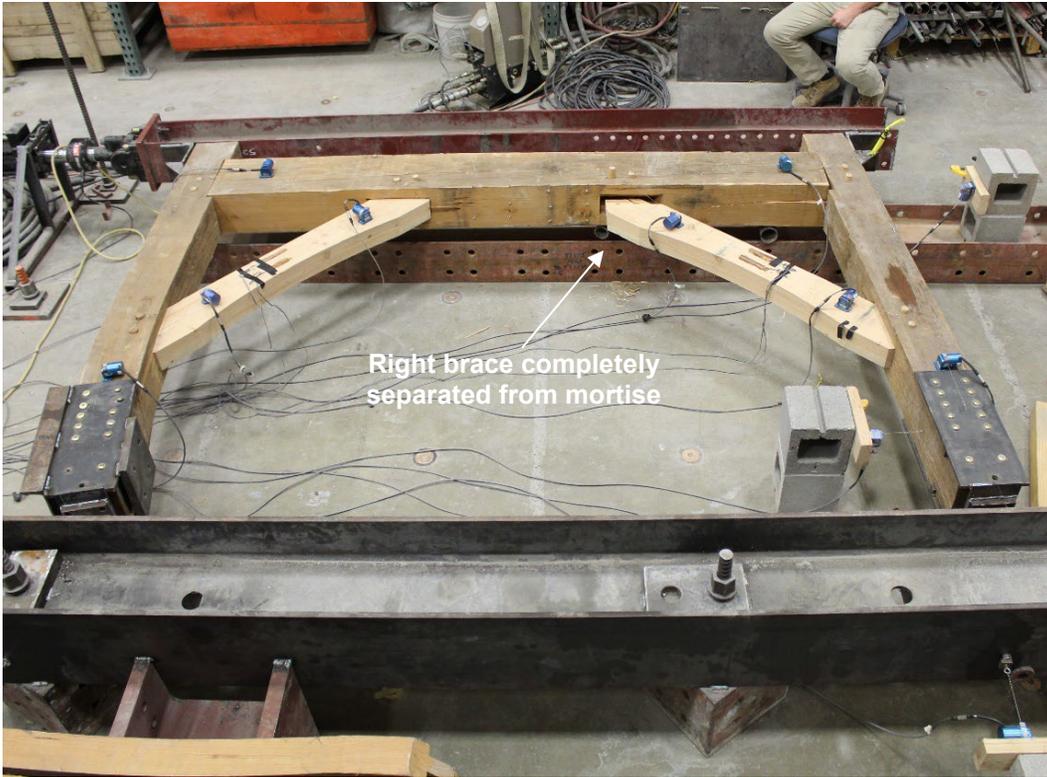
Fig. 3.20. View of the frame at the highest displacement cycle before stopping.

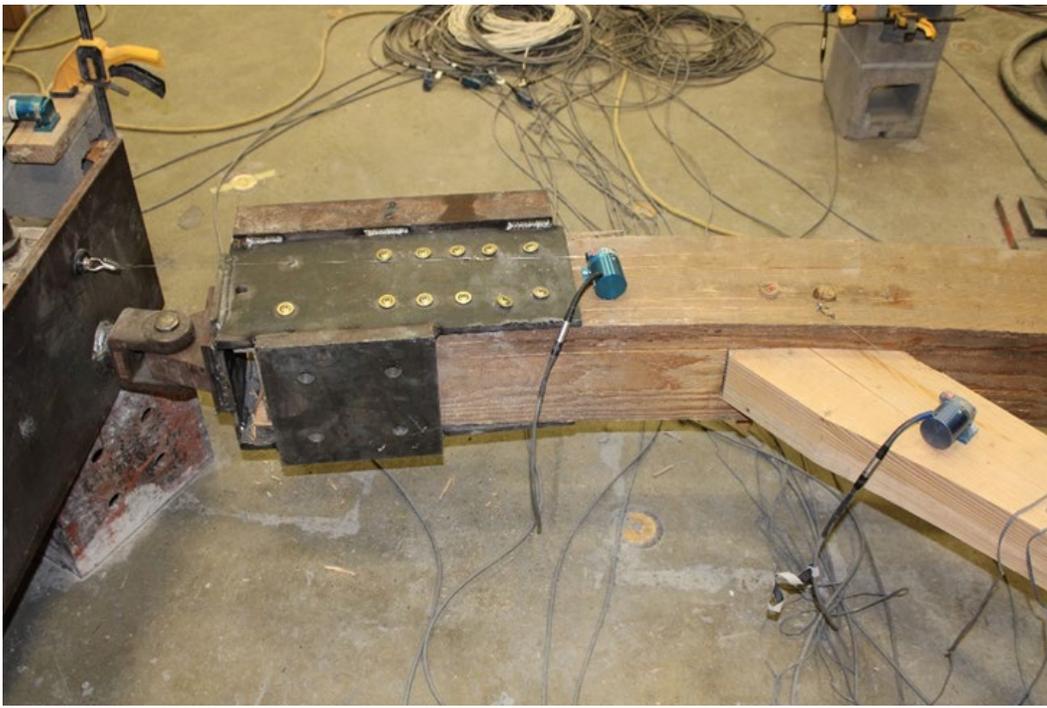
Fig. 3.21. Detail of left post footing experiencing flexure during the test.

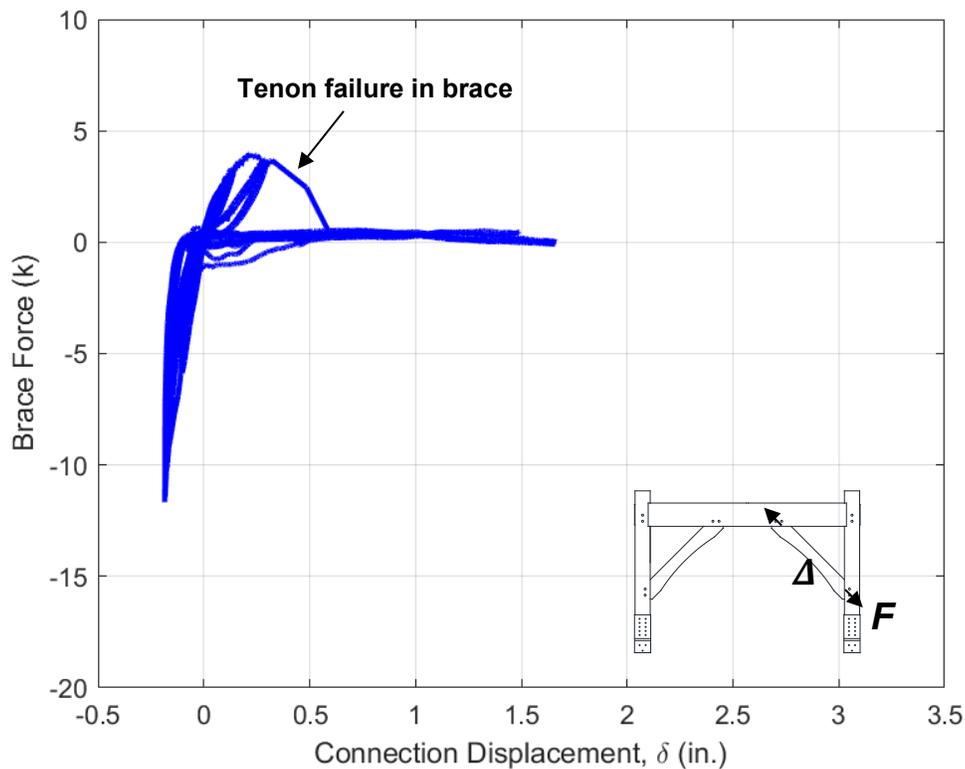
When removed from the testing apparatus, the 3-peg frame was observed to have tenon joint failure in both braces. As multiple cracks were heard during the test procedure, the right brace-to-beam failed in tearout at roughly 4.5 kips and the left brace-to-post failed in both tearout and peg shear when the load neared 6 kips. This was confirmed by the hysteresis graphs of force versus connection displacement in the right brace (Fig. 3.22) and force in the left brace versus connection displacement (Fig. 3.23). Following both of these cracks, the frame failed to transfer any more load. Fig. 3.24 shows the normalized lateral strength versus story drift ratio. The ultimate strength was 6.0 kips, compared to the expected nominal strength of 6.4 kips. The frame ductility was 2.2.

Fig. 3.22. Right brace force versus connection displacement for 3-peg frame.

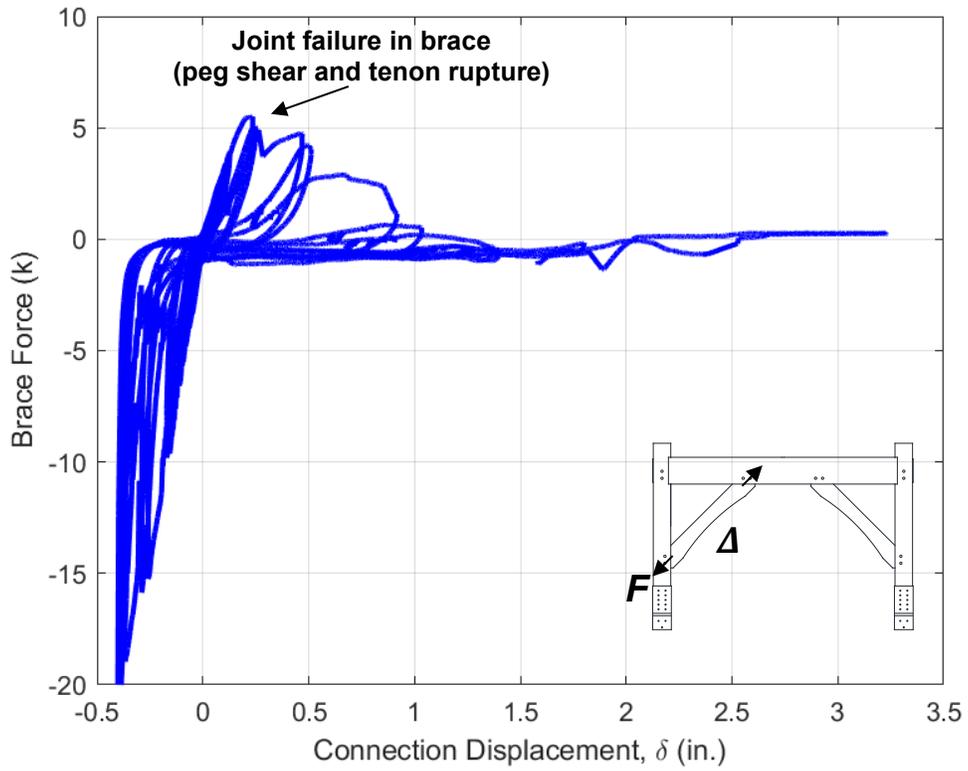
Fig. 3.23. Left brace force versus connection displacement for 3-peg frame.

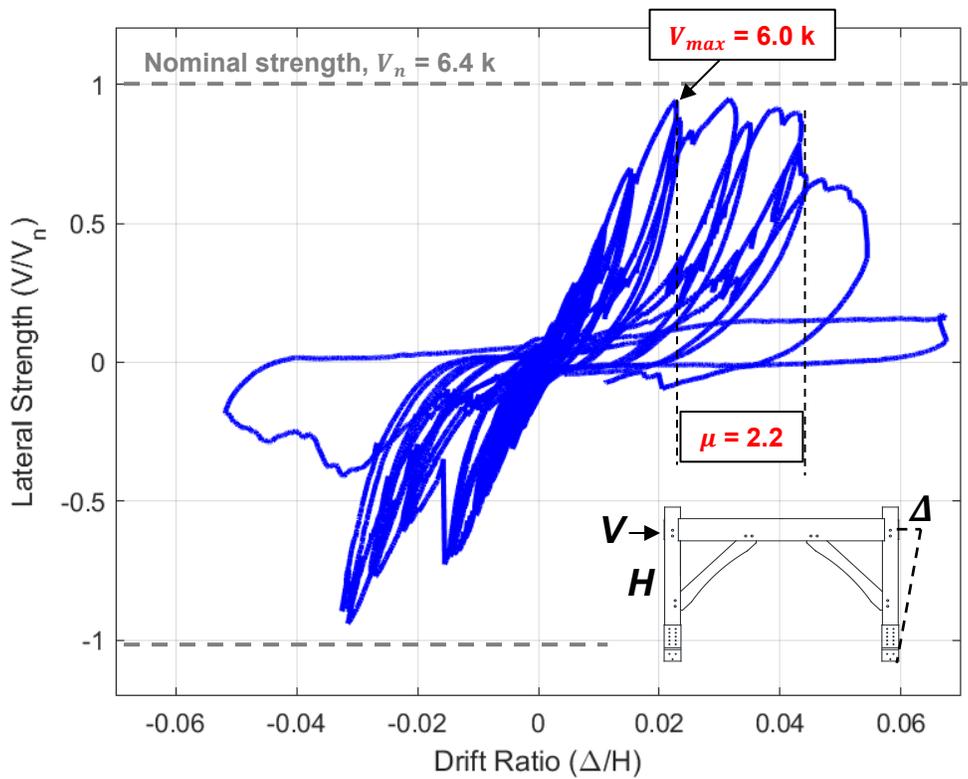
Fig. 3.24. Normalized lateral strength versus story drift ratio for 3-peg frame.

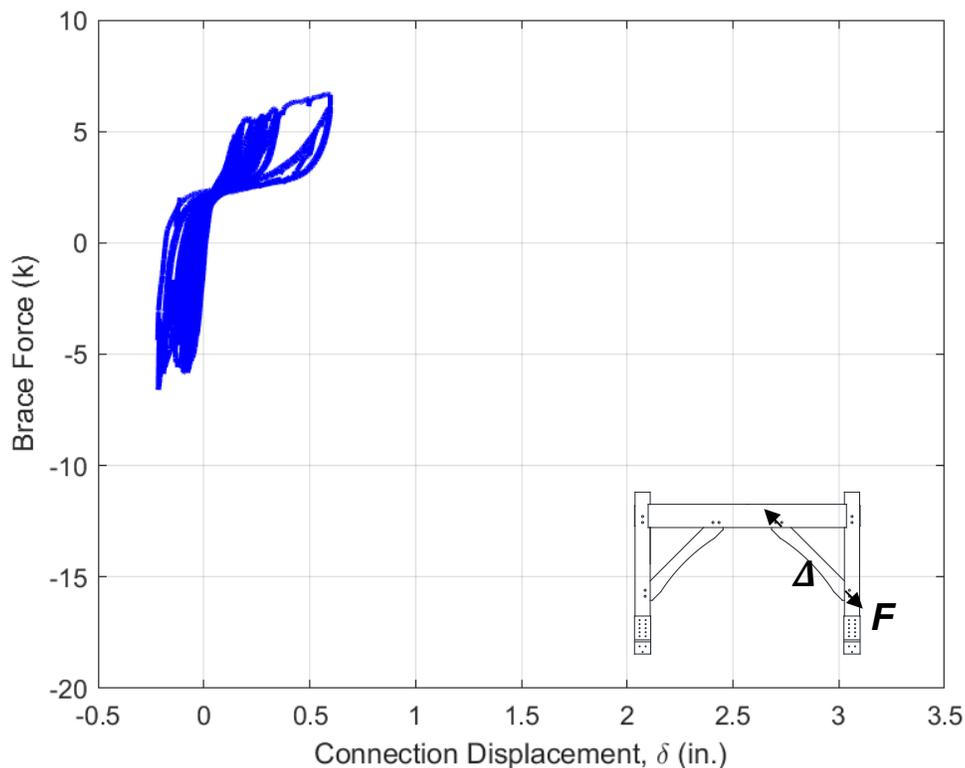
The 2-peg frame exhibited lateral cracking in the beam prior to any total failure of the brace connections demonstrated in the 3-peg test. Fig. 3.25 shows the force versus connection displacement recorded in the right brace, with the force only reaching 4.7 kips before splitting in the beam occurred. It should be noted the connection displacement was significantly less than the 3-peg frame trial, due to the early tenon failure that occurred in the 3-peg test. Fig. 3.26 shows the left brace response. Fig. 3.27 shows the normalized lateral strength versus story drift ratio. The ultimate strength was 4.7 kips, compared to the expected nominal strength of 4.3 kips. The frame ductility was 1.2.

Fig. 3.25. Right brace force versus connection displacement for 2-peg frame.

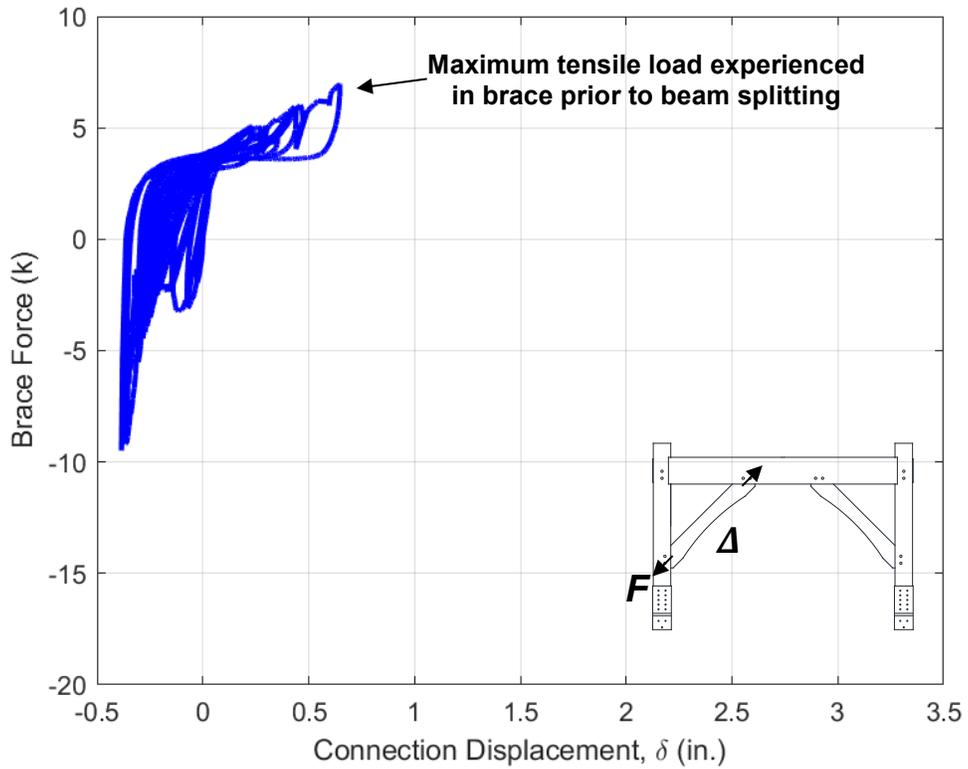
Fig. 3.26. Left brace force versus connection displacement for 2-peg frame.

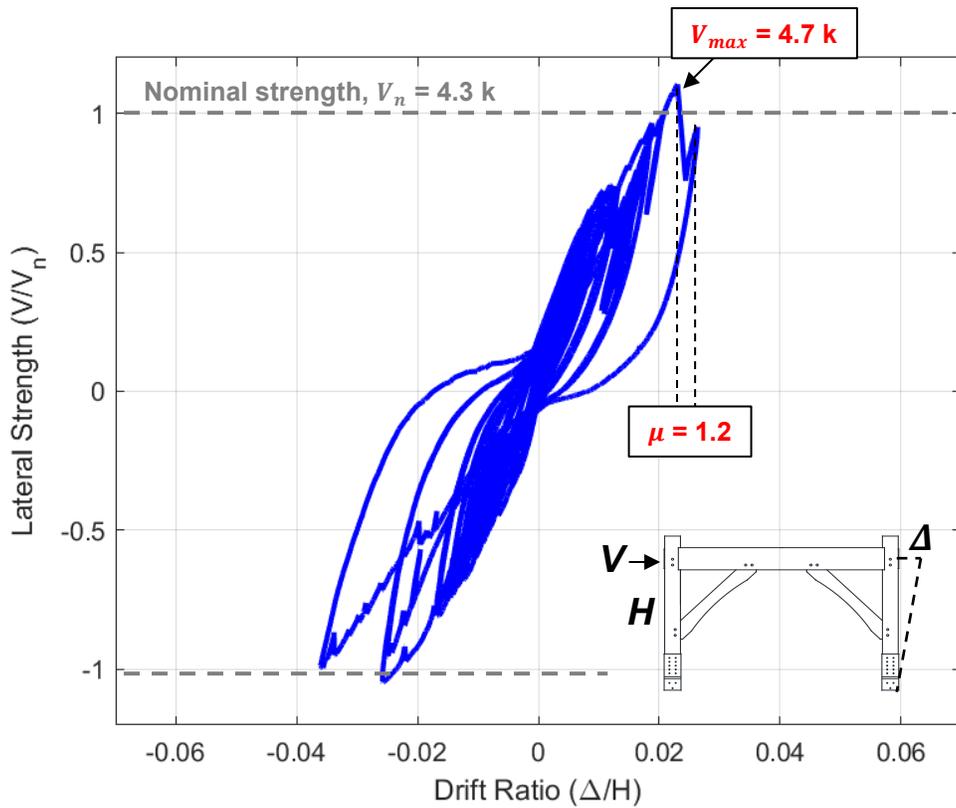
Fig. 3.27. Normalized lateral strength versus story drift ratio for 2-peg frame.

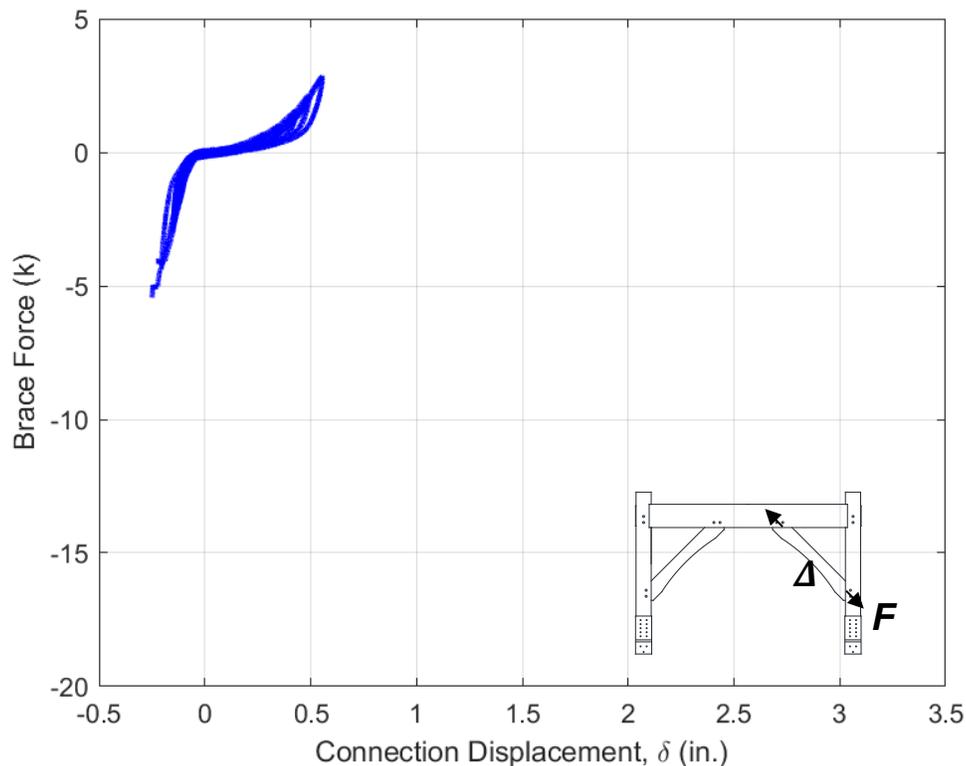
Fig. 3.28. Right brace force versus connection displacement for rehabilitated 2-peg frame.

Results from testing the rehabilitated 2-peg frame showed an increase in strength of the frame. Though the right brace tenon was compromised from the partial failure experienced in the first test (limited transfer of load visible in Fig. 3.28), the frame was able to transfer load for a significantly longer duration of the testing protocol. The left brace response is shown in Fig. 3.29. Fig. 3.30 shows the normalized lateral strength versus story drift ratio. The ultimate strength was 7.0 kips, significantly above the 4.3-kip nominal strength of the 2-peg frame. The frame ductility was 2.7. Fig. 3.31. shows the beam tenon and Fig. 3.32 shows the peg shear failure inside the post mortise.

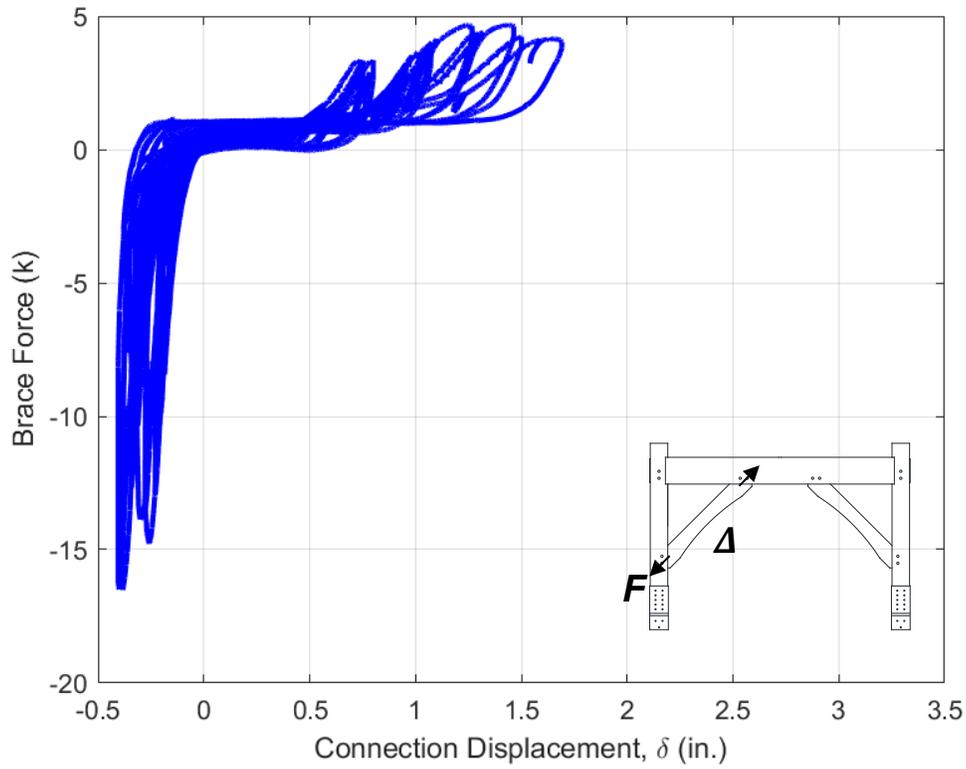
Fig. 3.29. Left brace force versus connection displacement for rehabilitated 2-peg frame.

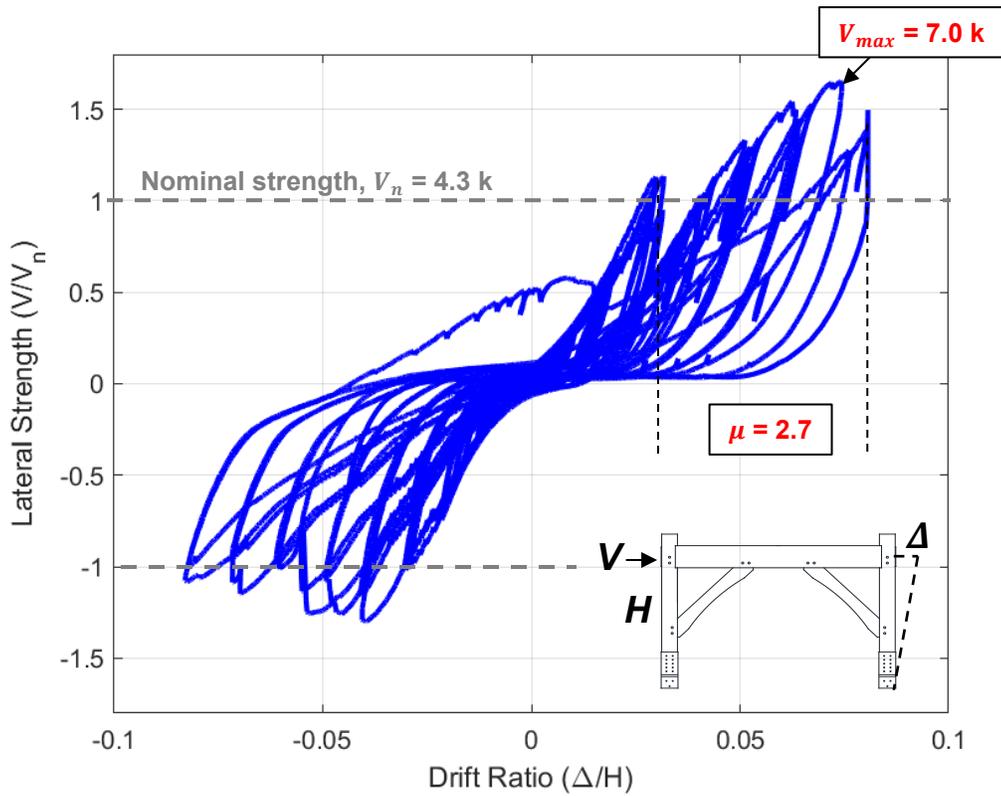
Fig. 3.30. Normalized lateral strength versus story drift ratio for rehabilitated 2-peg frame.

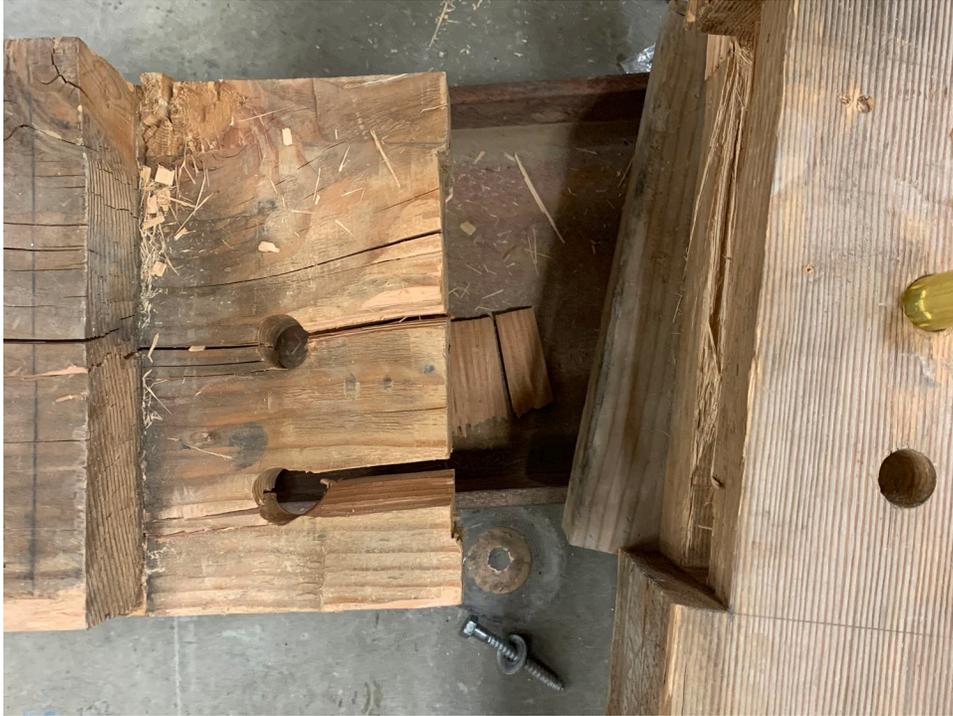
Fig. 3.31. Beam tenon from rehabilitated 2-peg frame displaying mode III_m failure.

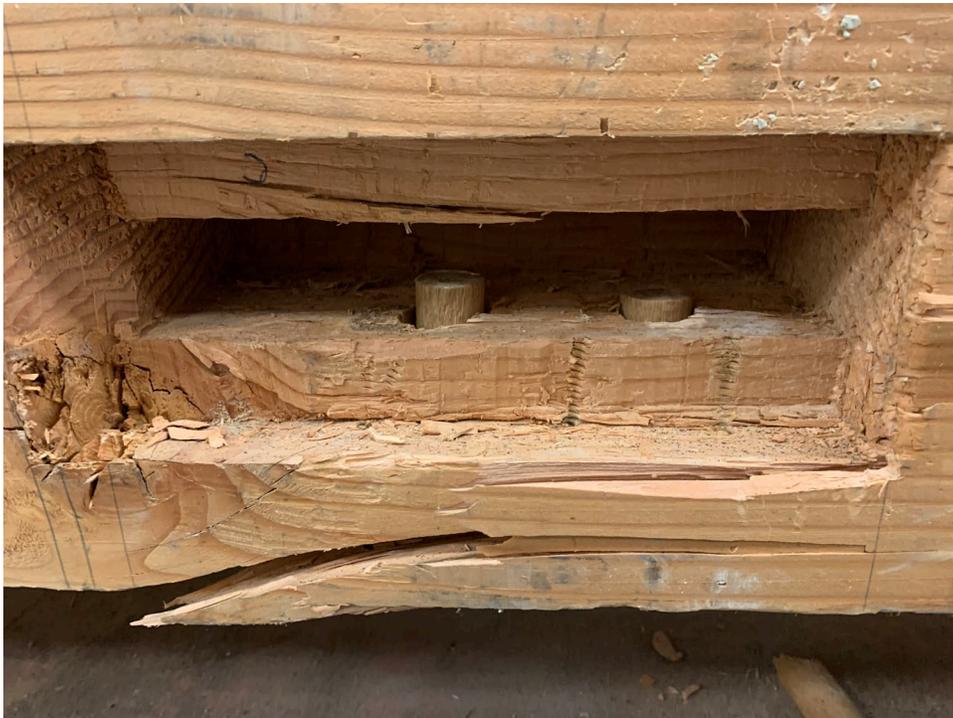
Fig. 3.32. Peg shear failure inside of post mortise from rehabilitated 2-peg frame.

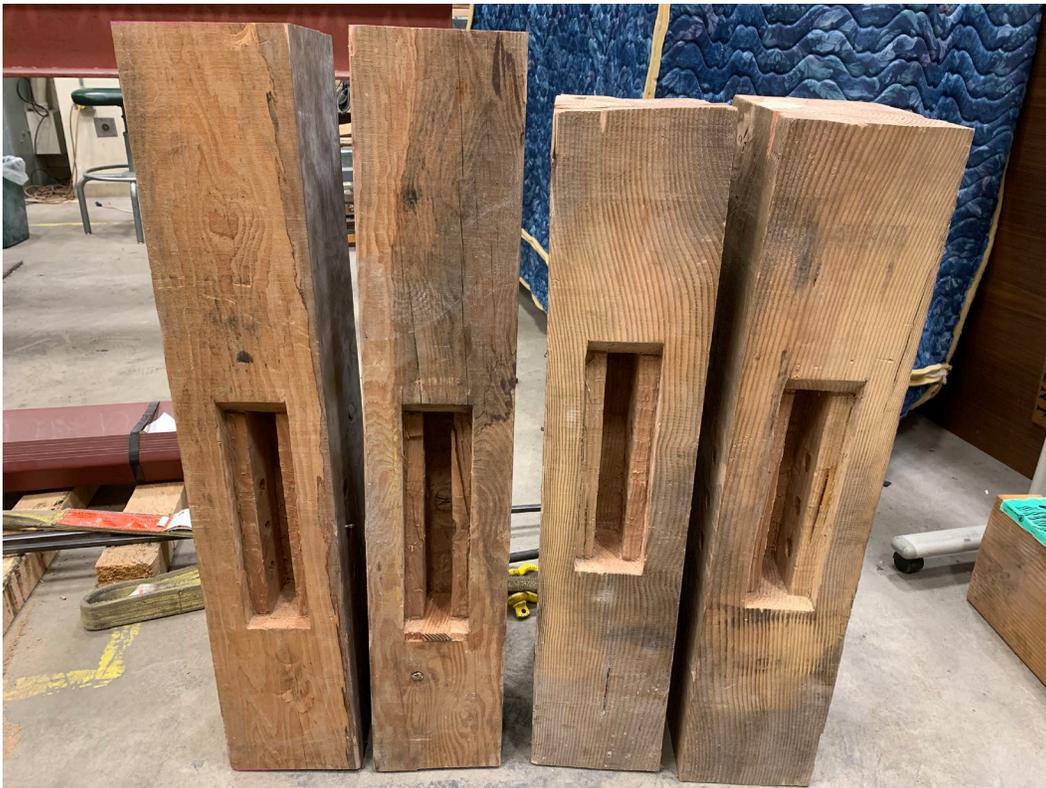
Fig. 4.1. Mortise specimens sourced from previously tested 3-peg frame.

Each of the two mortise connections from the beam were cut out in roughly even-sized chunks using a circular saw shown in Fig. 4.1. The mortise connections sourced from the frame posts were also cut in this manner. Both newly manufactured braces were cut evenly down the center, as shown in Fig. 4.2, to create knee brace connection specimens.

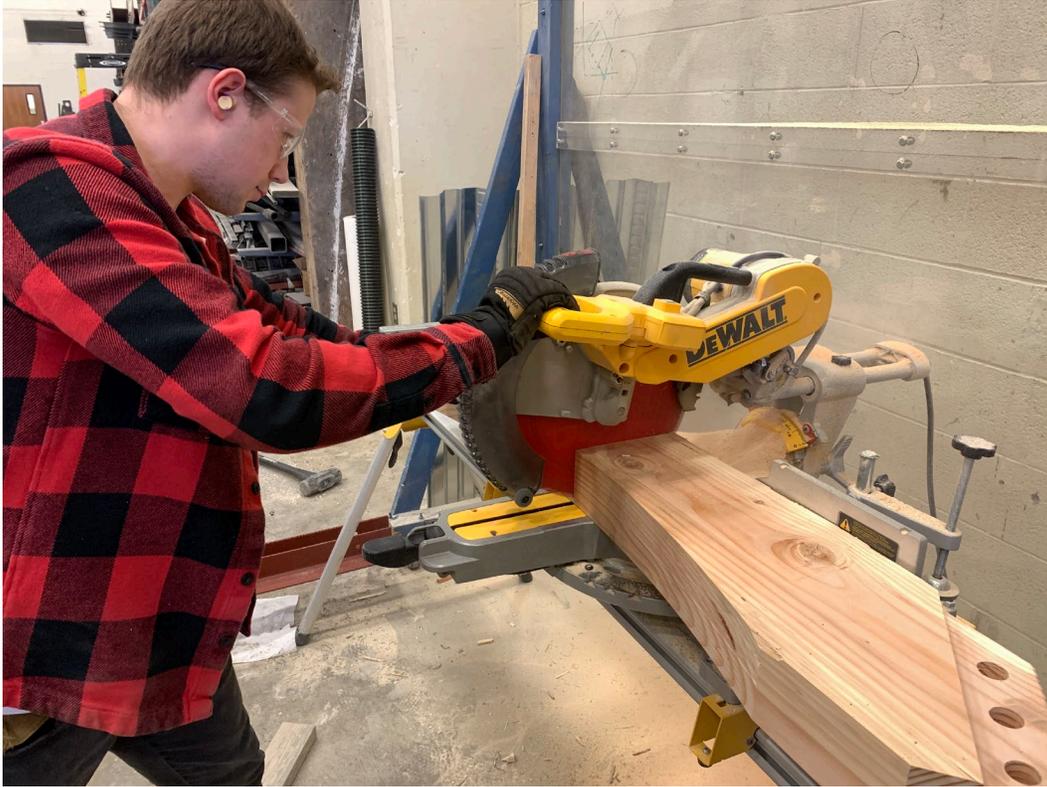
Fig. 4.2. Dividing newly manufactured brace for connection specimens.

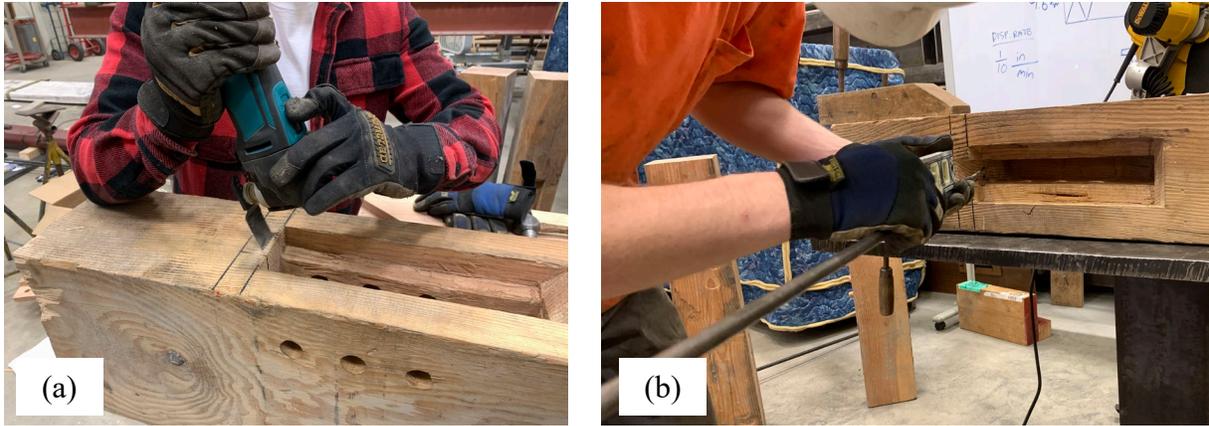
Fig. 4.3. Modification of connection details: (a) beveling out, and (b) boring bit insertion.

Two of the connections were first beveled-out through part of the tenon bearing surface. A 15-degree bevel was first cut through the center-slot of the bearing. A $\frac{1}{2}$ " boring bit was used to drill a weep-hole through the beveled surface at a 20-degree angle, penetrating the rear face of the post. This connection detail modification was performed on one of the mortises cut from the beam, and one of the mortises cut from the post of the three-peg frame. Test specimens would be labeled one through four, with either a drained (“D”) or un-drained (“U”) condition, shown in Fig. 4.3.

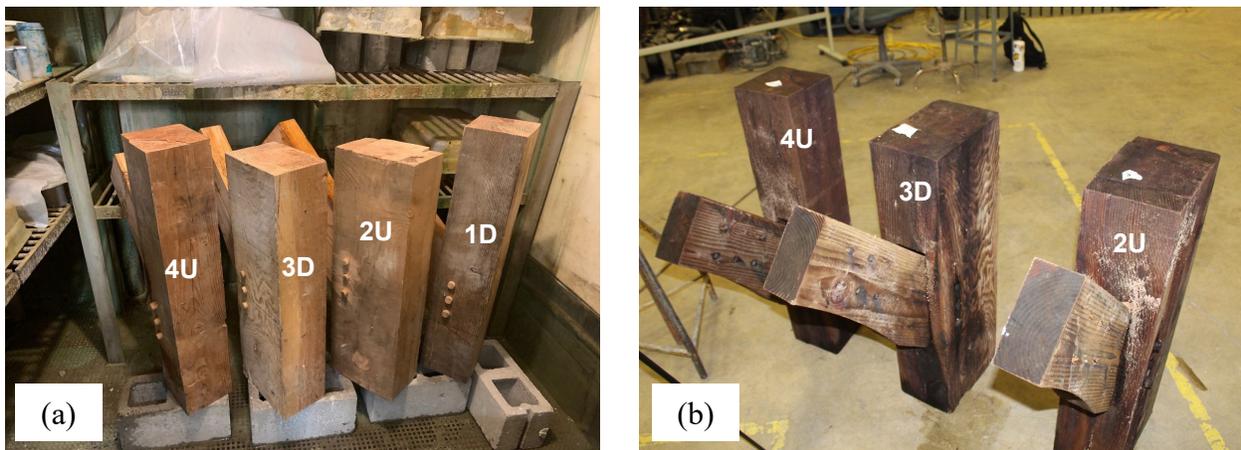
Fig. 4.4. Joint specimens: (a) at start of 6-month period, and (b) after 6-month period.

The mortise and tenon specimens were assembled with the 1-inch diameter pegs and each placed on concrete masonry units in order to ensure no excessive moisture entrapment occurred at the base of the posts. Each specimen was placed in a curing and storage room (“fog” room) with constant vapor to maintain high humidity. The specimens were stored in the fog room for six months. Fig. 4.4 shows the specimens before and after the six-month period.

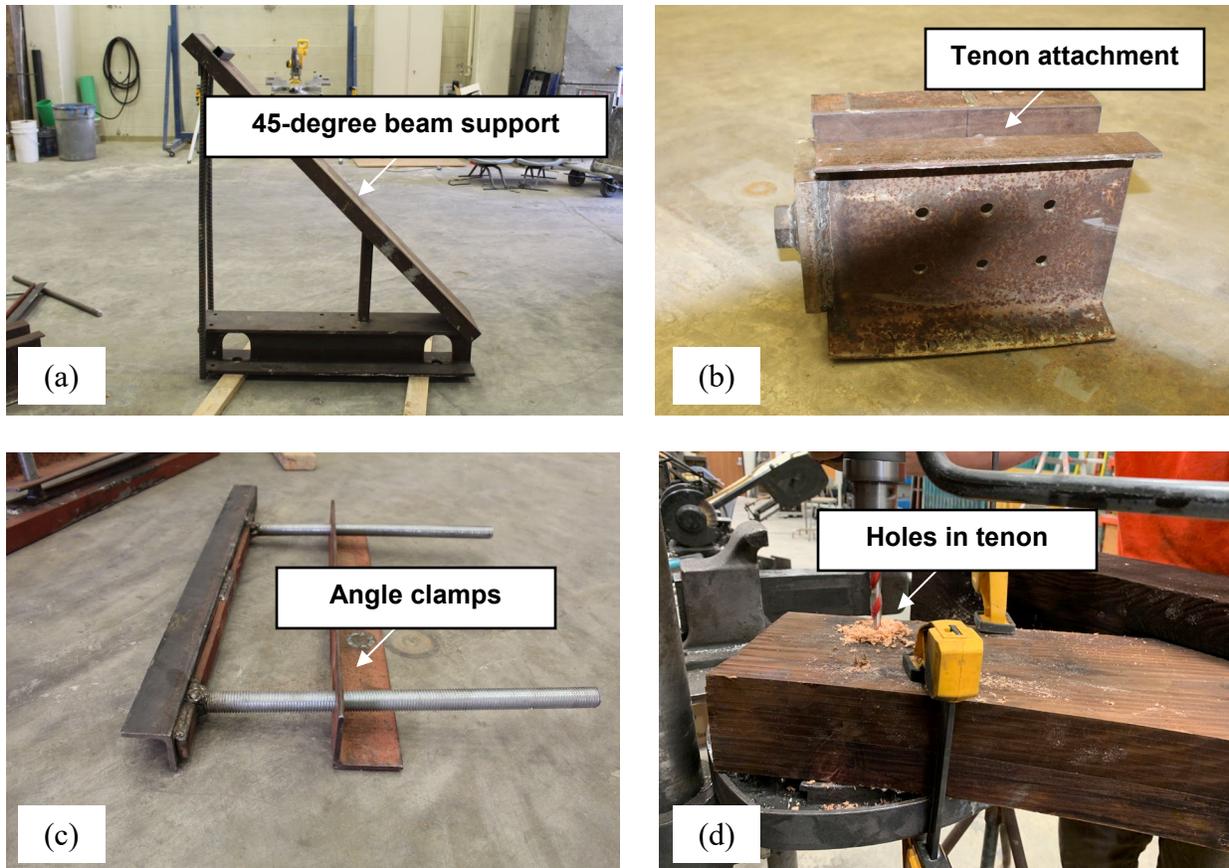
Fig. 4.5. Test apparatus and specimen prep: (a) beam, (b) tenon, (c) clamps, and (d) holes.

While the specimens were under damp conditions, a testing setup was developed in order to perform the monotonic loading tests. Each connection would undergo a tension test regime within a Baldwin Universal Testing machine. The test specimens would each be placed on a 45-degree channel, which is supported on top of a wide-flange beam (Fig. 4.5a). The posts were clamped down onto the channel in two locations with angle-shapes connected to all-threads (Fig. 4.5c).

A brace-plate connection was made using C-shape members welded at the top to a steel plate (Fig. 4.5b). Six holes were drilled into each end of the brace members on each specimen to connect to the plates (Fig. 4.5d). The holes were designed according to NDS section 12.5 (AWC 2018), including end distance, edge distance, and spacing requirements for fasteners in a row. NDS Table 12G was used to determine bolt design values. The nominal capacity of the brace determined to be 14,160 lbs. This exceeded the 9.5-kip nominal capacity of the tenon connection, indicating that the plate and fastener connection would be safe. Six ½-inch hex-head bolts were fastened through the plates and the brace members, allowing the plate connection to attach to the top of the Baldwin machine via a large bolt and nut at the top. The same bolted connection was welded onto the bottom of the wide-flange beam to fasten the bottom of the test apparatus to the lower part of the Baldwin.

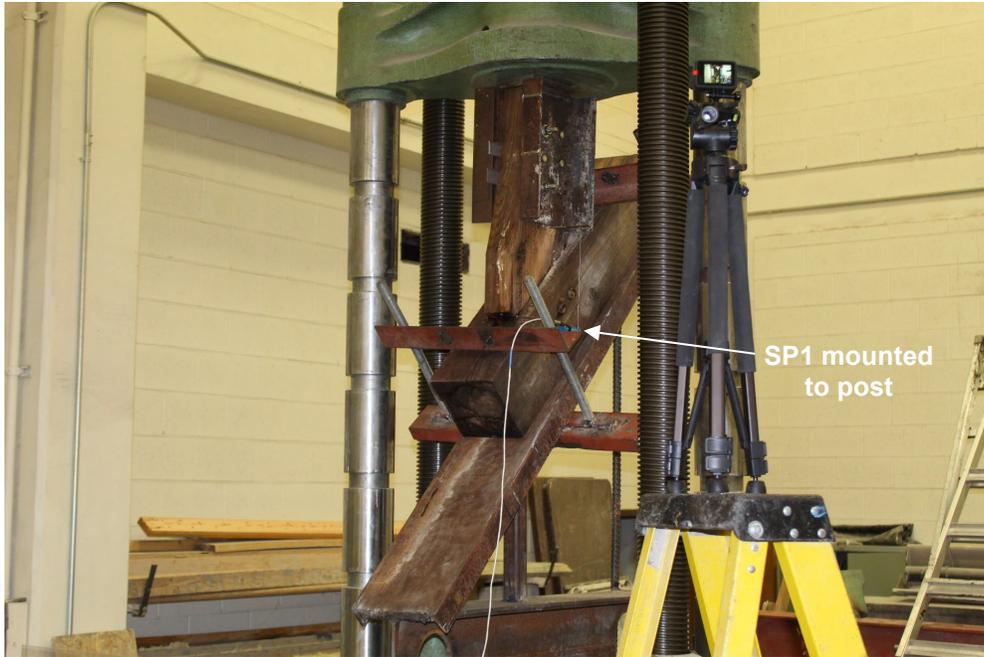
Fig. 4.6. The first specimen undergoing testing in the Baldwin machine.

Each specimen was loaded onto the beam setup and fastened to the Baldwin machine. A steel tube member was welded to the top of the 45-degree channel so that shims could be inserted to keep the specimen from sliding up during the tests. The monotonic tests were performed by the Baldwin machine lowering its bottom end attached to the wide-flange beam at 0.1 in./min. A string pot was also attached to the post and pinned to the plates before every test to measure displacement of the brace from the connection.

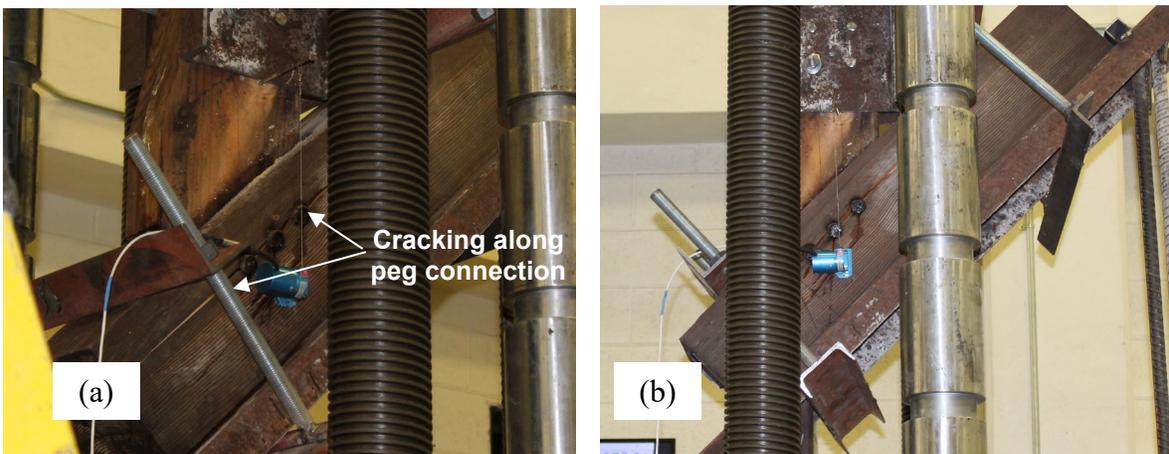
Fig. 4.7. Test specimens after tension load failure: (a) corner and (b) side views.

Each test yielded similar behavior amongst the connection specimens. Audible cracking was heard during the intervals of 6 kips to 7 kips of load from the machine. Evidence of this can be seen on each test curve in Fig. 4.8. Ultimate failure was usually accompanied with splitting in the post through the peg holes as visible in Fig. 4.7a and 4.7b.

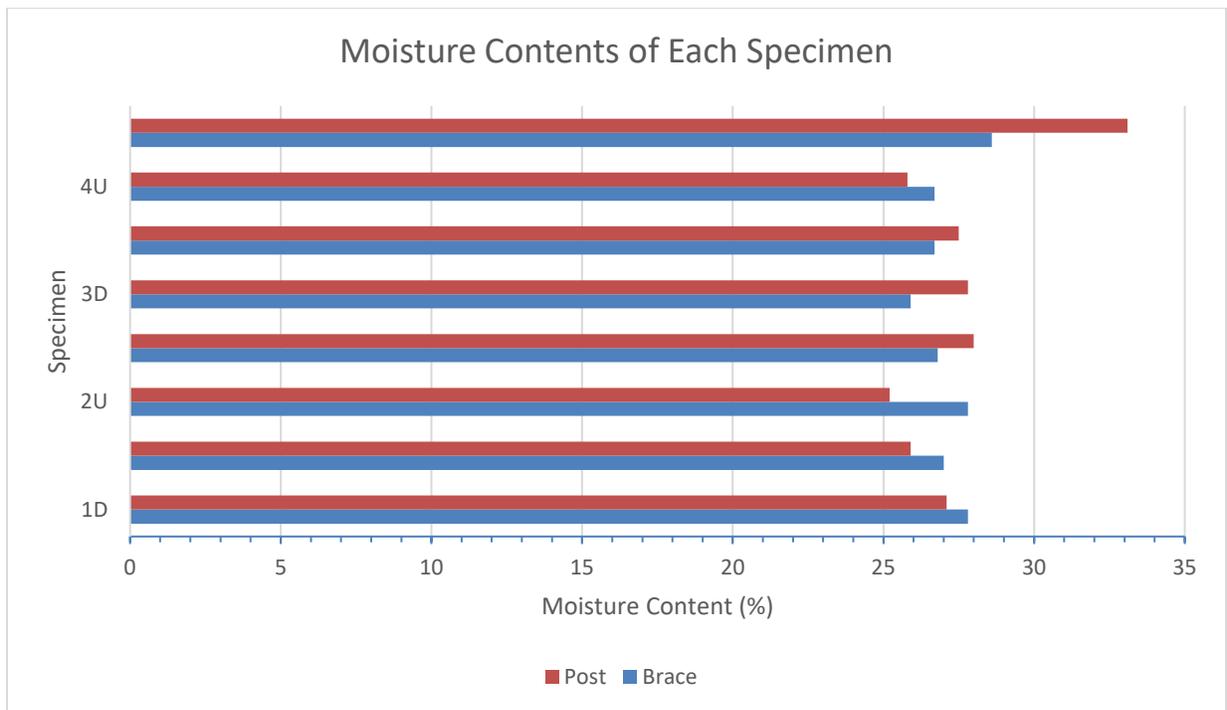
Fig. 4.8. Moisture content of durability test specimens.

Moisture content readings were taken from multiple locations on each specimen directly after being removed from the testing apparatus. Fig. 4.8 displays those results as measured. The findings indicate that there was not much overall variability in moisture content between drained and undrained specimens. The average moisture content in the drained specimens was 27%, whereas the average moisture content in the undrained specimens was 28%.

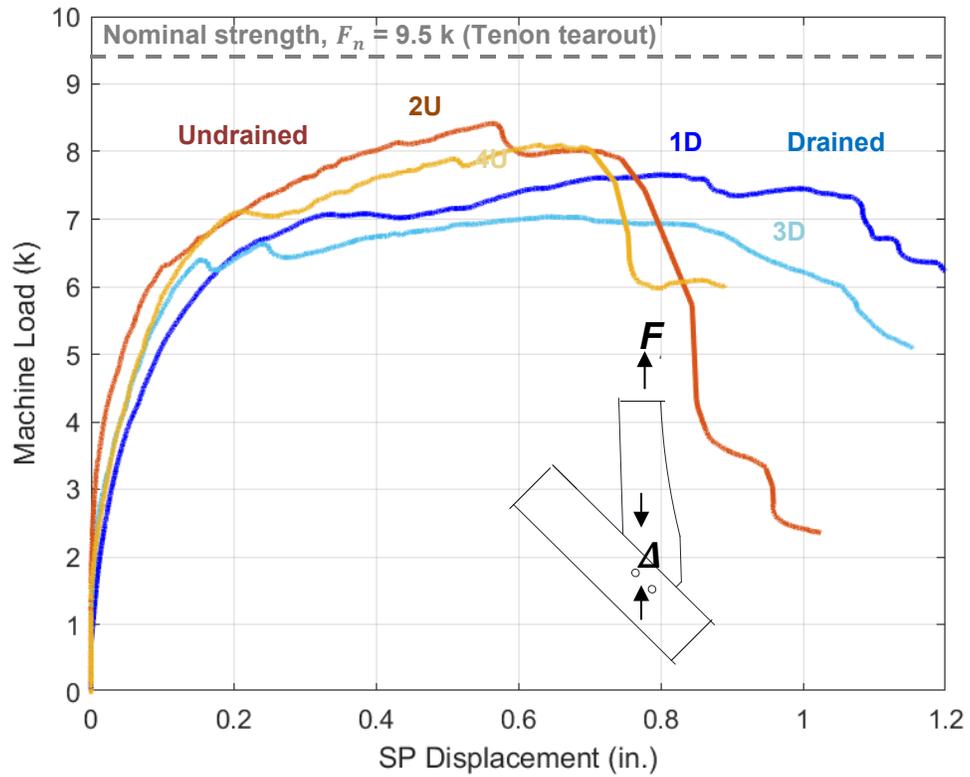
Fig. 4.9. Tensile load versus connection displacement for durability specimens.

The collection of data from all tests indicated that the undrained specimens actually performed better than the drained specimens in terms of maximum load sustained. Specimens 2U and 4U failed at 8.41 kips and 8.09 kips respectively, while specimens 1D and 3D failed at 7.65 kips and 7.03 kips (Fig. 4.9). It is worth noting that the drained specimens did withstand a higher displacement before ultimate failure.

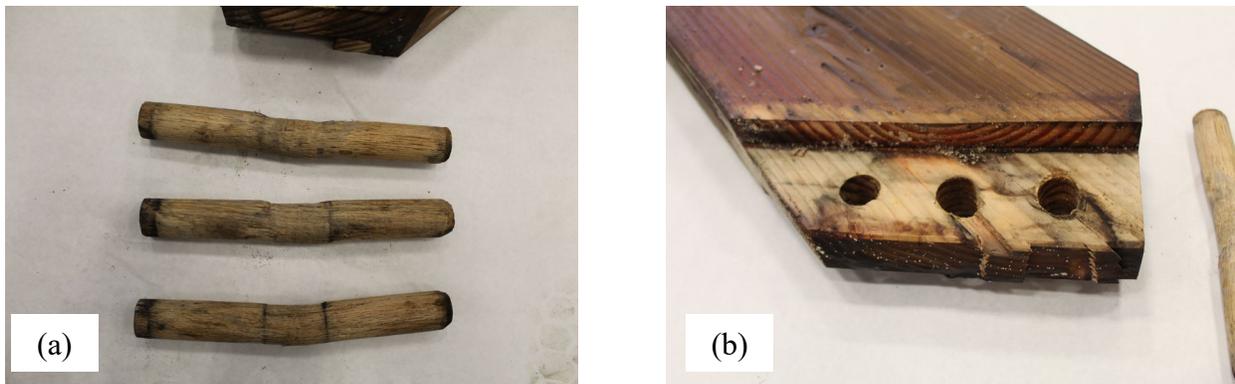
Fig. 4.10. Durability test specimen 1D: (a) peg bending, and (b) tenon failure.

Upon taking apart all specimens, the joint failure behavior was observed in each specimen. The tenon failure and peg-bending behavior was generally uniform across all specimens. Some tenons showed more excessive shear than others, as observed in Fig. 4.10 to Fig. 4.13.

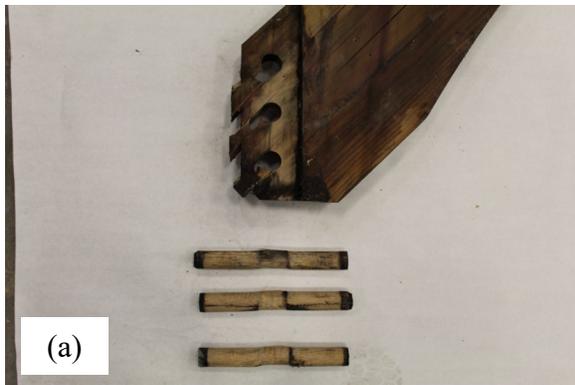
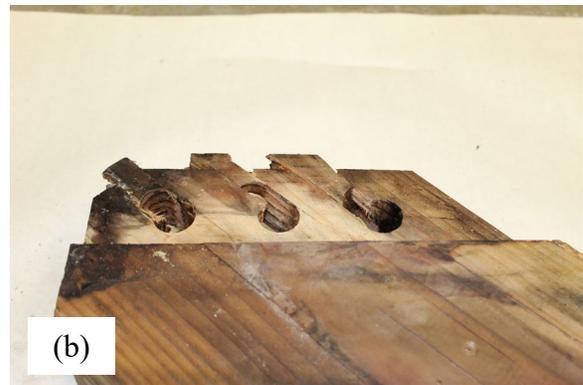
Fig. 4.11. Durability test specimen 2U: (a) peg bending, and (b) tenon failure.

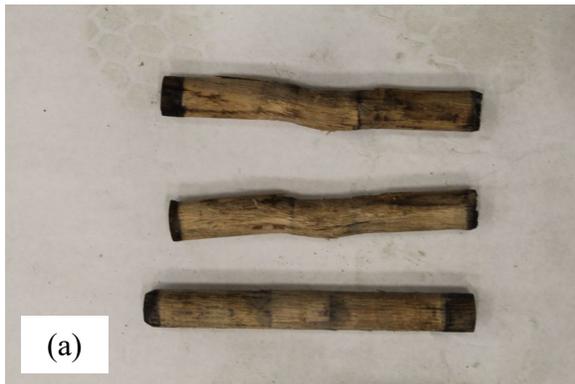
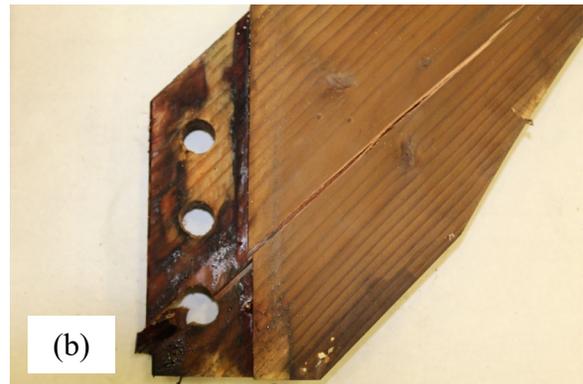
Fig. 4.12. Durability test specimen 3D: (a) peg bending, and (b) tenon failure.

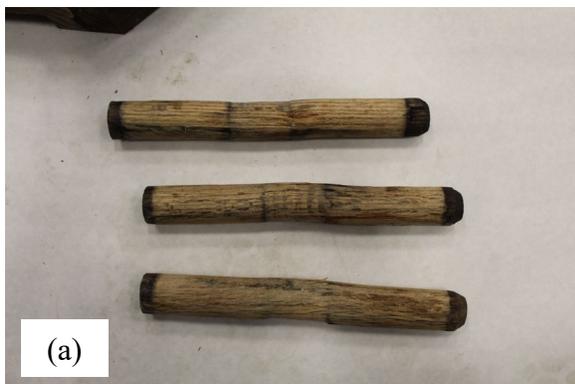
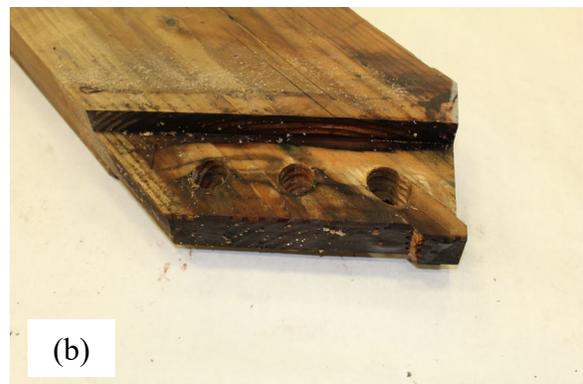
Fig. 4.13. Durability test specimen 3D: (a) peg bending, and (b) tenon failure.
