BYU Civil & Environmental Engineering

Performance Criteria for Free-Standing Timber Frames with Knee Braces

November, 2022

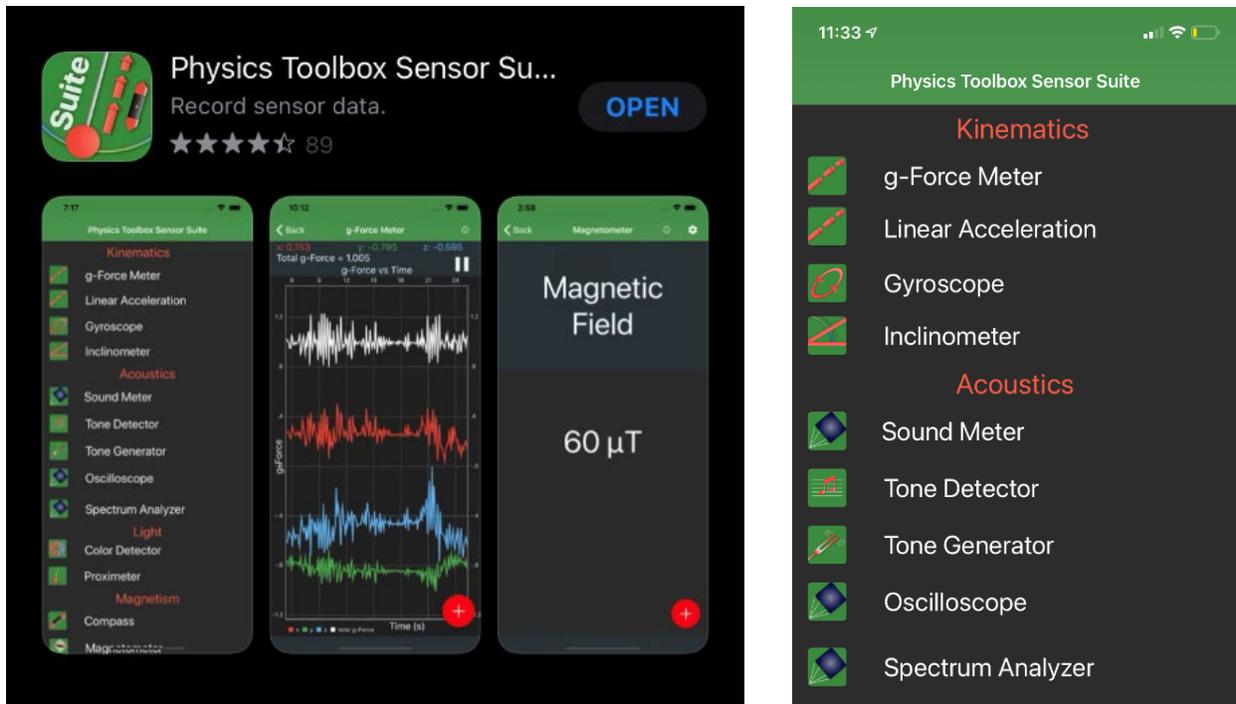
Fig. 5.1. Physics Toolbox Sensor Suite” app used to measure accelerations.

Timber frames were tested in the field under impulse loading to determine the fundamental period of vibration and to estimate damping. Tests were conducted using a “crowd-sourced” approach. In this approach, the Brigham Young University team tested timber frames in Utah. Volunteers from the Timber Frame Engineering Council tested timber frames outside of Utah. To measure acceleration, the team member (or the volunteer) downloaded an app to their smartphone. This study used the “Physics Toolbox Sensor Suite” app (<https://www.vieyrasoftware.net/>). Fig. 5.1 shows the app.

The app uses internal piezoresistive cantilever sensors or capacitive sensors, depending on the smartphone, to measure accelerations. In a smartphone with a piezoresistive cantilever sensor, a silicon cantilever bends as the smartphone accelerates. The change in resistance of the silicon correlates to acceleration. In a smartphone with a capacitive sensor, three masses are attached to springs (one spring in each principal direction). As the masses move, they change the electric potential across capacitor plates that are positioned between the masses (<https://www.vieyrasoftware.net/sensors-sensor-modes>).

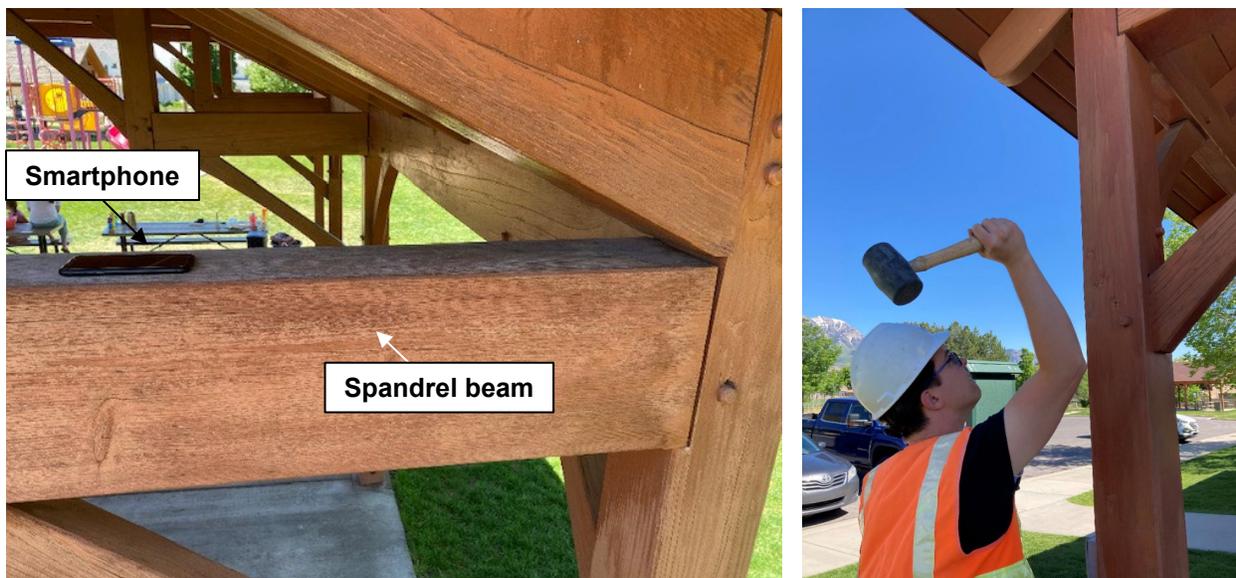
Fig. 5.2. Vibration test: (1) placement of smartphone, and (b) mallet strike.

Each frame was tested in each principal direction. Testing personnel would set up a ladder and place the smartphone on one of the spandrel beams in the transverse direction of the frame (Position ‘A’). They would then begin to record data on the app. The frame was tested by striking the post with a rubber mallet. Fig. 5.2 shows a typical placement of the smartphone and mallet strike. The intent was that the acceleration due to the impulse would be approximately 1 m/s². The strike was repeated every six seconds for five-six intervals. The test was repeated in each principal direction with the smartphone oriented parallel and perpendicular to the beam, for a total of four tests. For the second direction, the personnel would then move the smartphone to a spandrel in the longitudinal direction of the frame and impart the same impulses (Position ‘B’). Fig. 5.3 shows the orientation of the smartphone relative to the principal directions of the timber frame. The test data was recorded to a .csv file measuring the time, x,y and z accelerations. Fig. 5.4 shows a sample acceleration recording in the app.

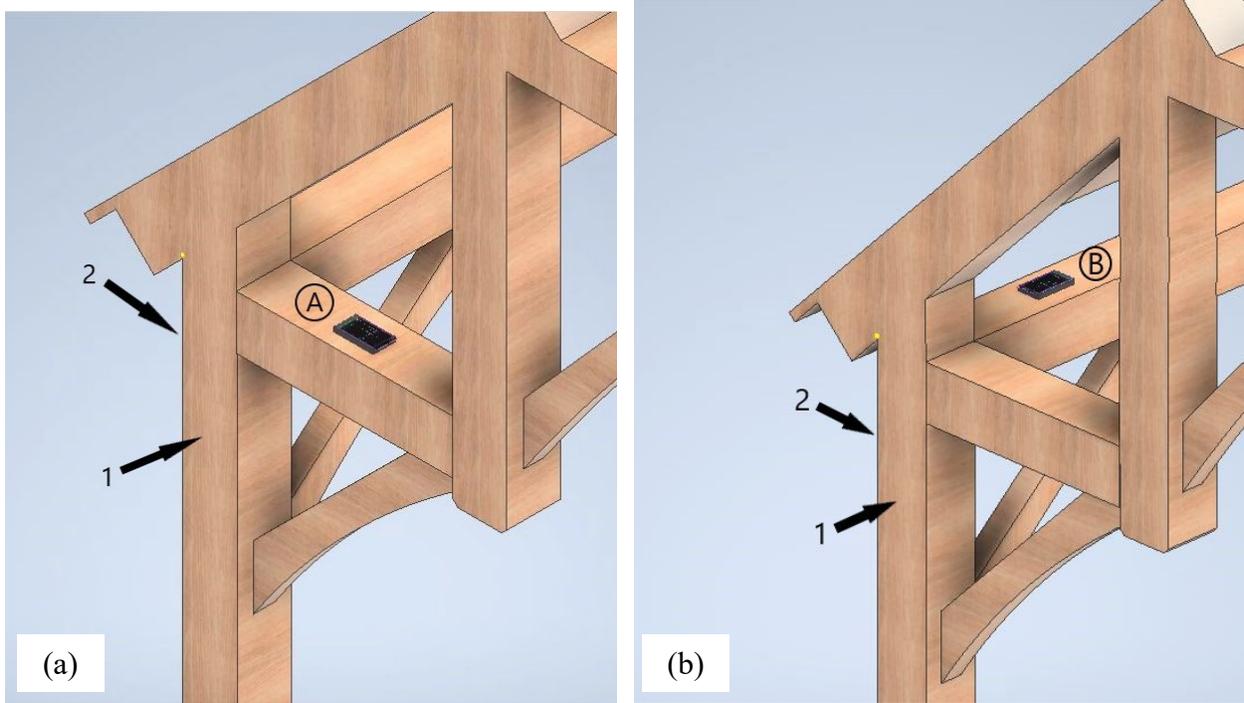
Fig. 5.3. Orientation of smartphone: (a) transverse and (b) longitudinal directions.

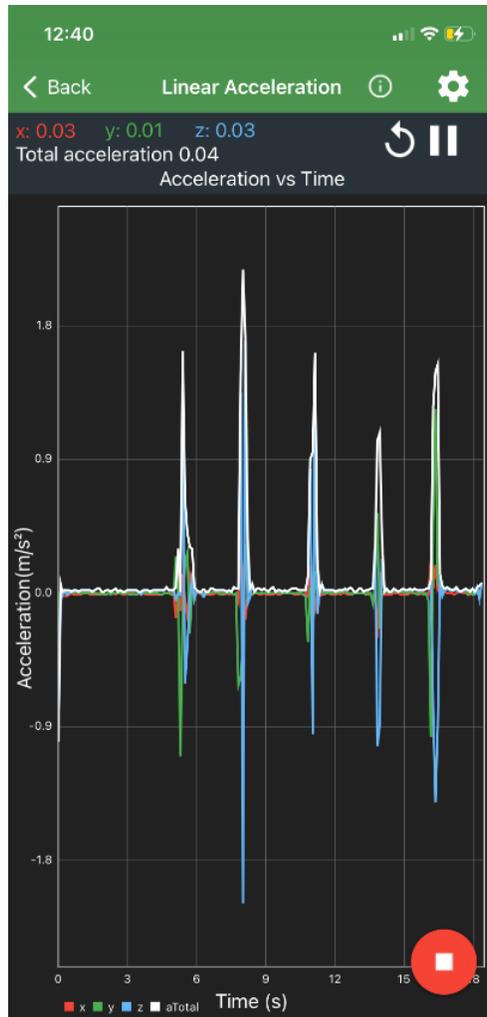
Fig. 5.4. Sample acceleration reading in the app.

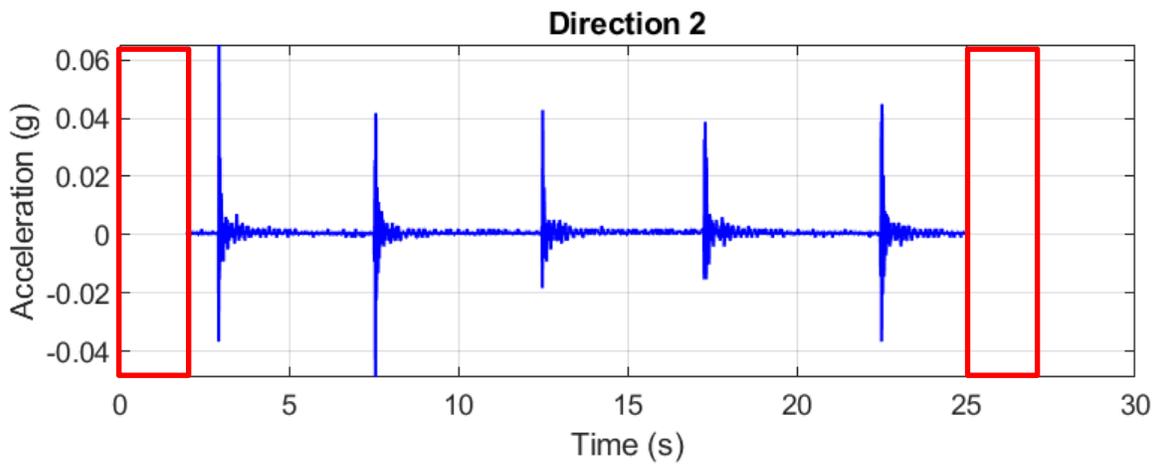
Fig. 5.5. Sample clipped acceleration record.

The data was post processed using MATLAB (2021). If necessary, the acceleration record was clipped (or zero padding was added) to eliminate edge effects in the frequency analysis. Fig. 5.5 shows an example of a clipped acceleration record.

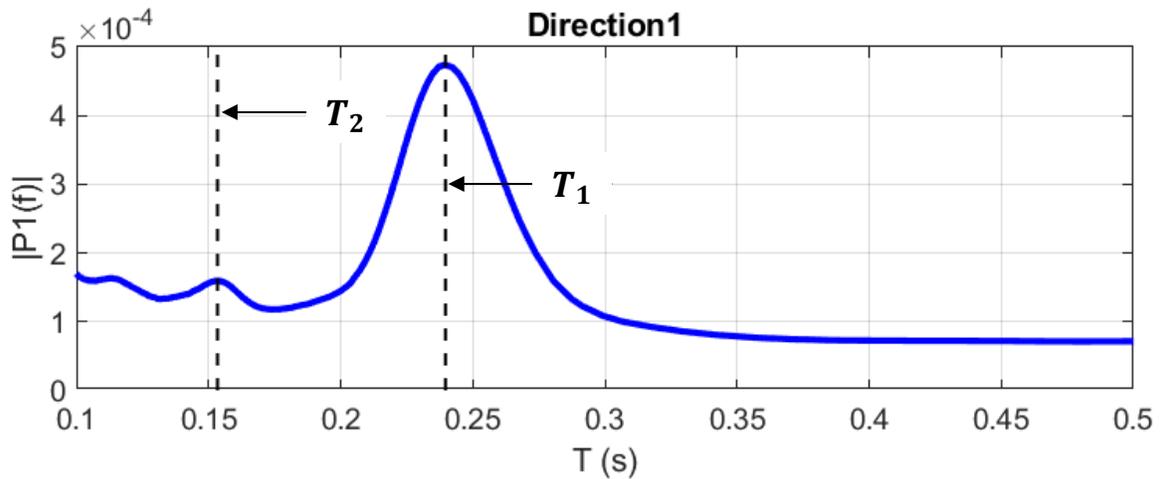
Fig. 5.6. Single-sided amplitude spectrum of period-content.

The fundamental period of vibration was determined using a frequency analysis of the test data. The acceleration record was then converted to the frequency domain using a fast Fourier transform (FFT) algorithm in MATLAB (2022) based on software developed by Frigo and Johnson (1998). The single-sided amplitude spectrum of period-content was used to identify the fundamental period of vibration in each principal direction.

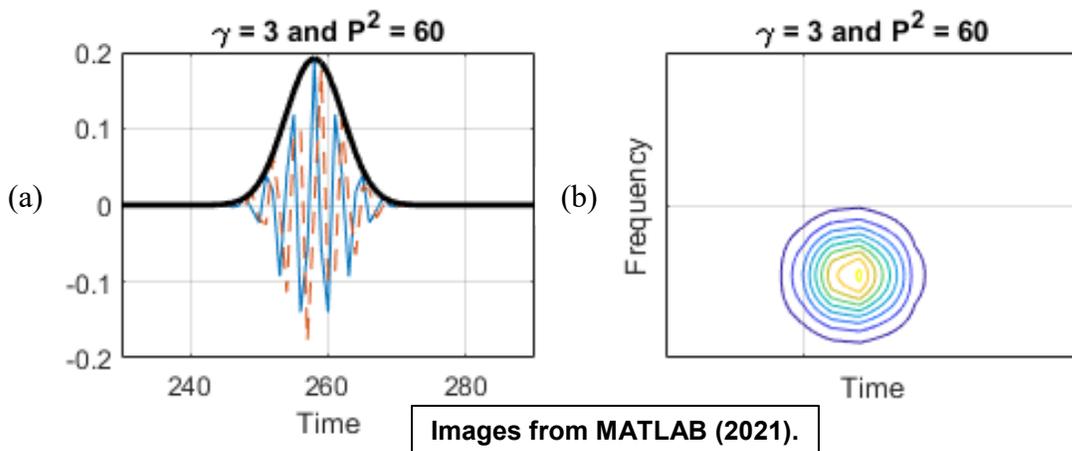
Fig. 5.7. Morse wavelet: (a) time domain and (b) frequency content versus time.

The modal damping ratio was determined using a wavelet demodulation. The demodulation was based on the procedure developed by Dien (2008). In this study, a continuous wavelet transformation (CWT) of the acceleration record was completed using the default Morse wavelet in MATLAB. Fig. 5.7 shows the amplitude and frequency content of the Morse wavelet. The Morse wavelet had a symmetry parameter (β) equal to 3 and a time-bandwidth product (P^2) equal to 60.

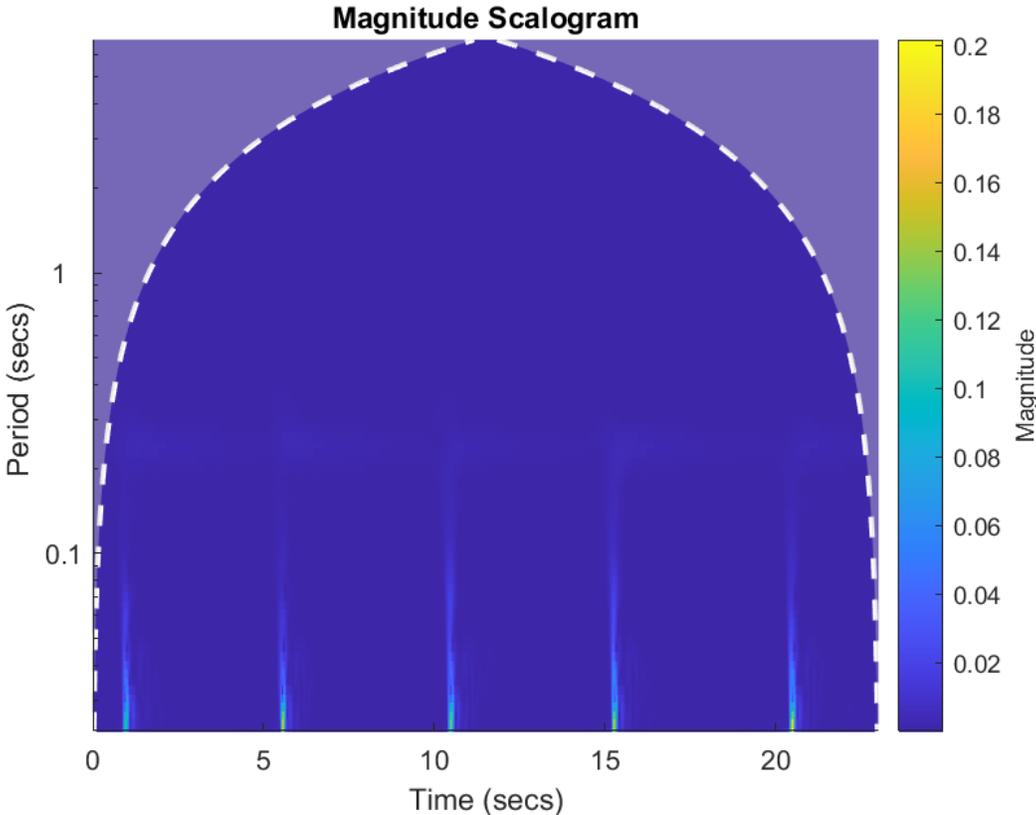
Fig. 5.8. Two-dimensional plot of frequency content (period of vibration) versus time.

The continuous wavelet transformation was used to determine the frequency content of the data versus time. Fig. 5.8 shows an example of the frequency content from a CWT that resulted from a typical vibration test data. Since the focus of this study was on the fundamental period of vibration, period content is plotted in the scaleogram in lieu of frequency content. In this plot, a two-dimensional magnitude scaleogram is used to indicate the time-varying content (color is the magnitude of the signal). However, it can also be helpful to visualize the time-varying frequency content through a three-dimensional plot, as shown in Fig. 5.9.

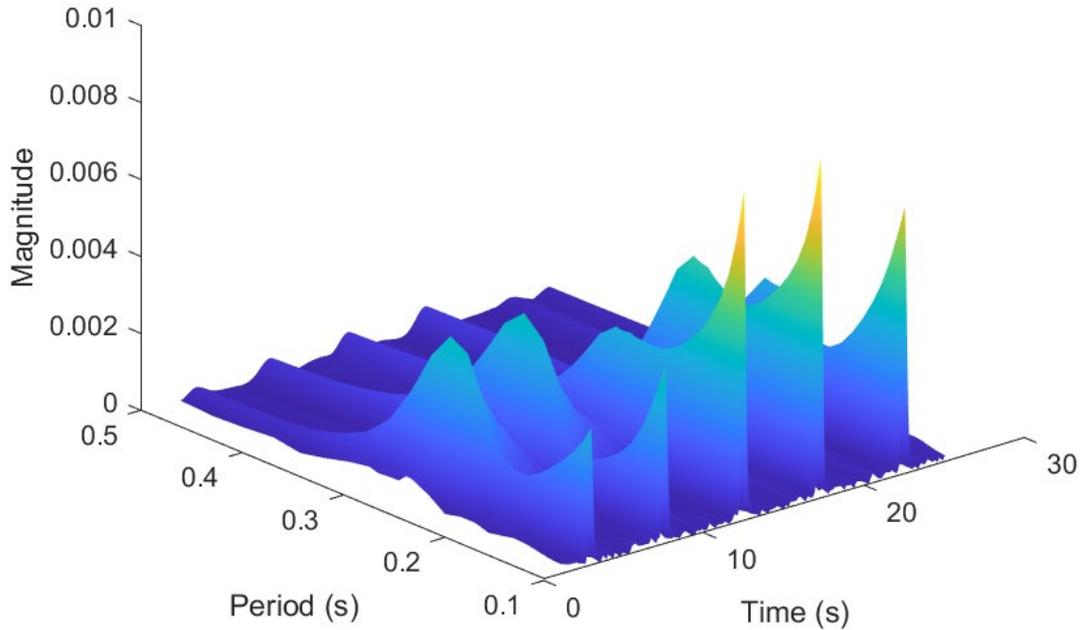
Fig. 5.9. Three-dimensional plot of frequency content (period of vibration) versus time.

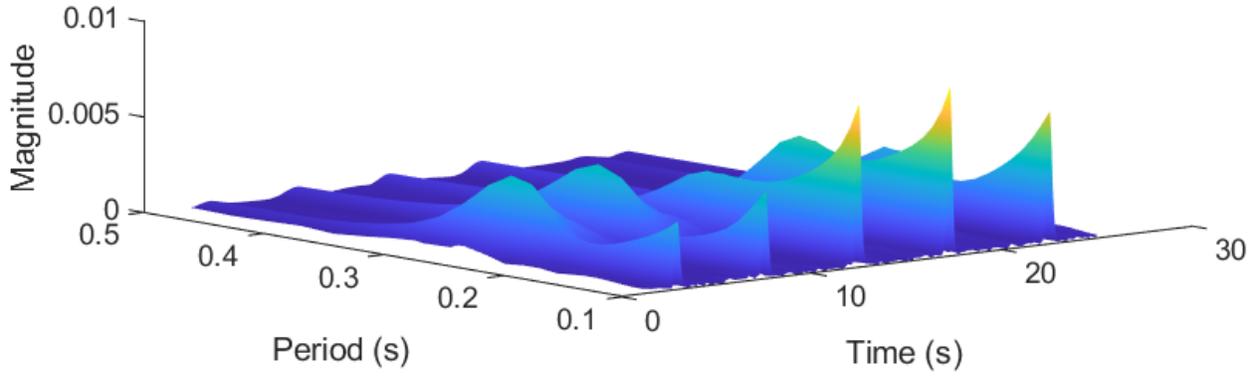
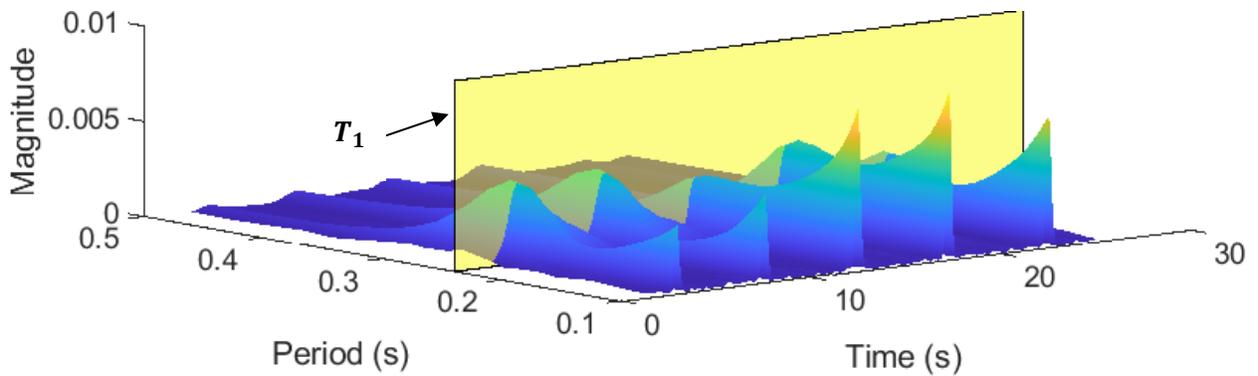
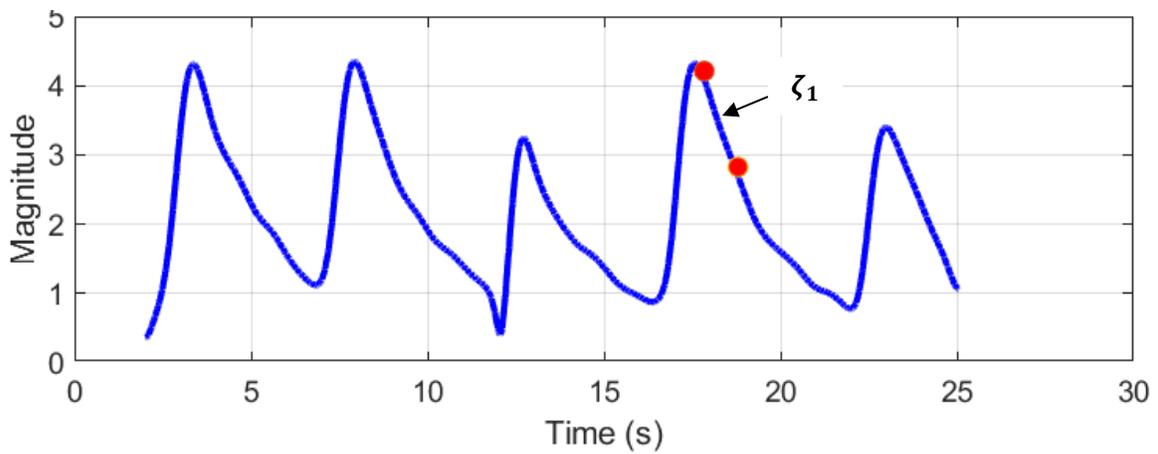
(a) Entire range of frequency content versus time.

(b) Slice of frequency content (wavelet amplitude) at fundamental period of vibration.

(c) Logarithmic decrement of wavelet amplitude at fundamental period of vibration.

Fig. 5.10. Illustration of wavelet demodulation process used to determine modal damping.

The wavelet demodulation process used to determine modal damping is illustrated in Fig. 5.10. Since the scaleogram contains the frequency content versus time for the entire range of frequency (or periods), therefore the scaleogram was “sliced” at sliced at fundamental period of vibration. Therefore, this slice is the wavelet amplitude for a given mode.

The logarithmic decrement (decay) of the wavelet amplitude was used to determine modal damping. The approach is based on the solution to the equation of motion for displacement of an underdamped single-degree-of-freedom system is

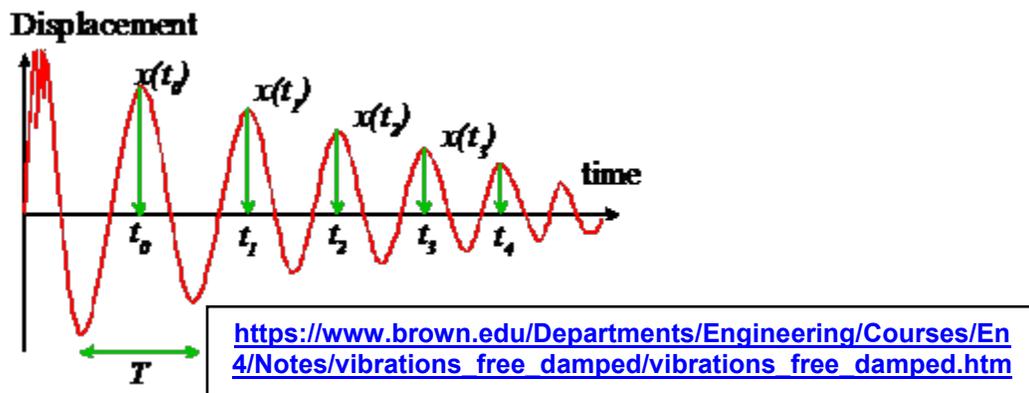
Fig. 5.11. Logarithmic decrement of free vibration with viscous damping.

Fig. 5.11 shows how to do log decrement analysis based on a damped free vibration response. The logarithmic decrement in terms of displacement is $\delta = \log \left(\frac{x(t_n)}{x(t_{n+1})} \right)$

Writing the equation for logarithmic decrement in terms of the period of vibration and the damping ratio (ratio of critical damping) produces the following simplified equation: $\delta = \frac{2\pi\zeta}{\sqrt{1 - \zeta^2}}$

Solving for the damping ratio gives $\zeta = \frac{\delta}{\sqrt{4\pi^2 + \delta^2}}$

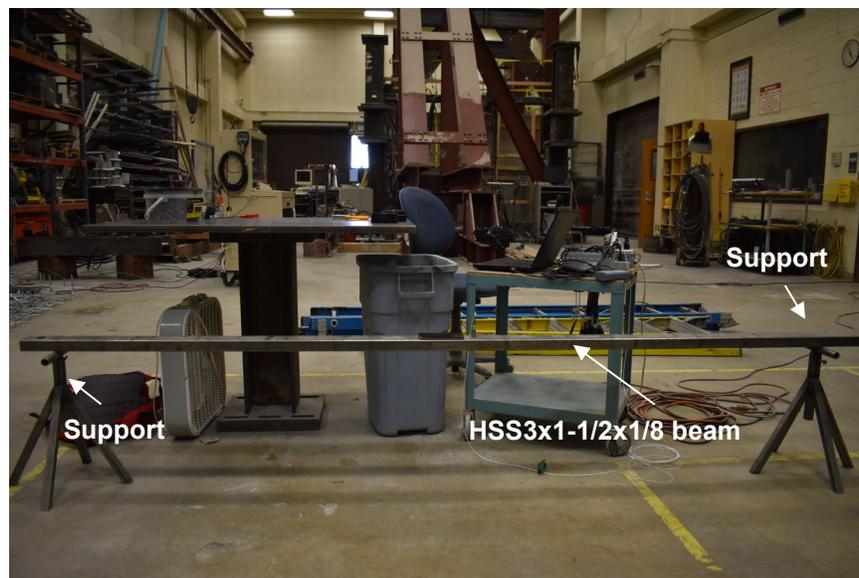
Fig. 5.12. Simply supported HSS beam for a vibration test.

To check the accuracy of the smartphone app, the smartphone was placed on a simply-supported steel HSS beam. Fig. 5.12 shows the beam. The beam was also instrumented with an accelerometer (Fig. 5.13). The beam was then struck to measure vibration data on both the phone and accelerometer. The FFT was used to determine the fundamental period of frequency of vibration and compared to the theoretical frequency. The results are shown in Fig. 5.14.

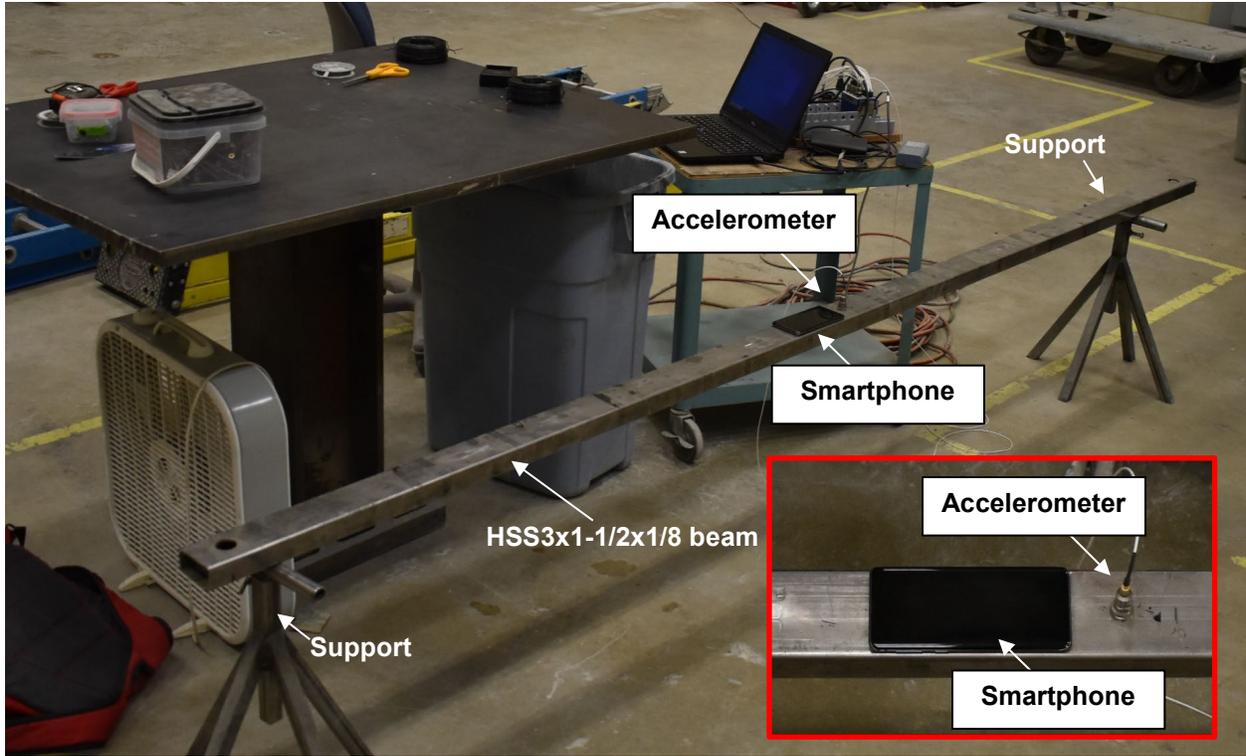
Fig. 5.13. Smartphone placed next to accelerometer on simply supported HSS beam.

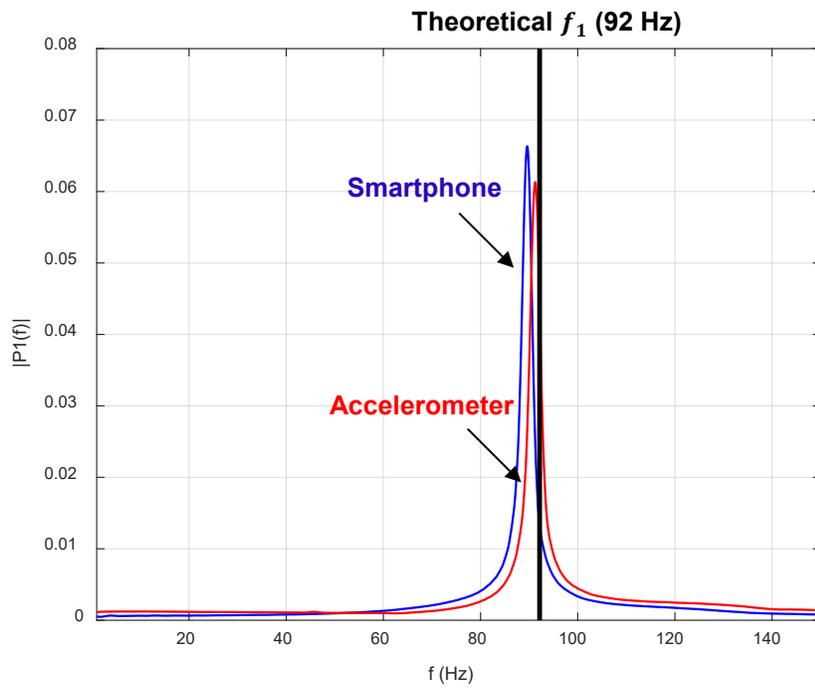
Fig. 5.14. Single-sided amplitude spectrum from HSS3x1-1/2x1/8 beam test.

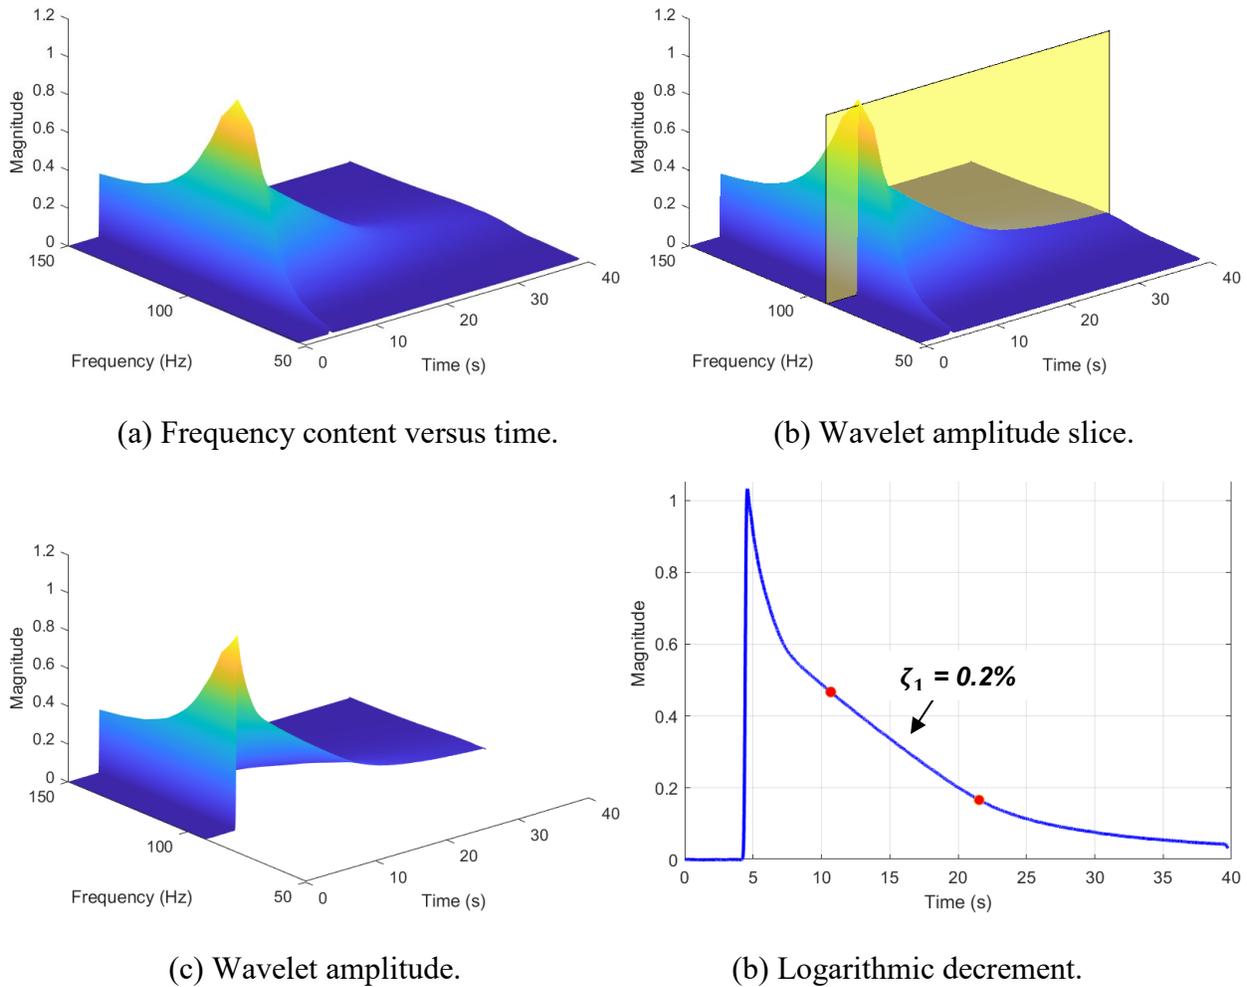
Fig. 5.15. Modal damping for the simply-supported steel HSS beam test.

To check the accuracy of the wavelet demodulation and log decrement method used to determine modal damping, the method was applied to two data sets: (1) the data from the simply-supported steel HSS beam test, and (2) data from the closed-form solution for free vibration of a single-degree-of-freedom system with a period of vibration of 2.81 seconds, and 10% viscous damping. Fig. 5.15 shows the results for the simply-supported beam (0.2% damping), and Fig. 5.16 shows the results for the single-degree-of-freedom system (9.6% damping).

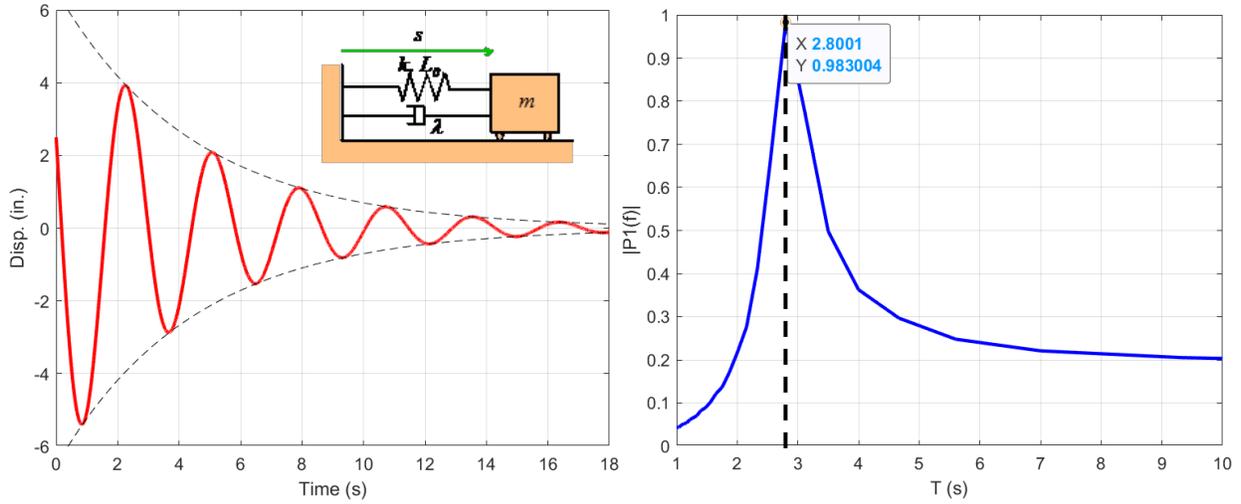
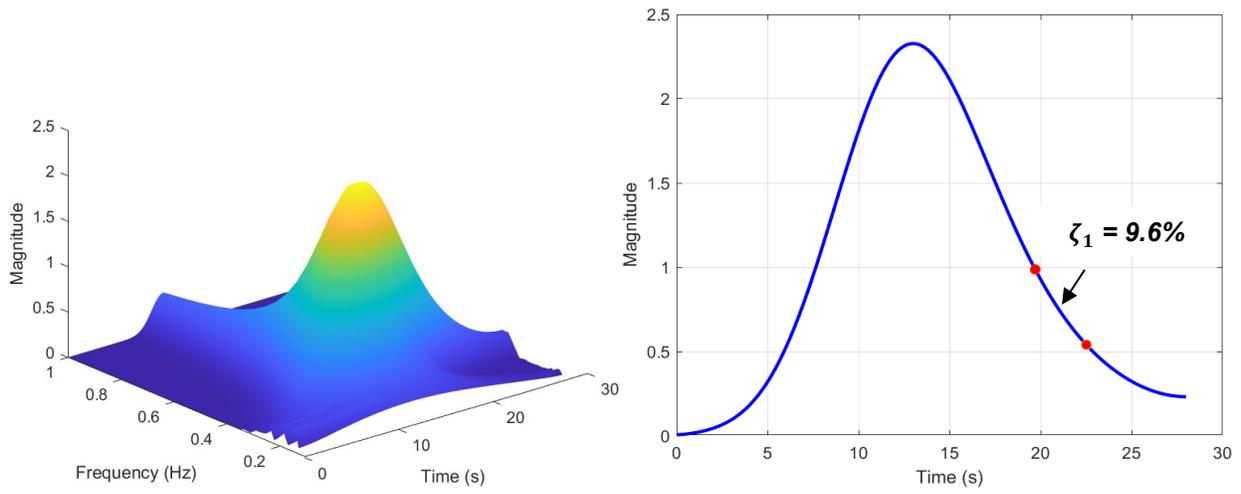
(a) Displacement versus time.

(b) Single-sided amplitude spectrum.

(c) Frequency content versus time.

(d) Logarithmic decrement.

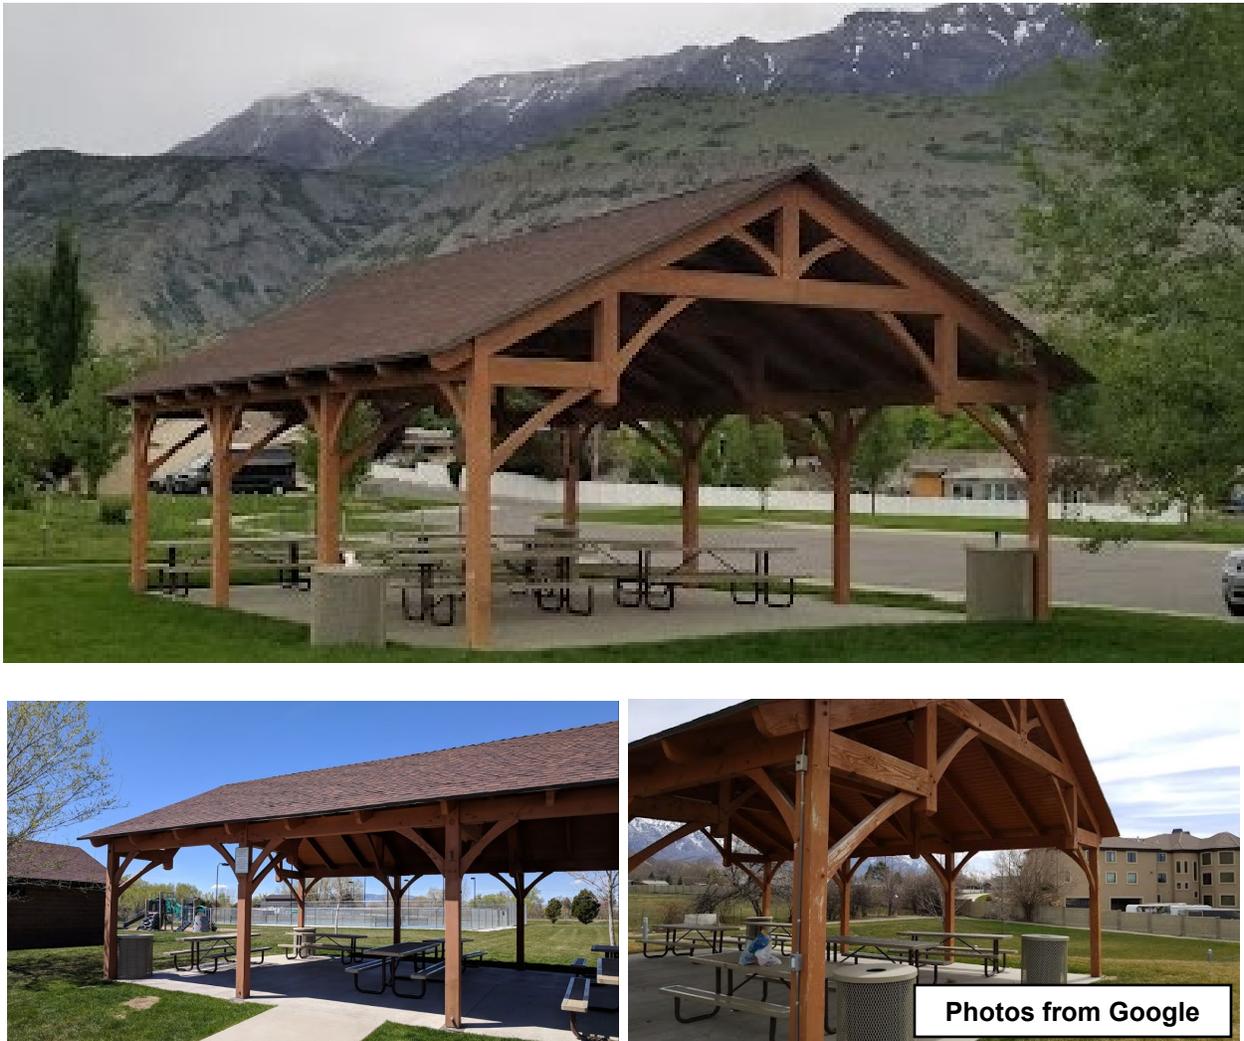
Fig. 5.18. Hollow Park pavilion.

The Hollow Park pavilion is a 25 ft wide by 35 ft long free-standing timber frame in a public park in Lindon, Utah. The frame is shown in Fig. 5.18. The beams span four posts in the longitudinal direction. The frame is supported by a concrete slab on grade. The mean roof height is approximately 12 ft. Fig. 5.19 shows example results from the frequency and wavelet analyses. The vibration test was conducted in May, 2021. The fundamental periods of vibration were 0.25 sec. and 0.31 sec. and the modal damping was approximately 1% to 2%.

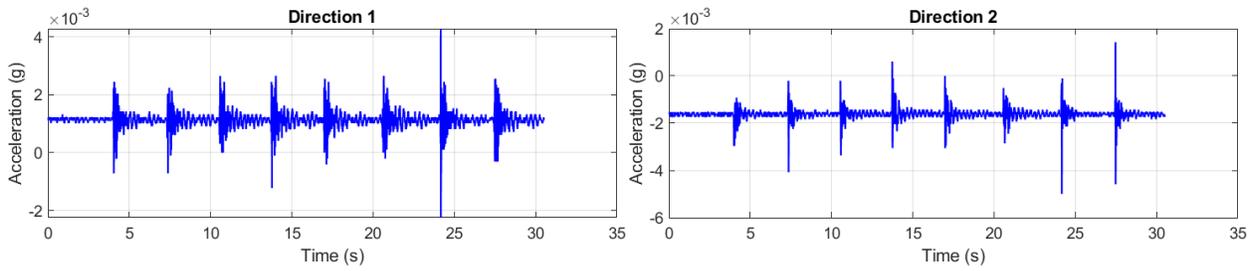
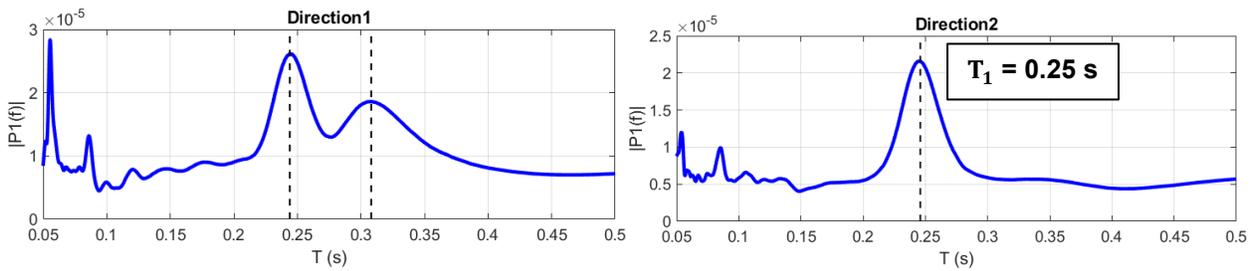
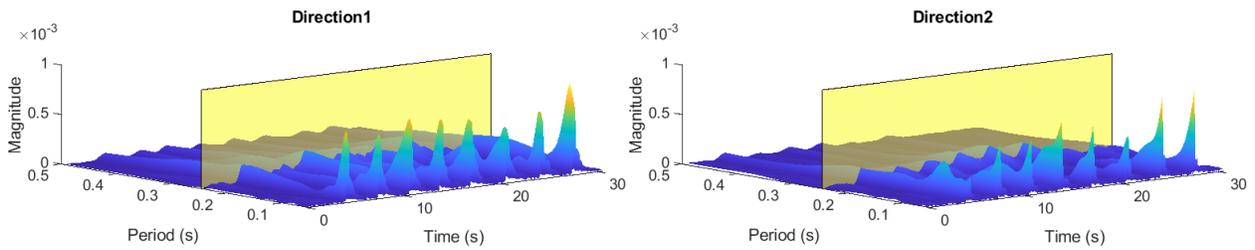
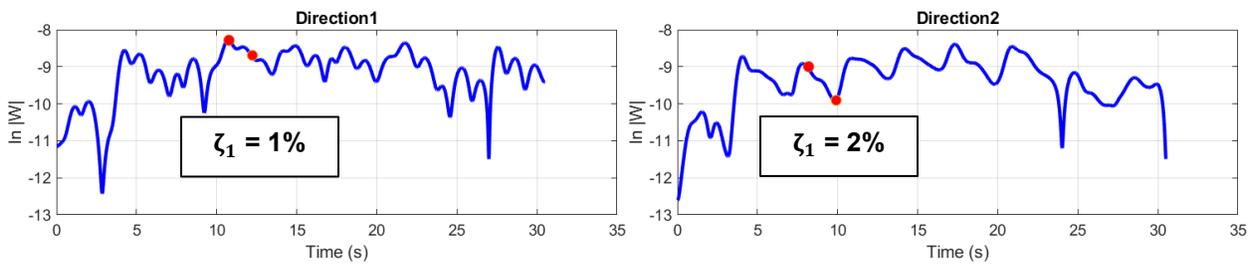
Fig. 5.19. Example frequency analysis of Hollow Park pavilion.

(a) Acceleration history

(b) Single-sided amplitude spectrum of period-content.

(c) Amplitude of period content versus time.

(d) Wavelet amplitude at fundamental period of vibration.

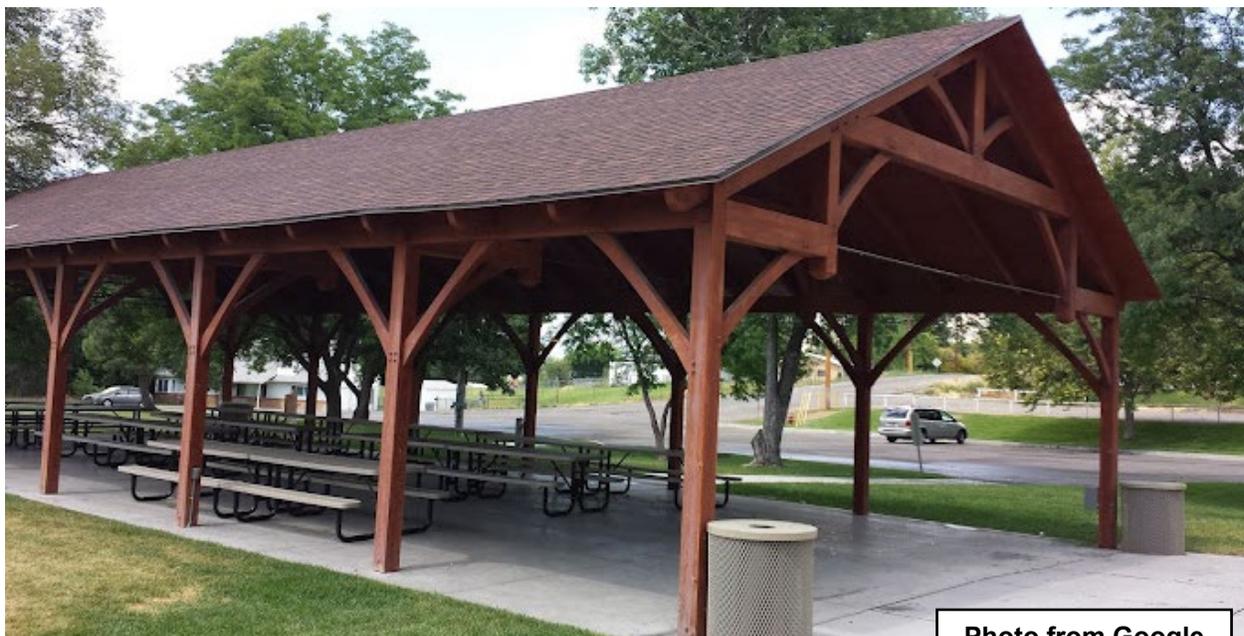
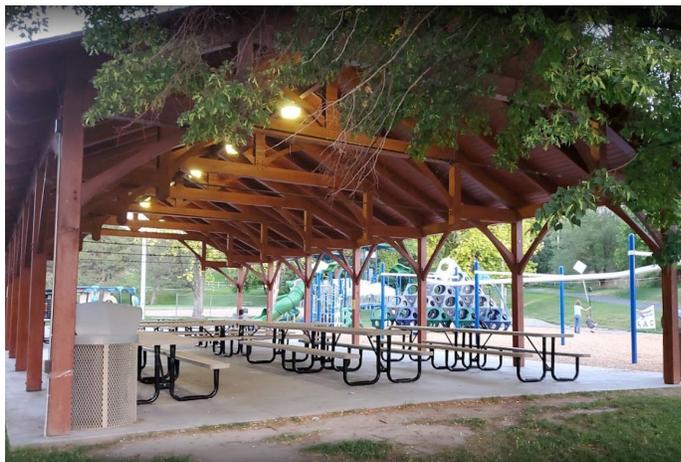
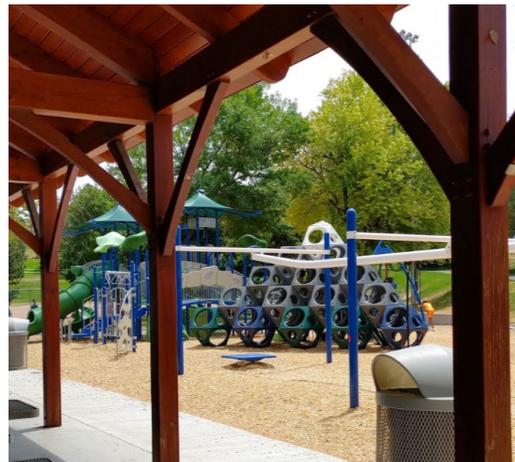
Fig. 5.20. Lindon City Park pavilion.

The Lindon City Park pavilion is a 72 ft long by 29.5 ft wide free-standing timber frame in a public park in Lindon, Utah (Fig. 5.20). It is supported on a concrete slab on grade. The beams span six posts longitudinally. The mean roof height is approximately 12 ft. The vibration test was conducted in May, 2021. The fundamental period of vibration was 0.32 sec. and the corresponding model damping was approximately 3% (see Fig. 5.21).

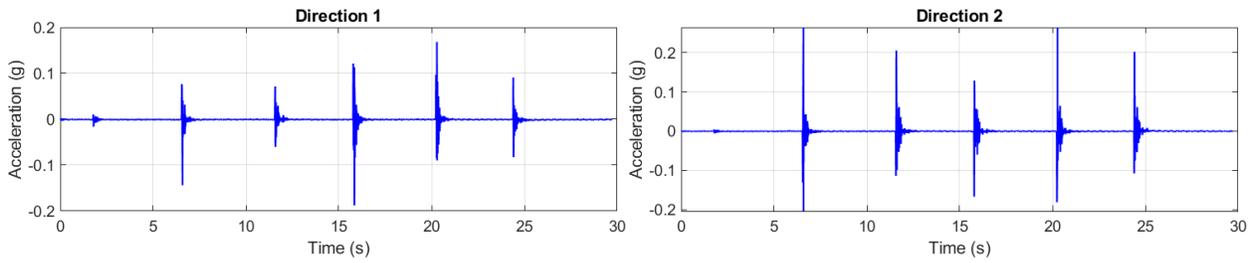
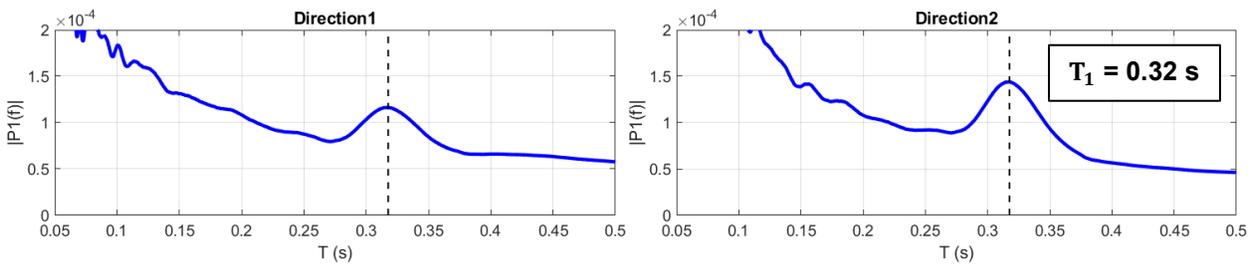
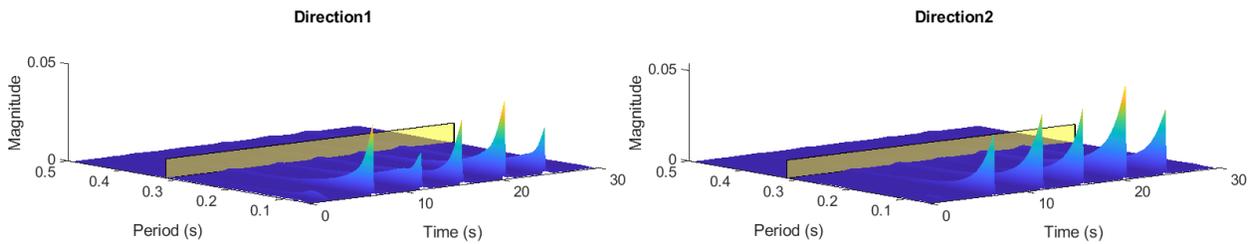
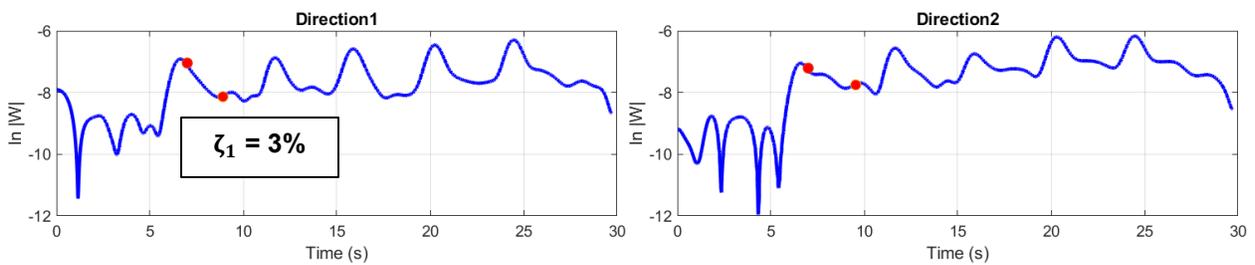
Fig. 5.21. Example frequency analysis of Lindon City Park frame.

(a) Acceleration history

(b) Single-sided amplitude spectrum of period-content.

(c) Amplitude of period content versus time.

(d) Wavelet amplitude at fundamental period of vibration.

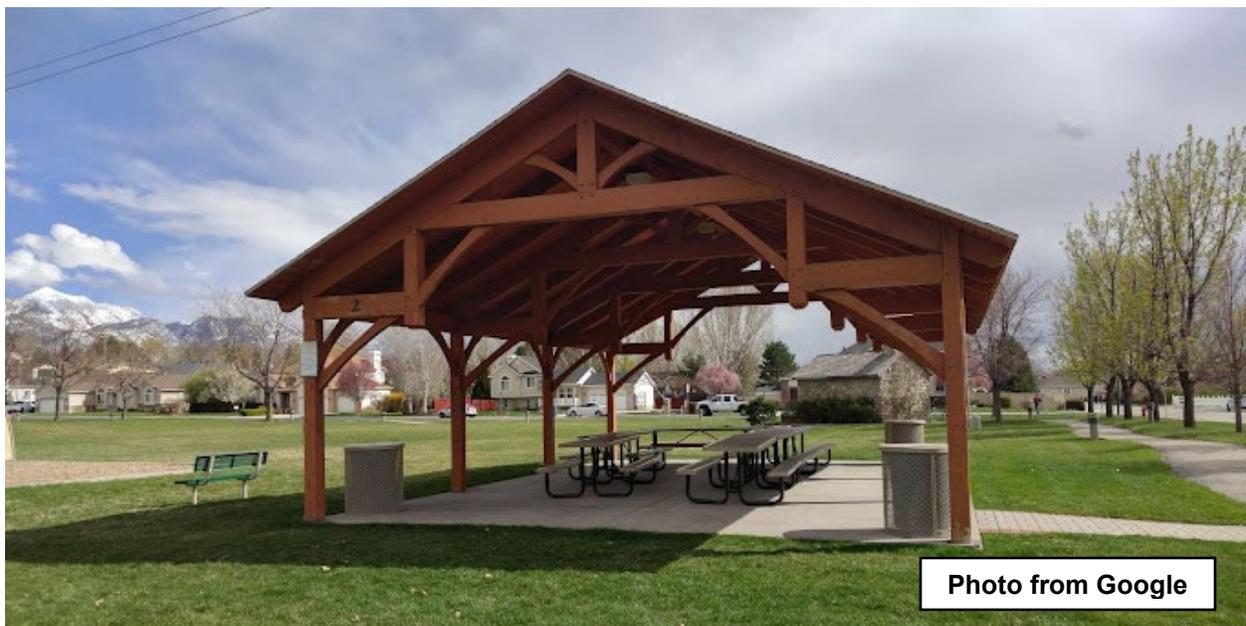
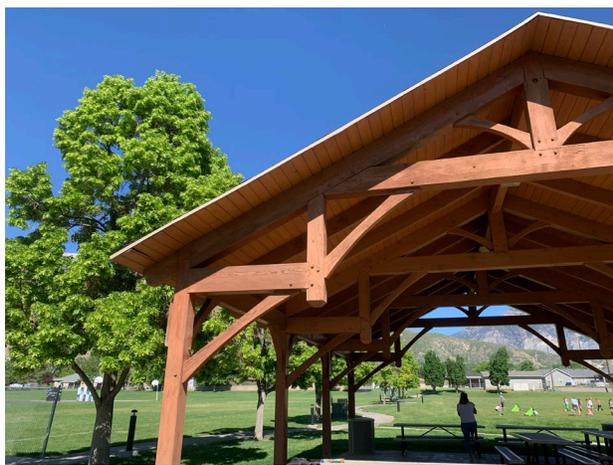
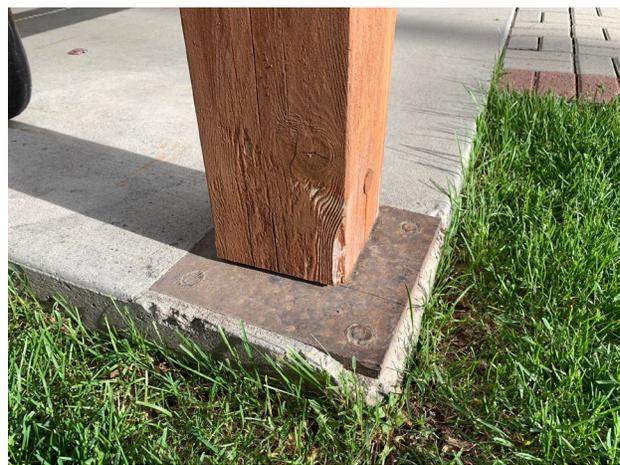
Fig. 5.22. Pioneer Park pavilion in Lindon, Utah.

The Pioneer Park pavilion is a 35 ft long by 25 ft wide free-standing timber frame in a public park in Lindon, Utah (Fig. 5.22). The posts are supported on a concrete slab on grade. The base of the post is on a steel plate. The beams span four posts longitudinally. The mean roof height is approximately 12 ft. The vibration test was conducted in May, 2021. The fundamental period of vibration was 0.25 sec. and the corresponding modal damping was 1% or less (see Fig. 5.23).
