BYU Civil & Environmental Engineering

Performance Criteria for Free-Standing Timber Frames with Knee Braces

November, 2022

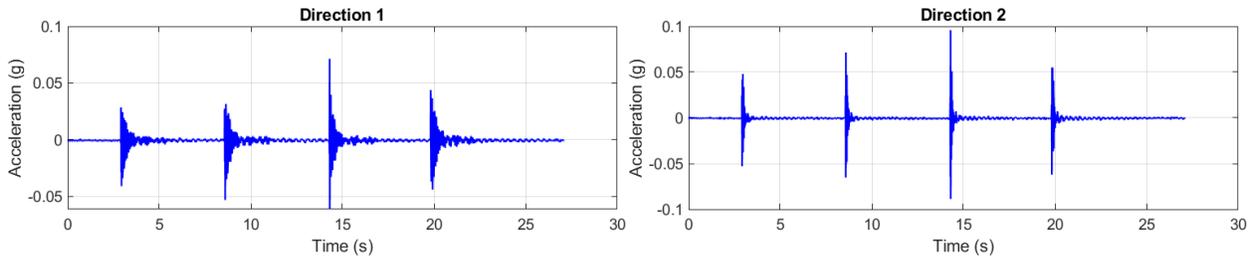
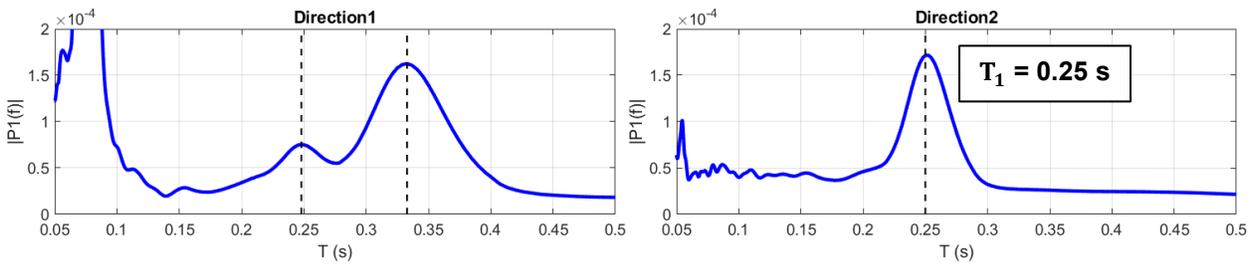
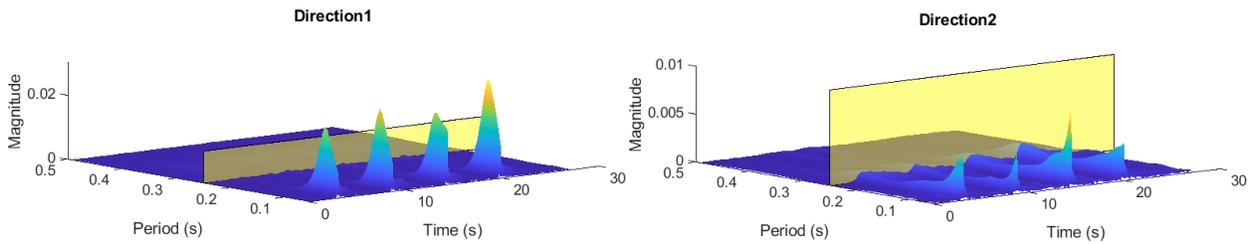
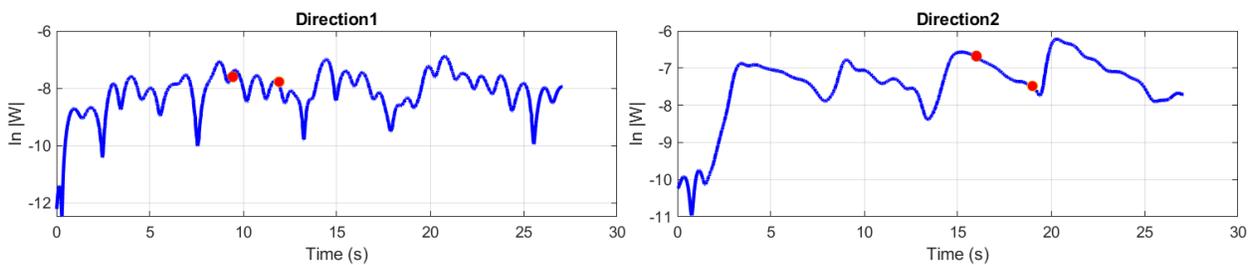
Fig. 5.23. Example vibration analysis results from the Pioneer Park pavilion.

(a) Acceleration history

(b) Single-sided amplitude spectrum of period-content.

(c) Amplitude of period content versus time.

(d) Wavelet amplitude at fundamental period of vibration.

The Pioneer Park pavilion is a 35 ft long by 25 ft wide free-standing timber frame in a public park in Lindon, Utah (Fig. 5.22). The posts are supported on a concrete slab on grade. The base of the post is on a steel plate. The beams span four posts longitudinally. The mean roof height is approximately 12 ft. The vibration test was conducted in May, 2021. The fundamental period of vibration was 0.25 sec. and the corresponding modal damping was 1% or less (see Fig. 5.23).

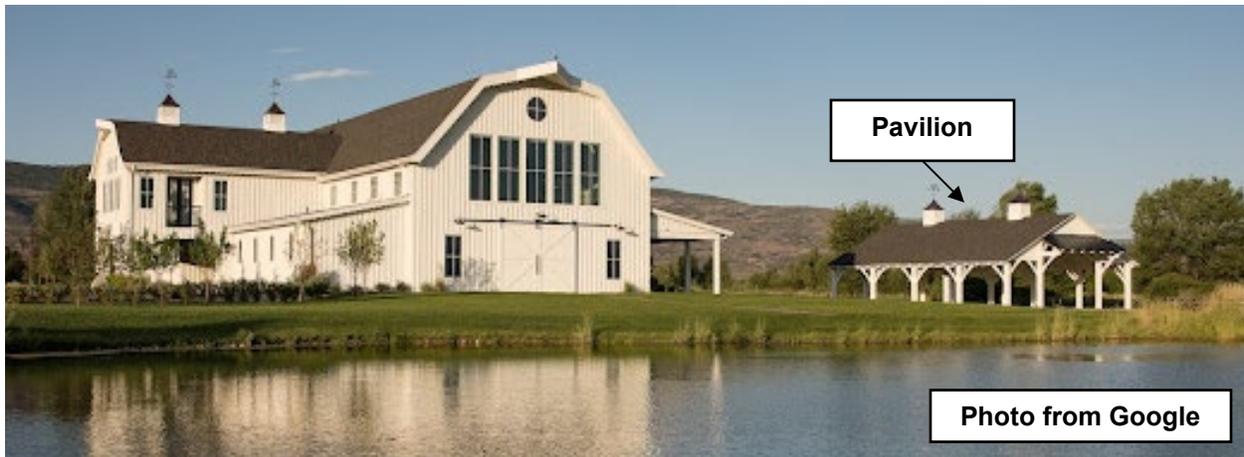
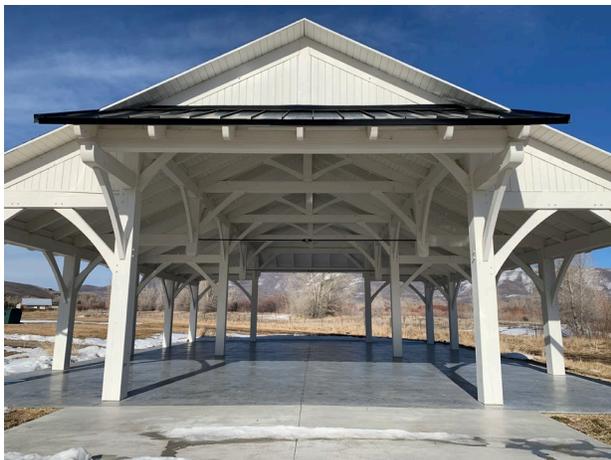
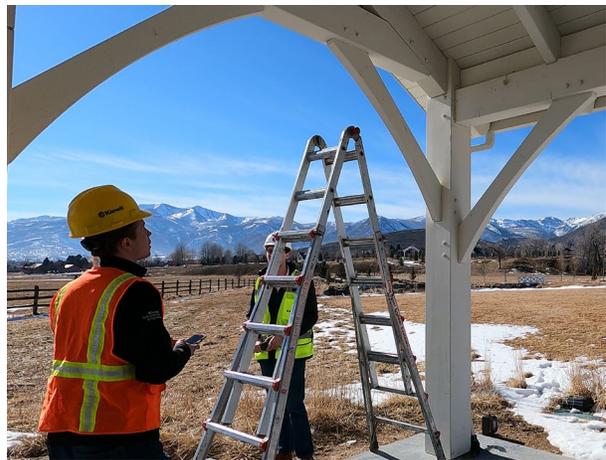
Fig. 5.24. River Bottoms Ranch pavilion in Midway, Utah.

The River Bottoms Ranch pavilion is a free-standing timber frame at a private event venue in Midway, Utah (Fig. 5.24). The frame is supported on a concrete slab on grade and spans five posts longitudinally. The mean roof height is approximately 12 ft. The vibration test was conducted in March, 2022. The fundamental periods of vibration were 0.20 sec. and 0.27 sec. and the modal damping was approximately 1% (see Fig. 5.25).

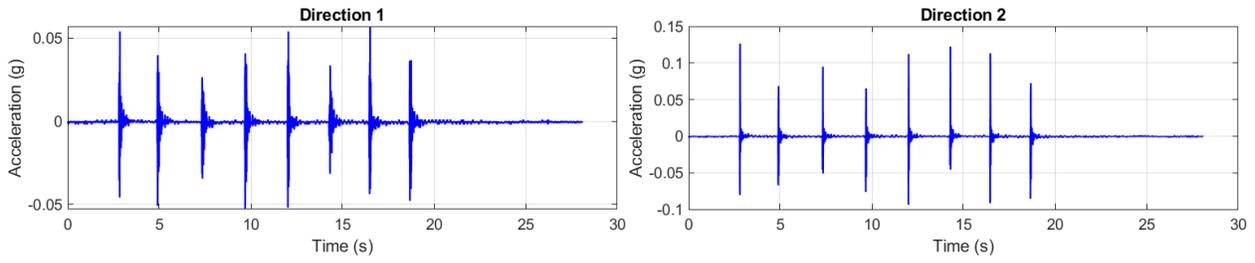
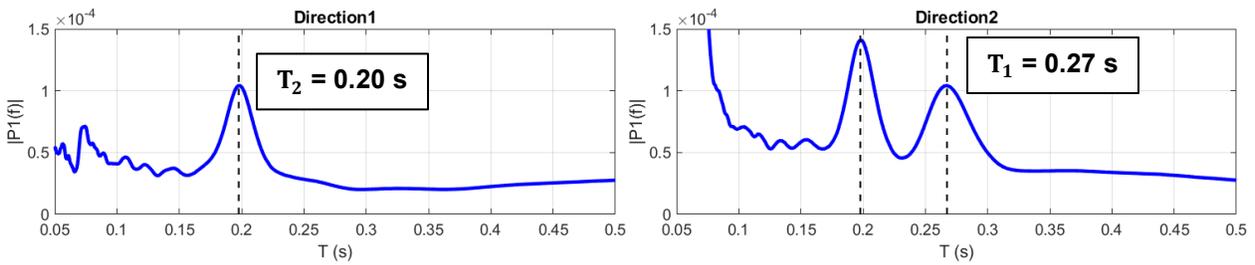
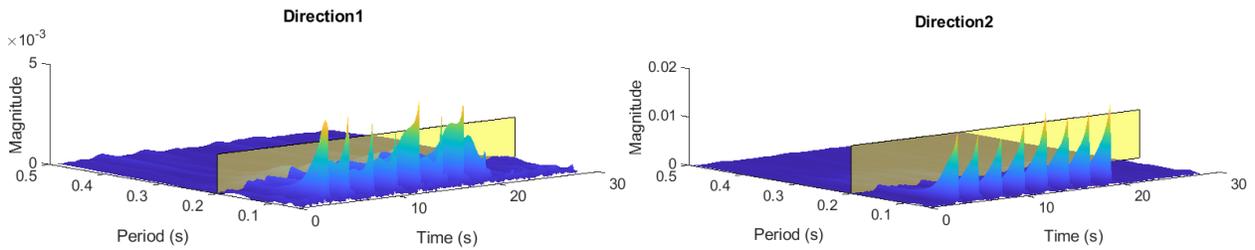
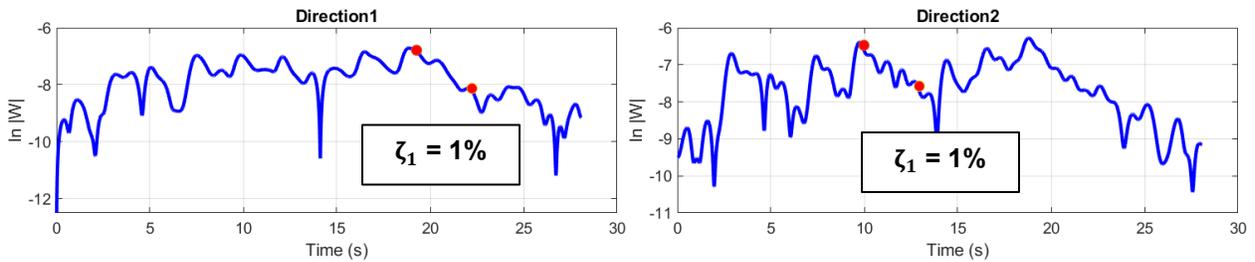
Fig. 5.25. Example frequency analysis of River Bottoms Ranch pavilion.

(a) Acceleration history

(b) Single-sided amplitude spectrum of period-content.

(c) Amplitude of period content versus time.

(d) Wavelet amplitude at fundamental period of vibration.

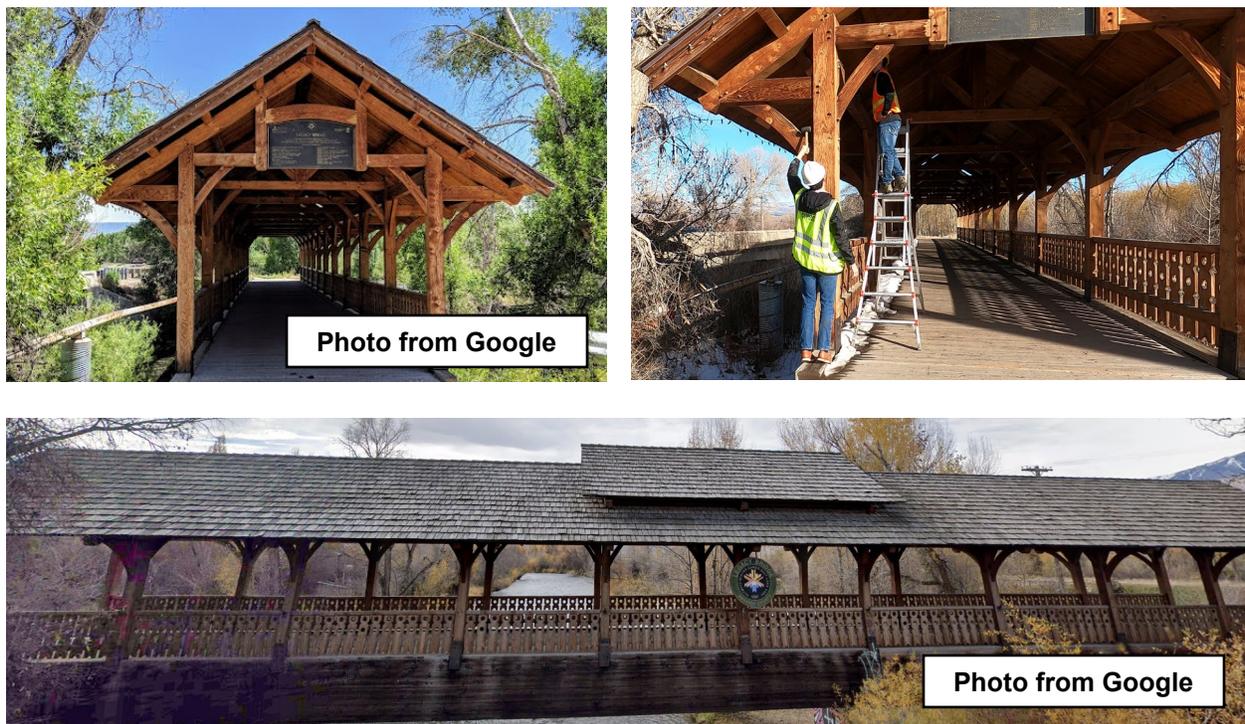
Fig. 5.26. Legacy covered bridge in Midway, Utah.

The Legacy Bridge is a covered bridge between Heber City and Midway, Utah (Fig. 5.26). The bridge is about 120-ft long—the longest covered bridge in Utah. The mean roof height is approximately 12 ft. The vibration test was conducted in March, 2022. The fundamental periods of vibration were 0.33 sec. and 0.2 sec. and the first-mode damping was approximately 1% (see Fig. 5.27).

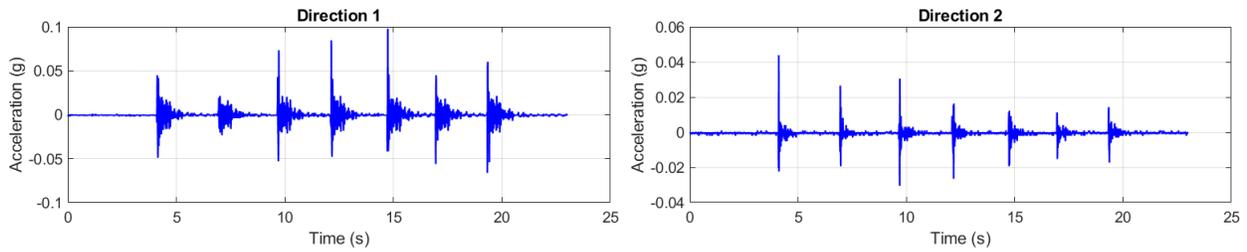
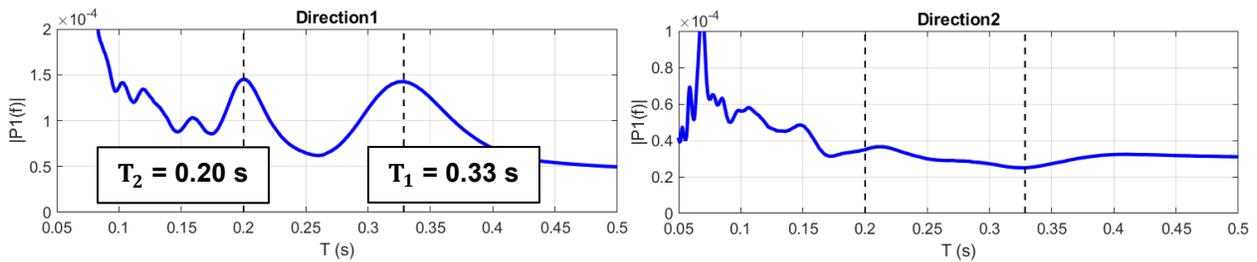
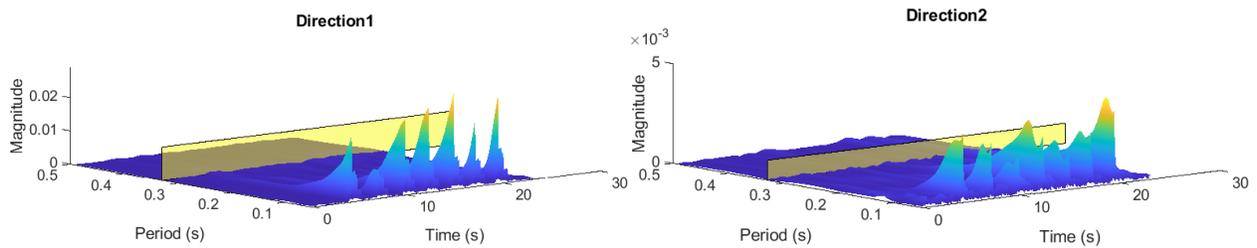
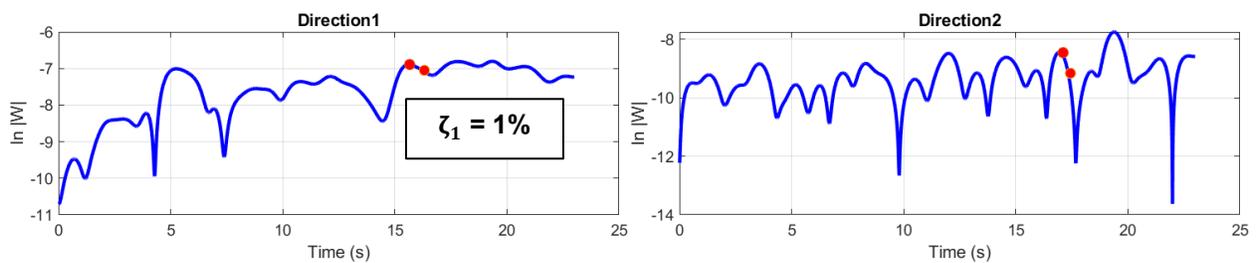
Fig. 5.27. Example frequency analysis of Legacy covered bridge.

(a) Acceleration history

(b) Single-sided amplitude spectrum of period-content.

(c) Amplitude of period content versus time.

(d) Wavelet amplitude at fundamental period of vibration.

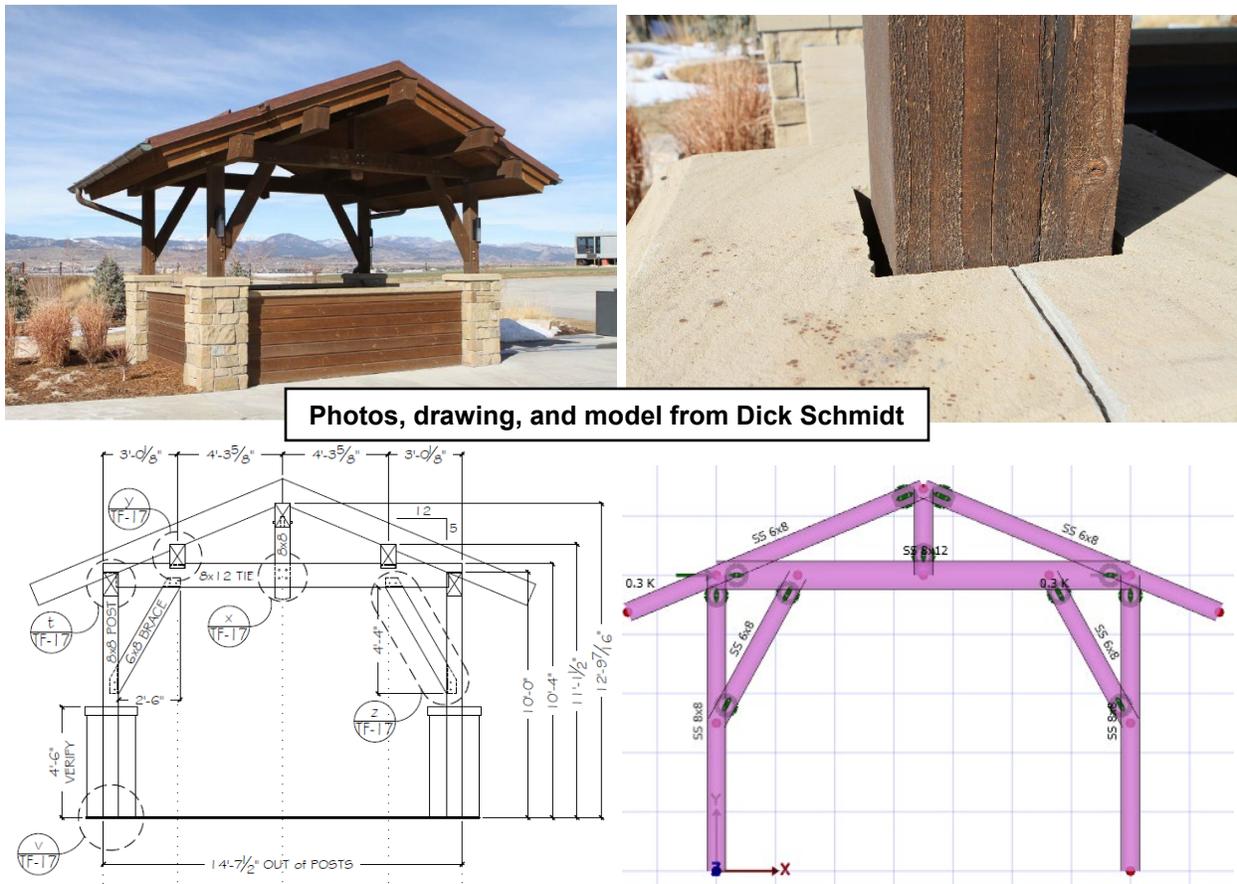
Fig. 5.28. Bag Corral pavilion in Berthoud, Colorado.

The Bag Corral pavilion is a 14.5 ft long by 10.5 ft wide free-standing timber frame at a golf center in Berthoud, Colorado (Fig. 5.28). It is a single-span frame in both directions. The posts are wrapped with masonry. There is a gap between the posts and the masonry. Each post on the frame is 5.5 ft high from the top of the pier to the spandrel beam. The mean roof height is 11.5 ft. The vibration test was conducted in March, 2022. The first period of vibration was 0.24 sec. and the corresponding damping was 2%. The second period of vibration was 0.16 sec. and the corresponding damping was 5% (see Fig. 5.29).

The Bag Corral pavilion described in Chapter 5 (see Fig. 5.28) was used for an example life cycle analysis. For the Bag Corral timber frame, the mass of wood needed to repair the various failure was calculated and multiplied by 50.5% to get the mass of carbon in the wood. Carbon emissions in production and transportation of wood were not included in the embodied carbon calculations. Wood has an embodied energy of about 2.4 MJ/kg (Lenzen and Treloar 2002), and

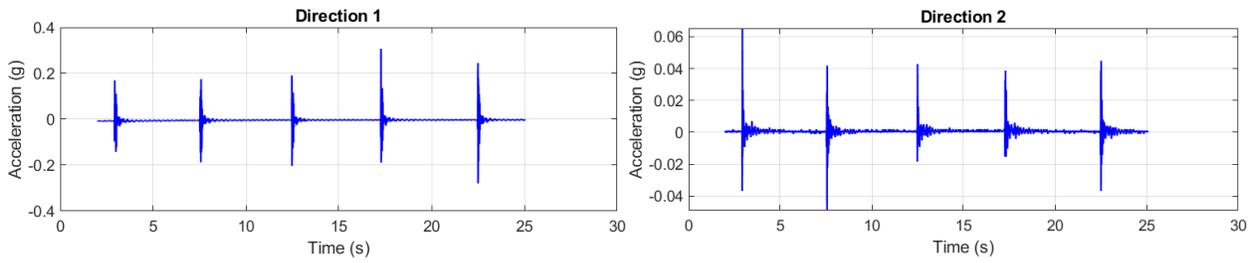
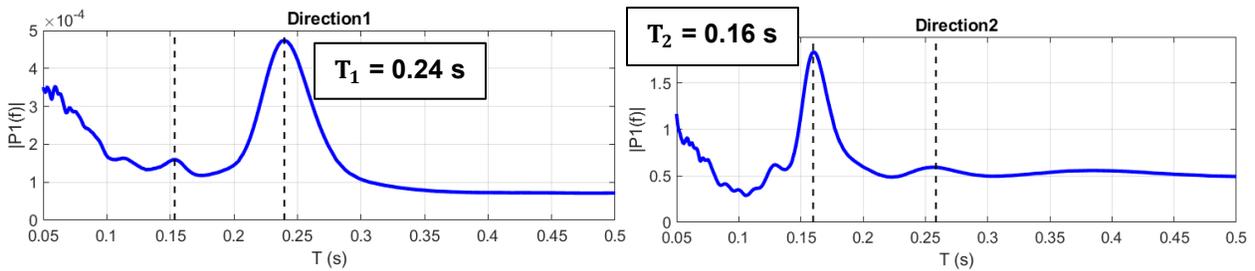
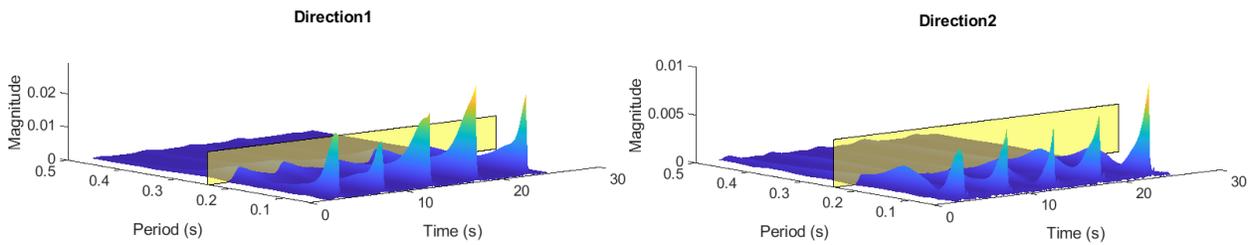
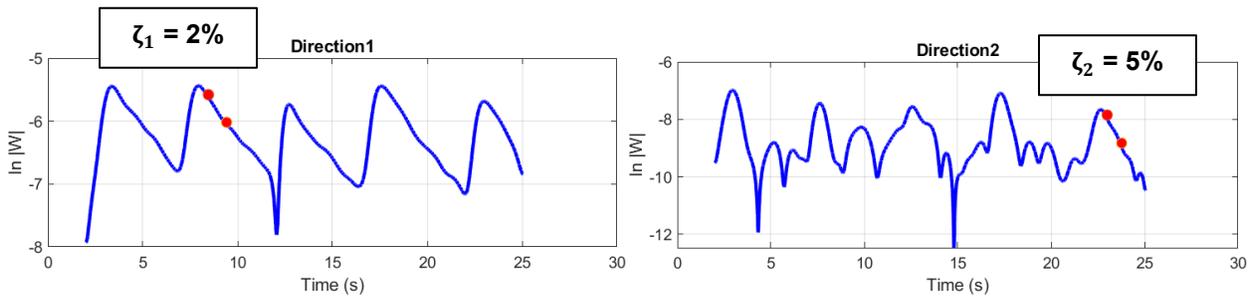
Fig. 5.29. Example frequency analysis of the Bag Corral pavilion.

(a) Acceleration history

(b) Single-sided amplitude spectrum of period-content.

(c) Amplitude of period content versus time.

(d) Wavelet amplitude at fundamental period of vibration.

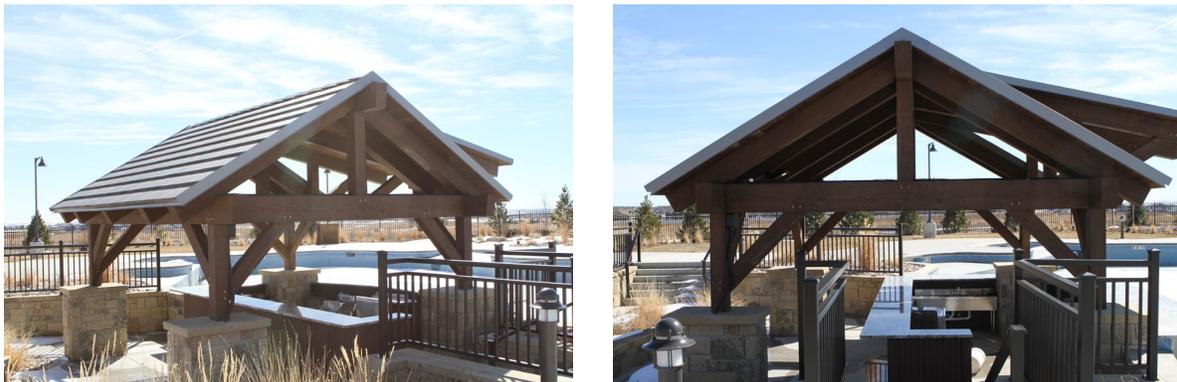
Fig. 5.30. Pool Bar pavilion in Berthoud, Colorado.

The Pool Bar pavilion is a 16.5' by 14.5' free-standing timber frame at a golf center in Berthoud, Colorado (Fig. 5.30). It is a single-span frame in both directions. The posts are wrapped with masonry. The gap between the posts and the masonry are filled with mortar. Each post on the frame is 4.5 ft high from the top of the pier to the spandrel beam. The mean roof height is 6.5 ft. from the top of the pier. The vibration test was conducted in March, 2022. The first period of vibration was 0.13 sec. and the corresponding damping was 2% (Fig. 5.31). The second period of vibration was 0.09 sec. The computed period of vibration for the structural model was 0.09 sec.

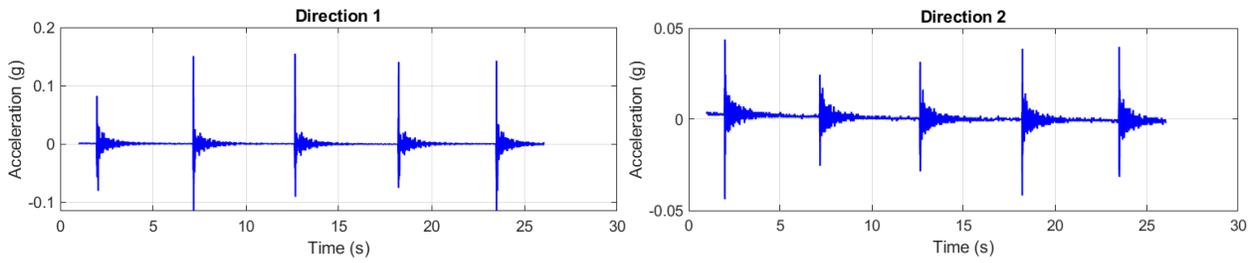
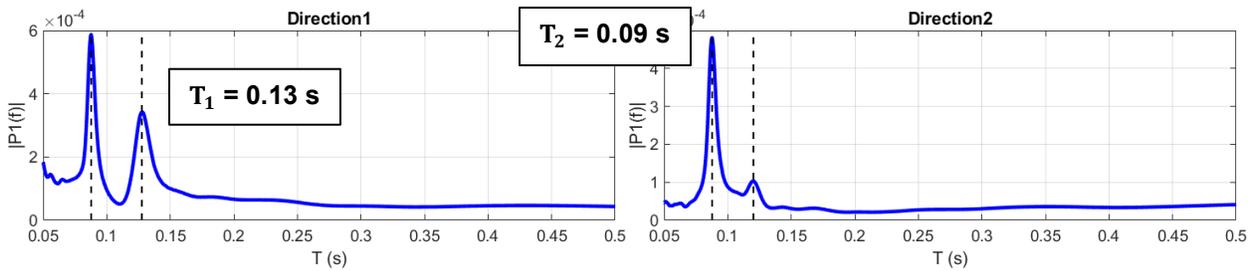
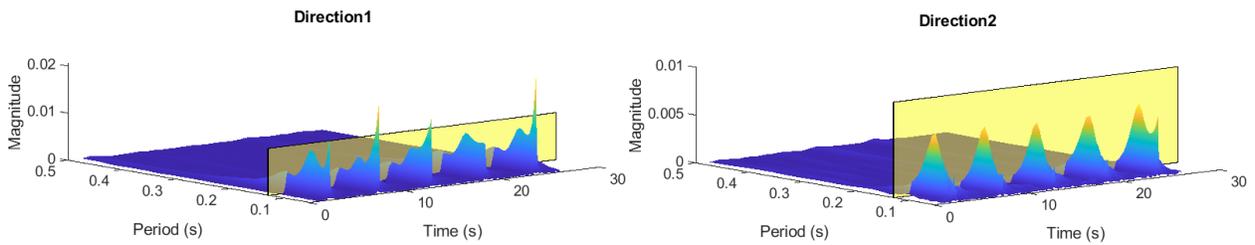
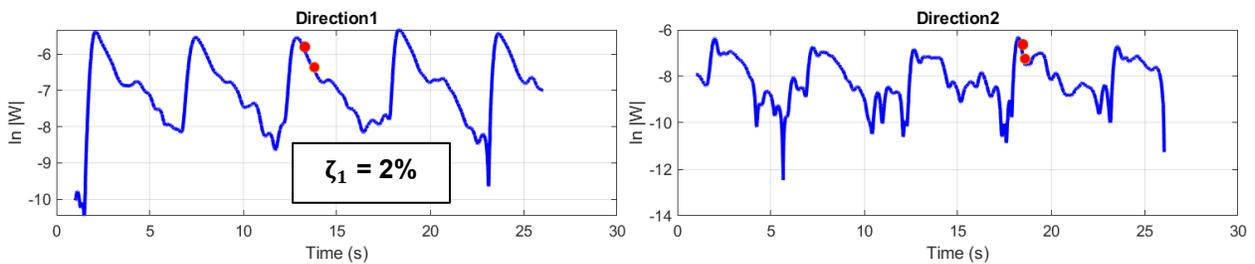
Fig. 5.31. Example frequency analysis of the Pool Bar pavilion.

(a) Acceleration history

(b) Single-sided amplitude spectrum of period-content.

(c) Amplitude of period content versus time.

(d) Wavelet amplitude at fundamental period of vibration.

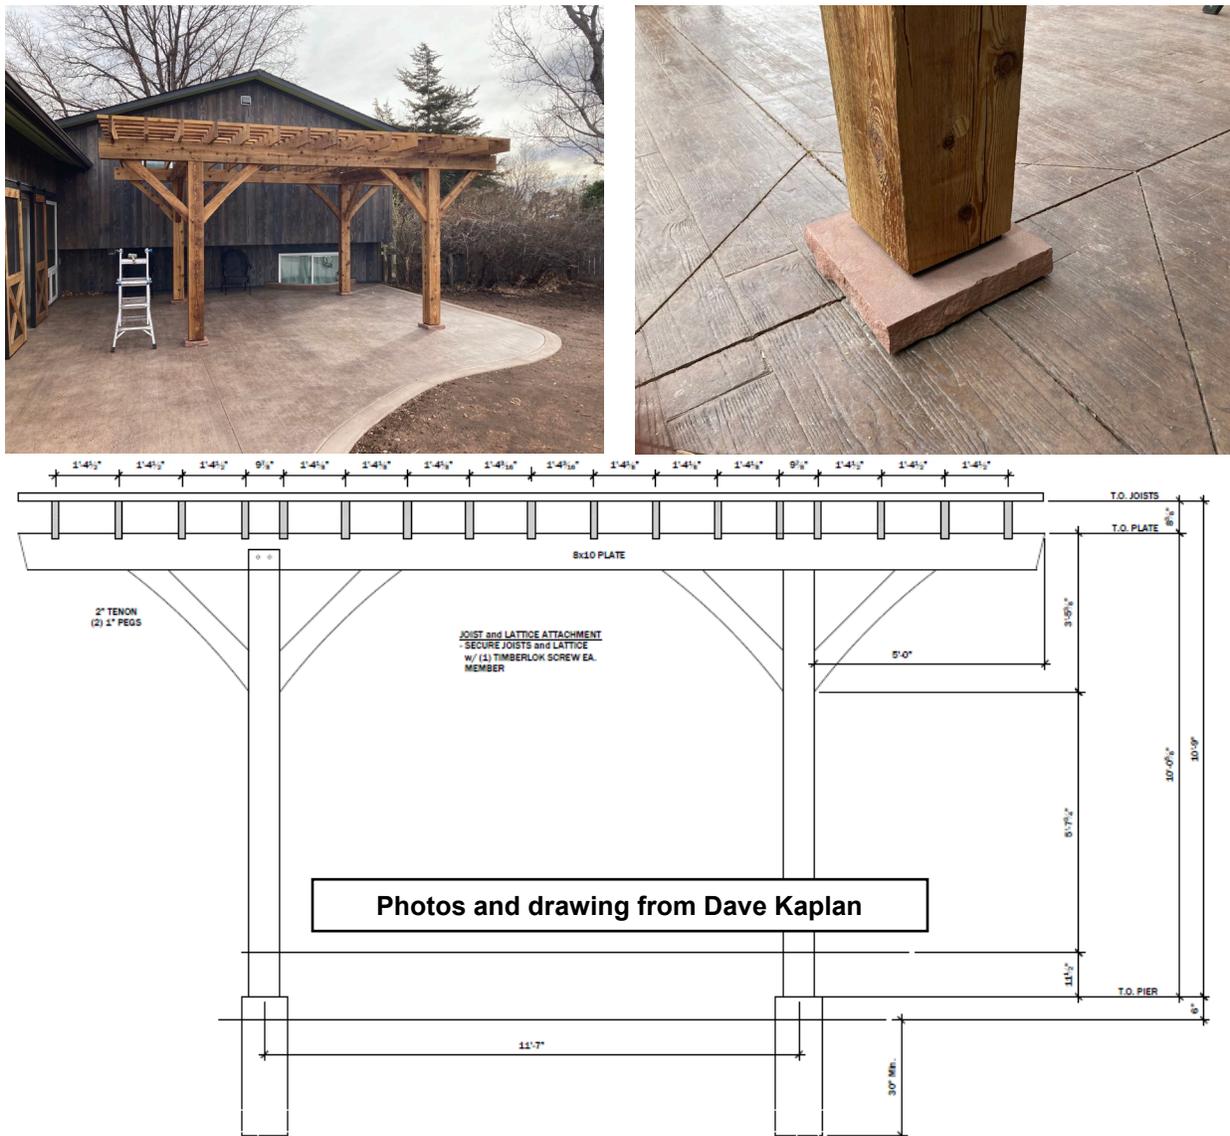
Fig. 5.32. Farghee Pergola in Ft. Collins, Colorado.

The Farghee pergola is a 12.5 ft by 12.8 ft free-standing timber frame in Fort Collins, Colorado. The frame is 10.5 ft tall from the base to the 8x10 wood plate (beam). The base of the posts rests on steel plates set on top of isolated stone pavers (Fig. 5.32). The vibration test was conducted in March, 2022. The first period of vibration was 0.16 sec and the corresponding damping was 2%. The second period of vibration was 0.10 sec.

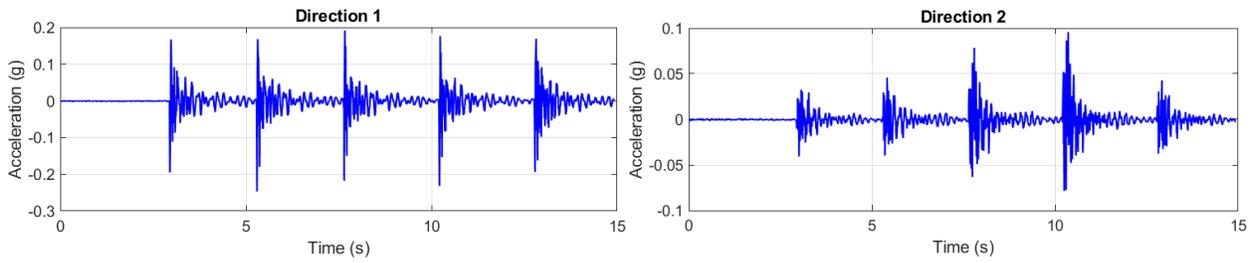
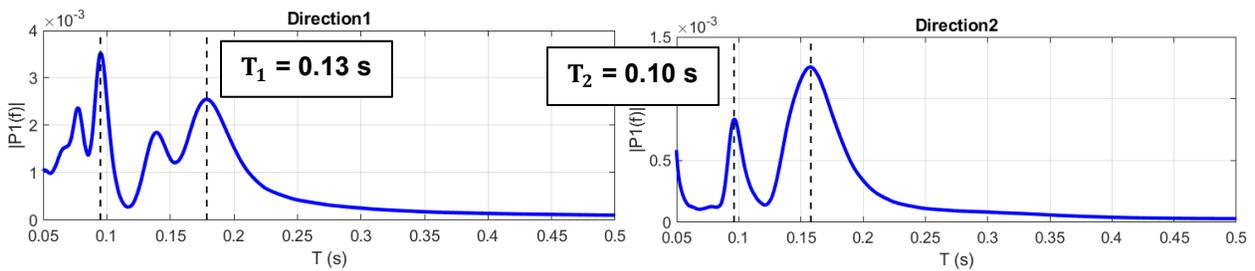
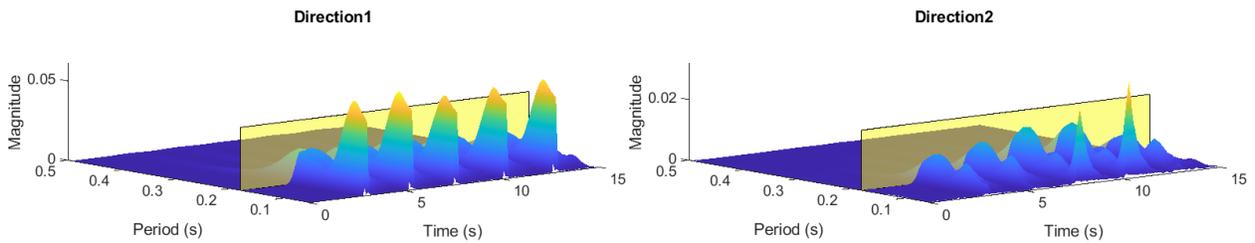
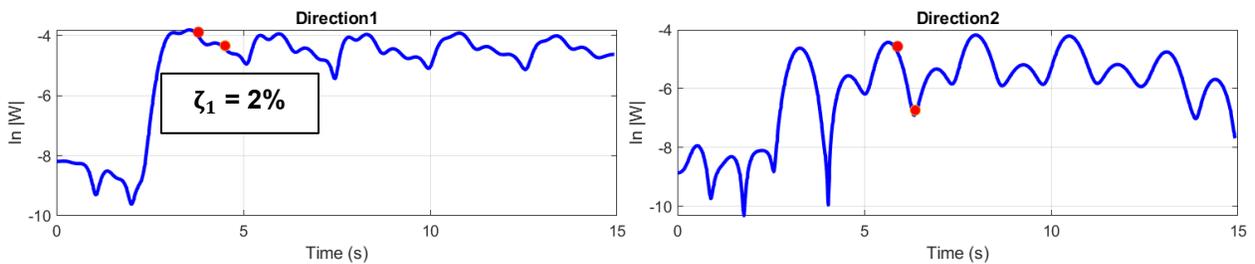
Fig. 5.33. Example frequency analysis of the Farghee pergola.

(a) Acceleration history

(b) Single-sided amplitude spectrum of period-content.

(c) Amplitude of period content versus time.

(d) Wavelet amplitude at fundamental period of vibration.

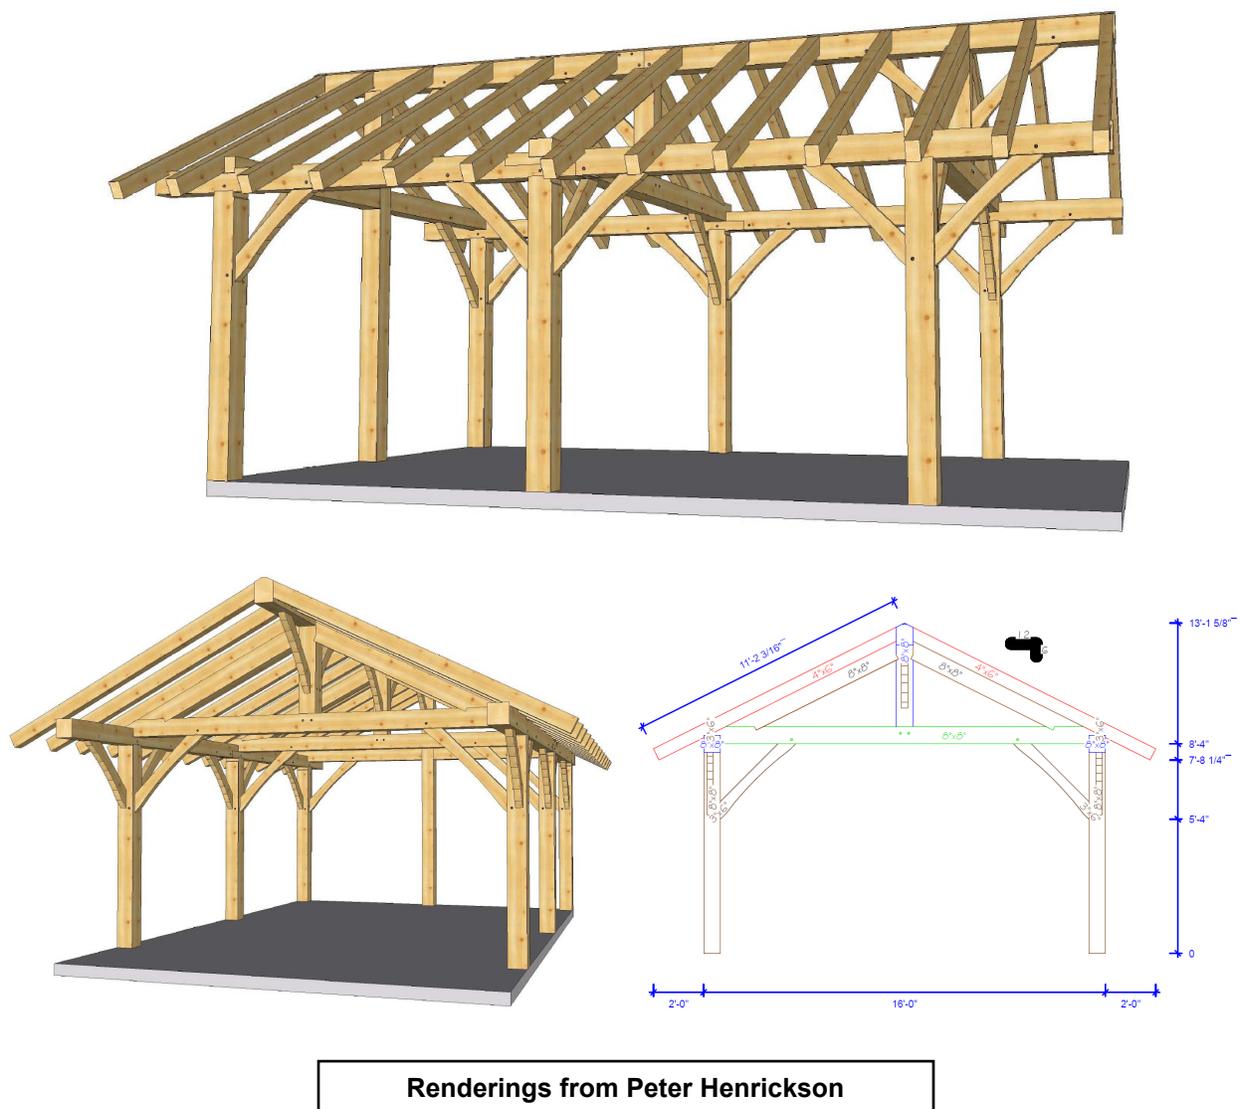
Fig. 5.34. Cook County High School frame in Grand Marais, Minnesota.

The Cook County High School frame, in Grand Marais, Minnesota, was a 20 ft by 16 ft free-standing timber frame that was built by the students as an educational experience (Fig. 5.34). The roof was not covered. The mean roof height is 10.75 ft. The vibration test was conducted in May, 2022. The first period of vibration was 0.32 sec. and the corresponding modal damping was 2% (see Fig. 5.35). The second period of vibration was 0.25 sec.

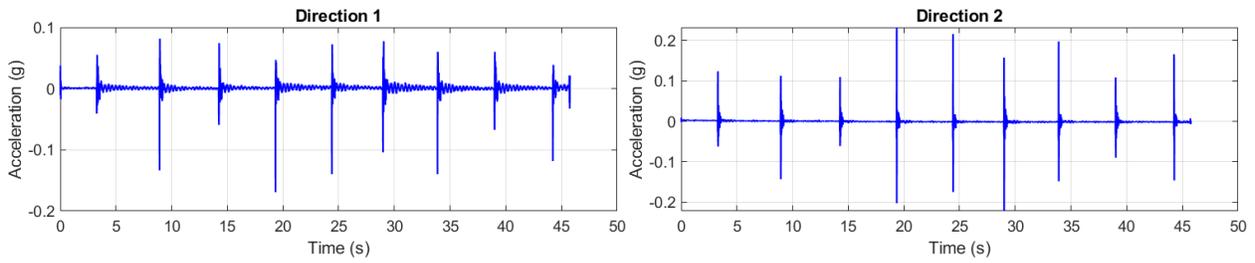
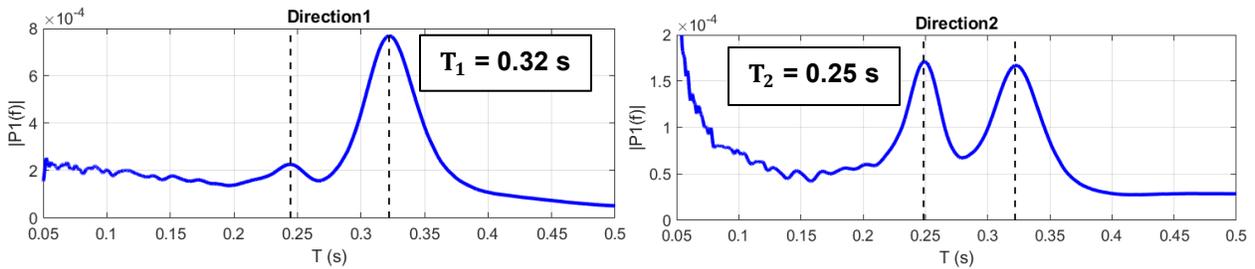
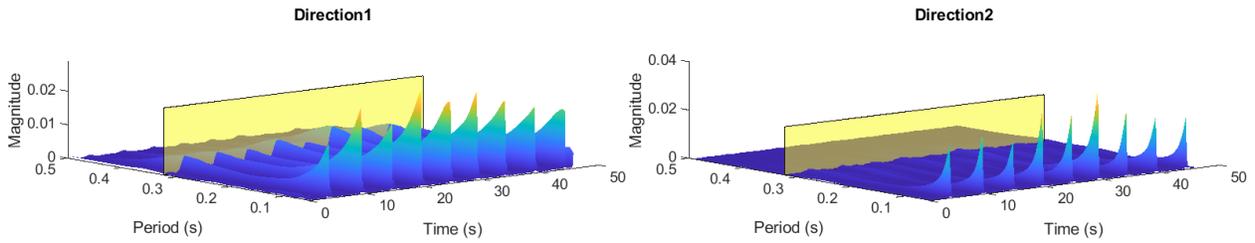
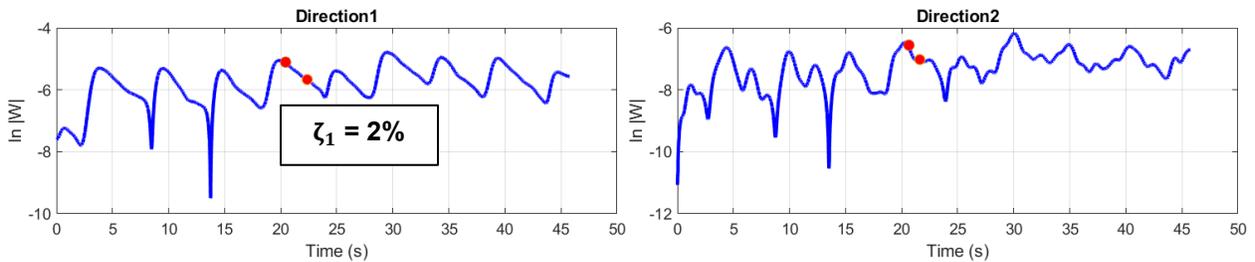
Fig. 5.35. Example frequency analysis of the Cook County High School frame.

(a) Acceleration history

(b) Single-sided amplitude spectrum of period-content.

(c) Amplitude of period content versus time.

(d) Wavelet amplitude at fundamental period of vibration.

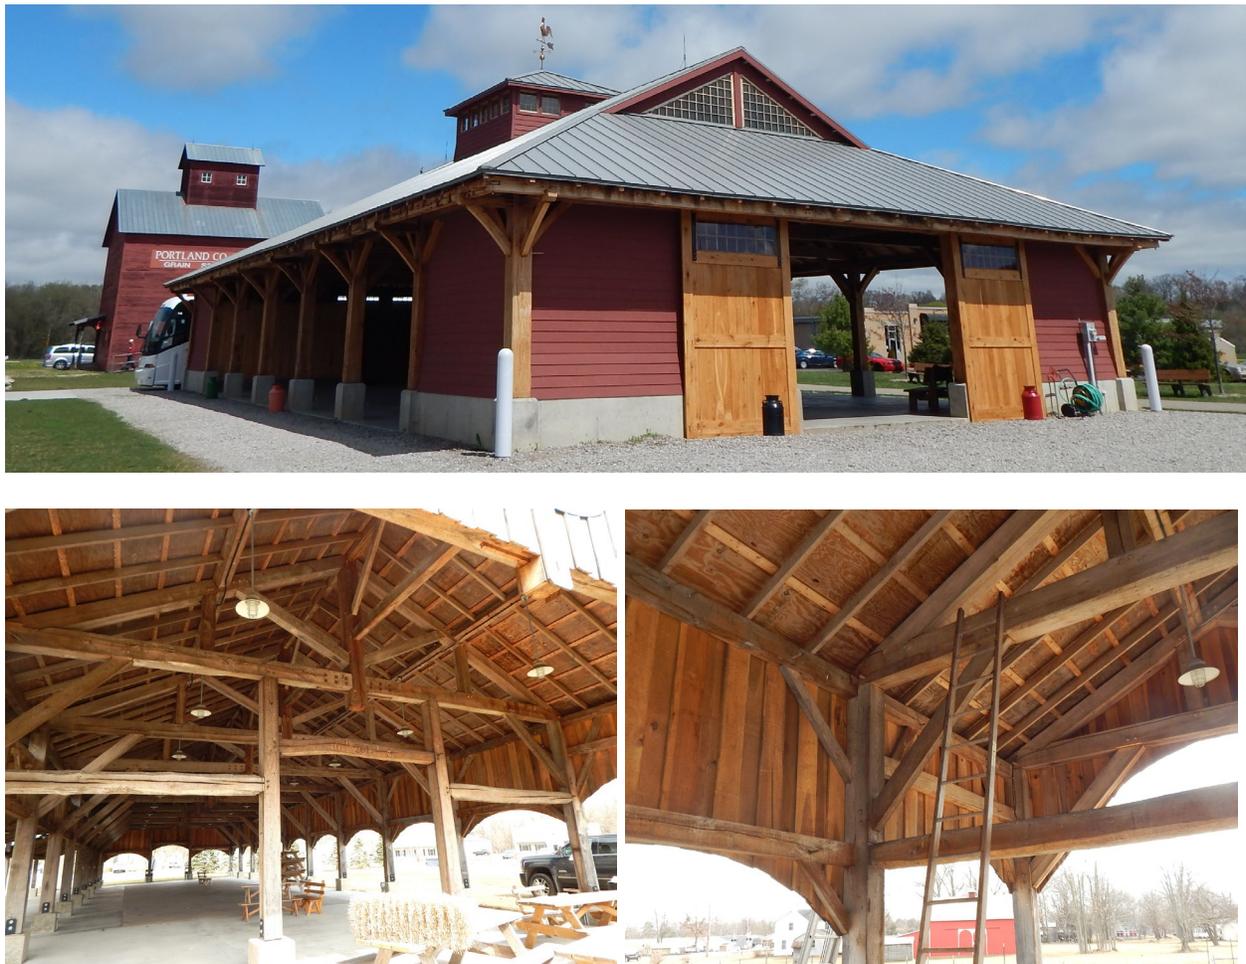
Fig. 5.36. Farmers Market pavilion in Vicksburg, Michigan.

The Farmers Market pavilion is a 121 ft long by 36 ft wide free-standing timber frame in Vicksburg, Michigan (Fig. 5.36 to Fig. 5.38). The frame spans across 10 posts longitudinally. The mean roof height is approximately 17.5 ft. The footings rest on steel plates embedded into the concrete footings, with a bolted base connection into the post. The vibration test was conducted in March, 2022. Similar to the Legacy bridge, the vibration data is noisy. With this in mind, the fundamental periods of vibration were 0.34 sec. and 0.31 sec. The first-mode damping was approximately 10% (Fig. 5.39).

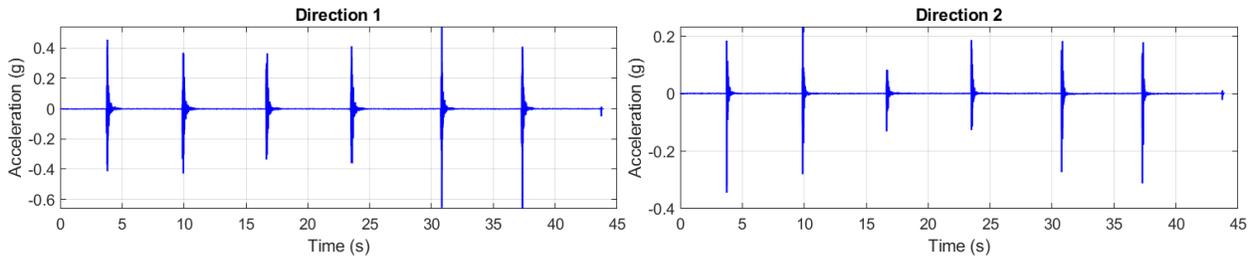
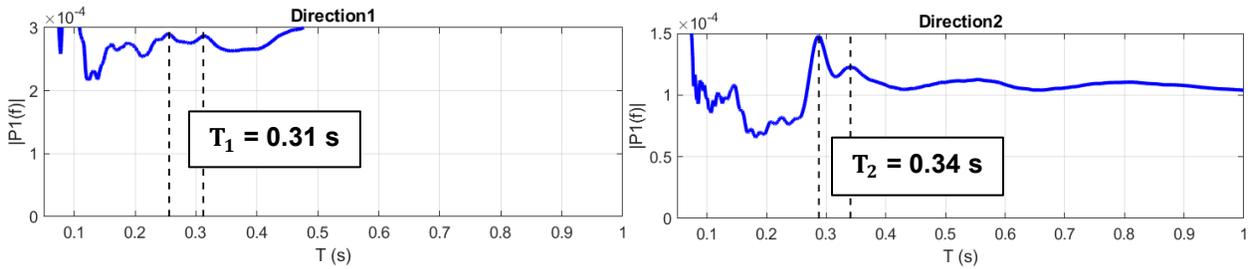
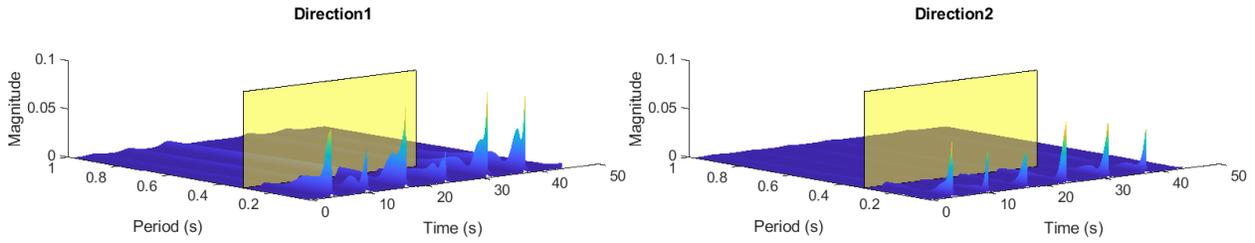
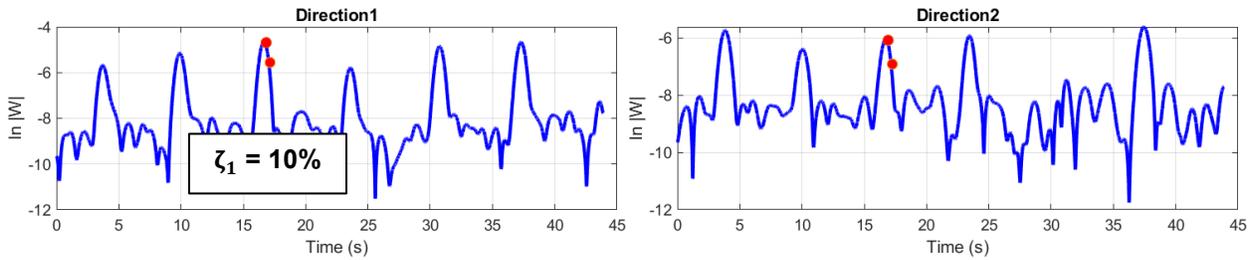
Fig. 5.39. Example frequency analysis of the Farmers Market pavilion.

(a) Acceleration history

(b) Single-sided amplitude spectrum of period-content.

(c) Amplitude of period content versus time.

(d) Wavelet amplitude at fundamental period of vibration.

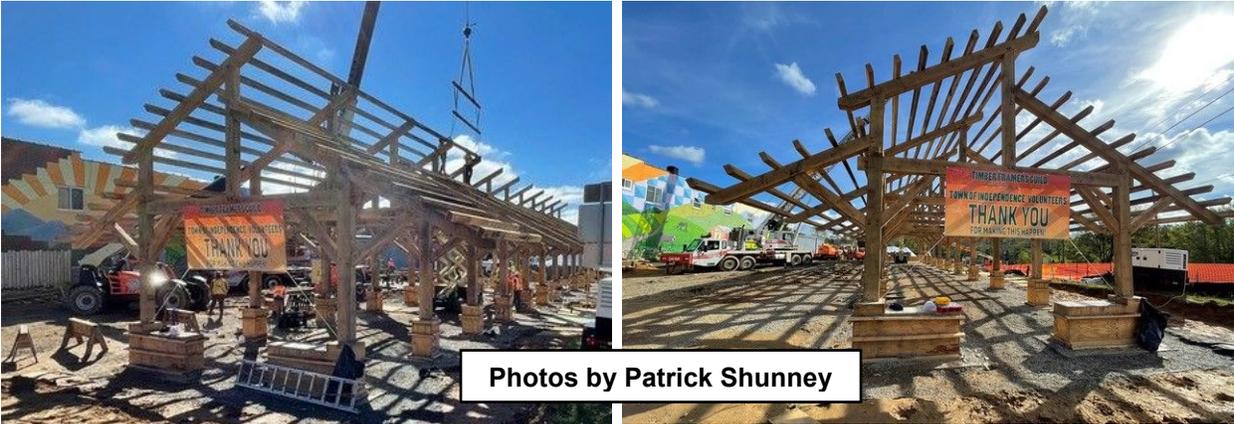
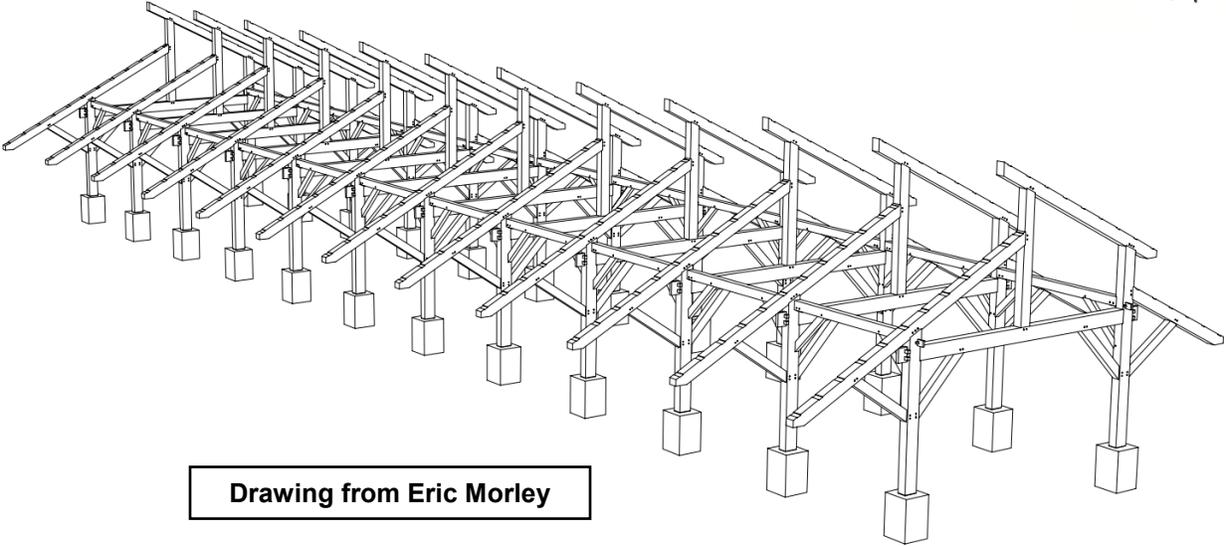
Fig. 5.40. Independence Farmers Market pavilion in Independence, Virginia.

The Independence Farmers Market pavilion is a 132-ft long by 20-ft wide (drip line of about 136 ft by 40 ft) free-standing timber frame in Independence, Virginia (Fig. 5.40). The timber frame is supported on concrete piers and spans twelve posts longitudinally. Each span is 12 ft across. The mean roof height is approximately 17 ft. The timber frame was built as a community building workshop by the TFG.

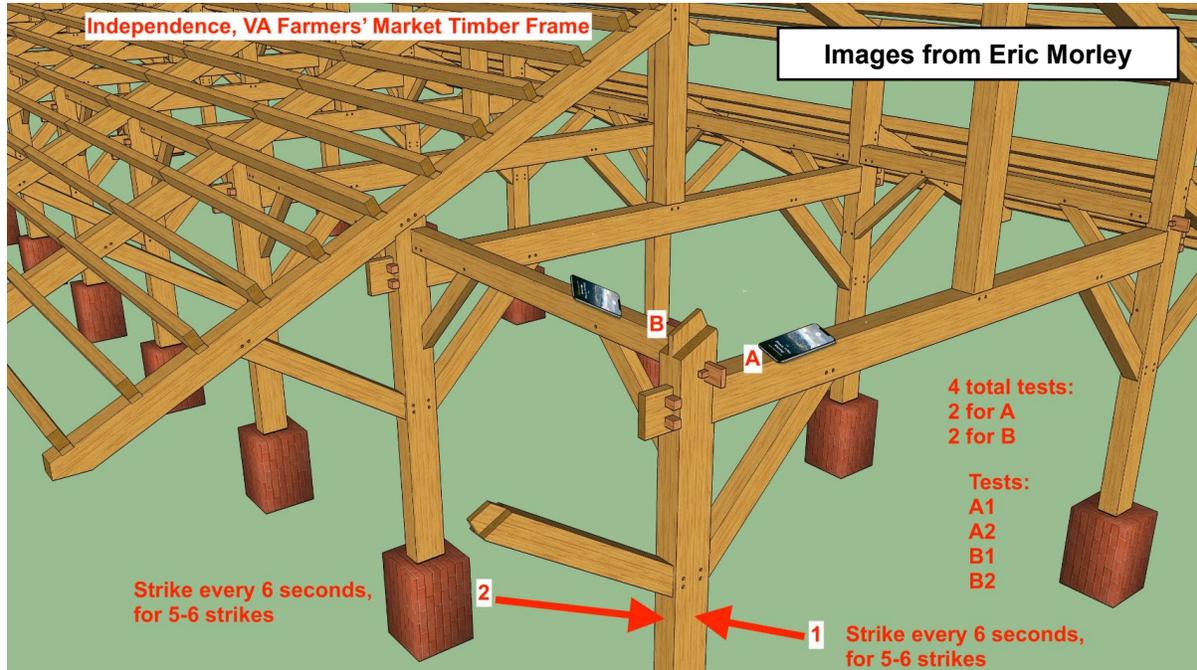
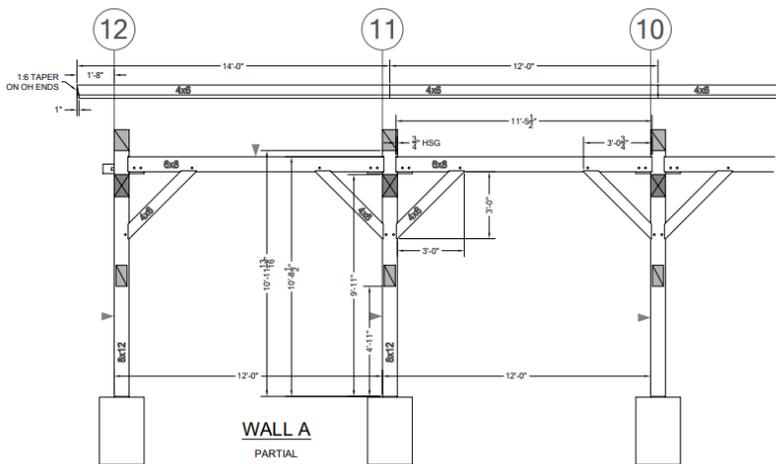
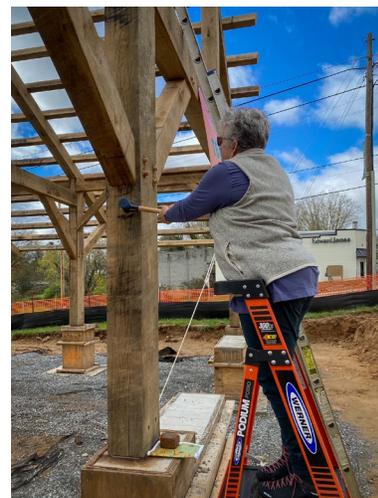
Fig. 5.41. Independence Farmers Market pavilion field test.

(a) Orientation of smartphone and test sequence

(b) Elevation drawing

(c) Hammer strike

The vibration test was conducted in November, 2021. Fig. 5.41 illustrates the field test. As was the case with other large timber frames, the fundamental period of vibration was difficult to clearly identify. For this pavilion, the period varied from 0.3 sec., 0.25 sec., and 0.18 sec. For comparison, the computed period of vibration for the structural model was 0.24 sec. (Fig. 5.42). The modal damping was 3% to 4% (Fig. 5.43).
