BYU Civil & Environmental Engineering

Performance Criteria for Free-Standing Timber Frames with Knee Braces

November, 2022

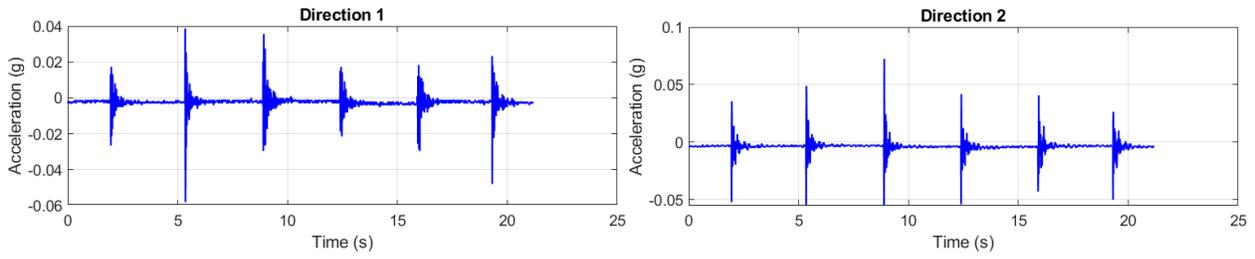
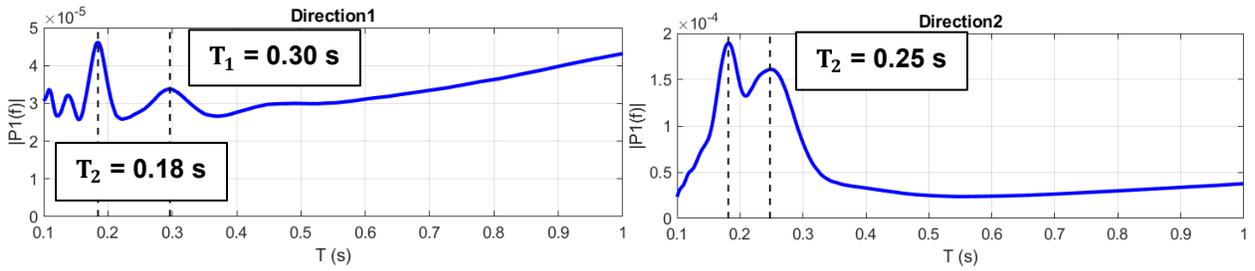
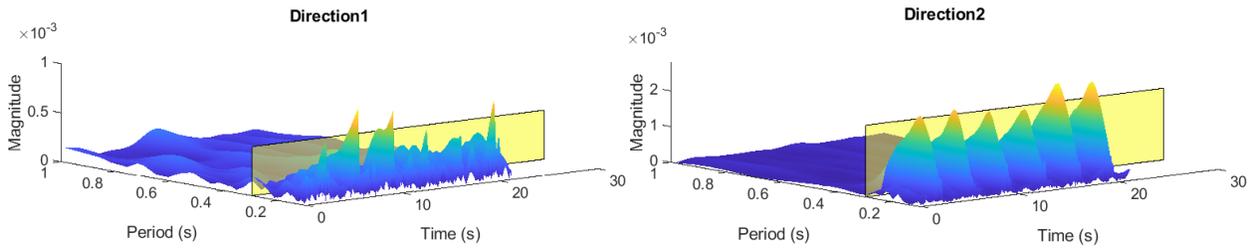
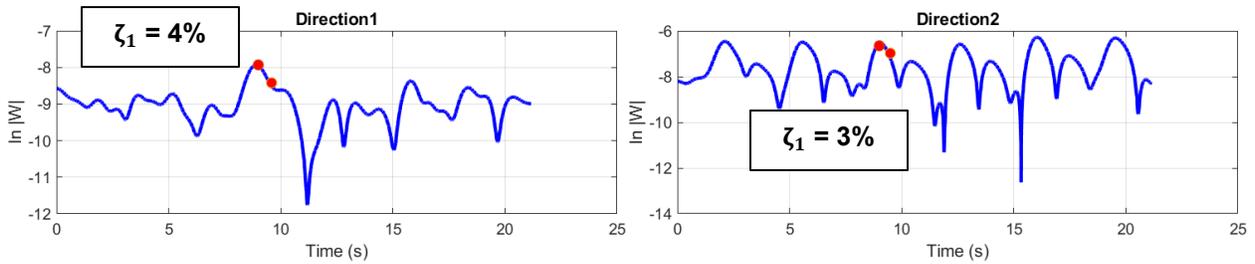
Fig. 5.43. Example frequency analysis of the Independence Farmers Market pavilion.

(a) Acceleration history

(b) Single-sided amplitude spectrum of period-content.

(c) Amplitude of period content versus time.

(d) Wavelet amplitude at fundamental period of vibration.

The vibration test was conducted in November, 2021. Fig. 5.41 illustrates the field test. As was the case with other large timber frames, the fundamental period of vibration was difficult to clearly identify. For this pavilion, the period varied from 0.3 sec., 0.25 sec., and 0.18 sec. For comparison, the computed period of vibration for the structural model was 0.24 sec. (Fig. 5.42). The modal damping was 3% to 4% (Fig. 5.43).

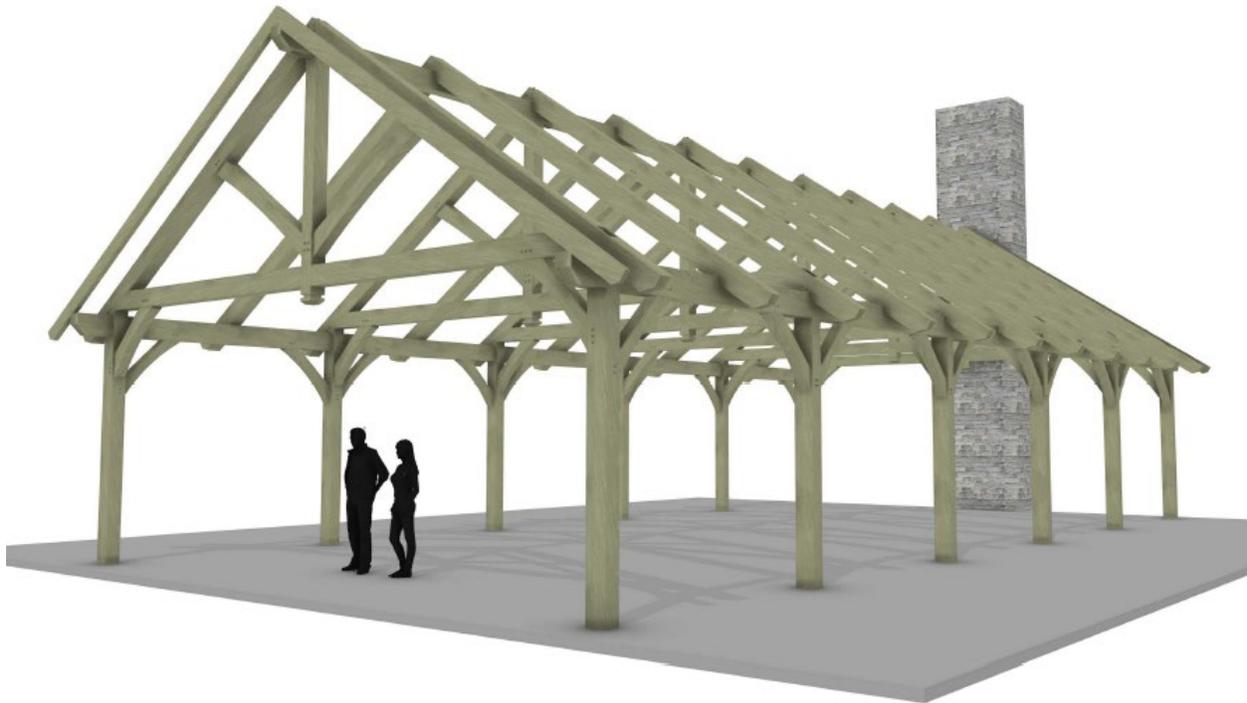
Fig. 5.44. Sunflowers Meadows pavilion in Newton, North Carolina.

The Sunflower Meadows pavilion is a 60-ft long by 30-ft wide free-standing timber frame in Newton, North Carolina (Fig. 5.44). The mean roof height is approximately 16 ft. The timber frame was made using White Oak. The posts are connected to the concrete slab below, and it spans across six posts longitudinally.

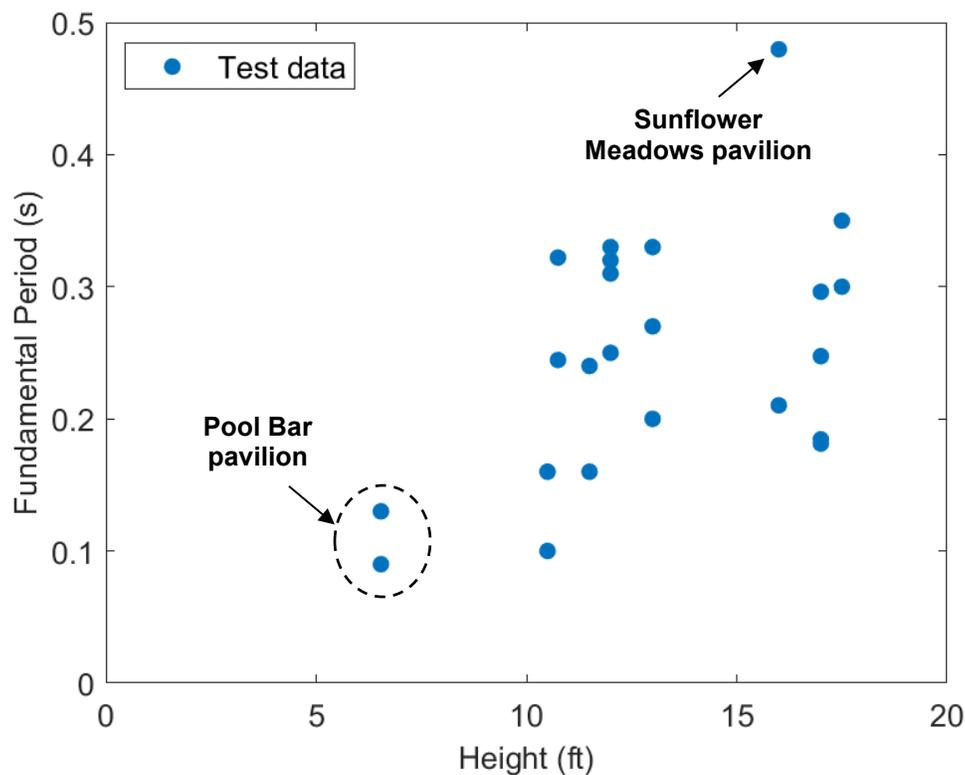
Fig. 5.48. Measured fundamental period of vibration versus mean roof height.

In Fig. 5.48, the measured periods of vibration (sec.) is plotted against the mean roof height (ft). Each dot in the plot is a test data point. The data points show an increasing trend (taller timber frames generally correlate with longer periods), but there is no clear mathematical relationship.

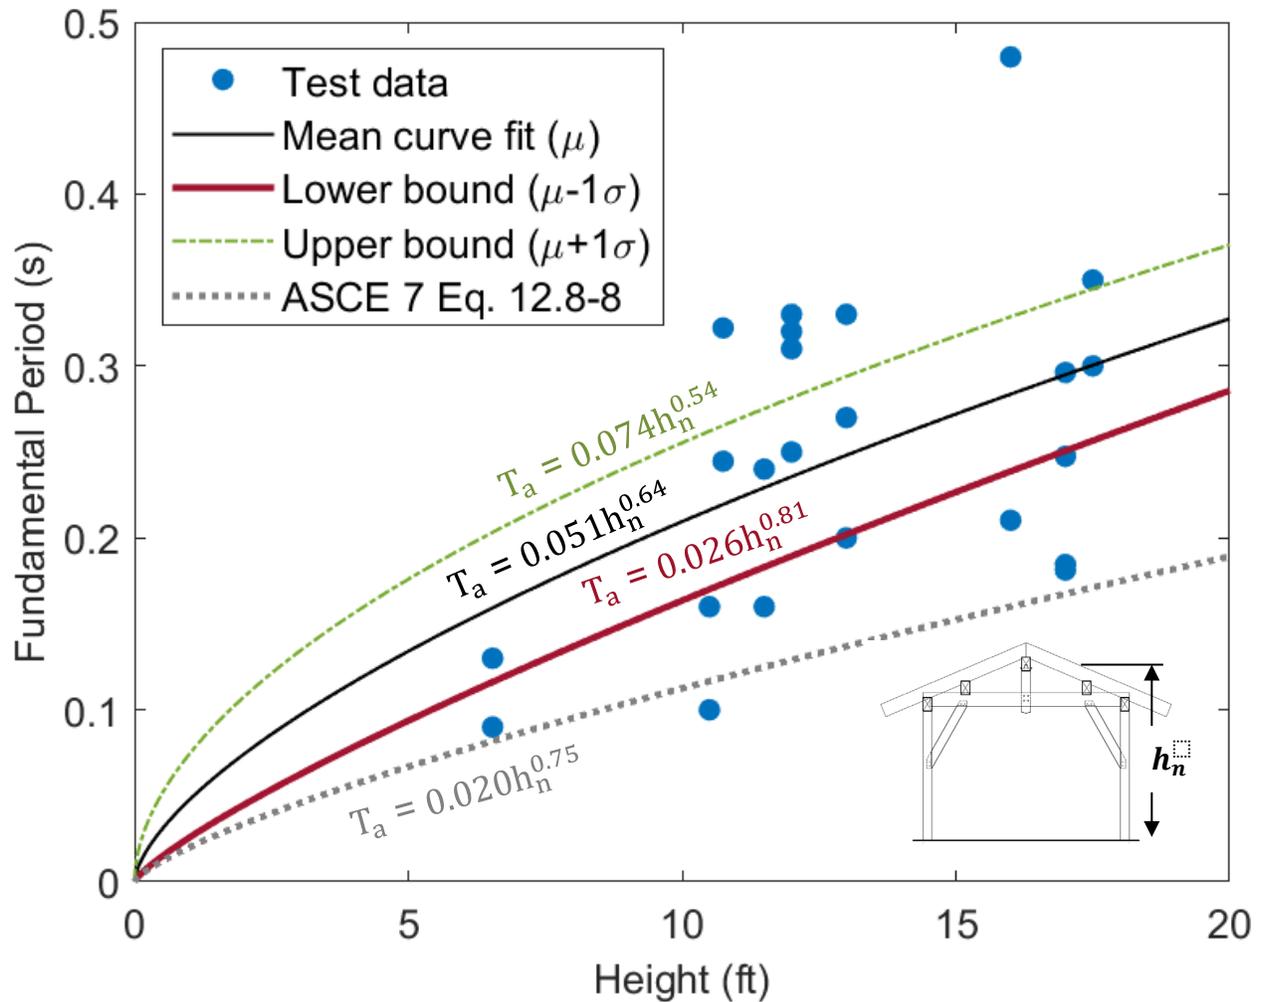
Fig. 5.49. Fundamental period of vibration versus mean roof height.

For timber frames, the parameters for Eq. (5.1) were determined using the following process. First, a random set of positive parameters were selected. Second, the sum of the squared errors between a test data point and the curve fit was computed. Third, the parameters were then adjusted to minimize the sum of the squared errors. This produced the “best” parameters for the mean curve fit. However, for seismic design the parameters in ASCE 7 correspond to the mean minus one standard deviation (“the lower bound” curve). Therefore, the curve fitting process was repeated by fitting the points for the mean minus one-standard deviation curve. Similarly, for wind design the parameters in ASCE 7 correspond to the mean plus one standard deviation (the “upper bound” curve), and a third set of parameters was fit to the mean plus one standard deviation. The resulting parameters are shown in Fig. 5.49. For reference, the ASCE 7 curve fit for typical buildings is also shown. The measured fundamental period was generally longer compared to the values using the ASCE 7 equation.

In general, the plot shows that the power function curve fit provides a reasonable approximation to the test data, especially considering the scatter in the test data. Previous research shows that the fundamental period of vibration measured in a test depends on the amplitude of the vibration (Skolnik et al. 2006). Low-amplitude vibrations, such as those from ambient sources, lead to shorter periods, whereas high-amplitude vibrations lead to relatively longer periods. In other words, larger structures require higher-amplitude vibrations to determine the period of vibration. Therefore, the approach to vibration tests used in this study are not appropriate for determining the fundamental period of buildings or larger structures.

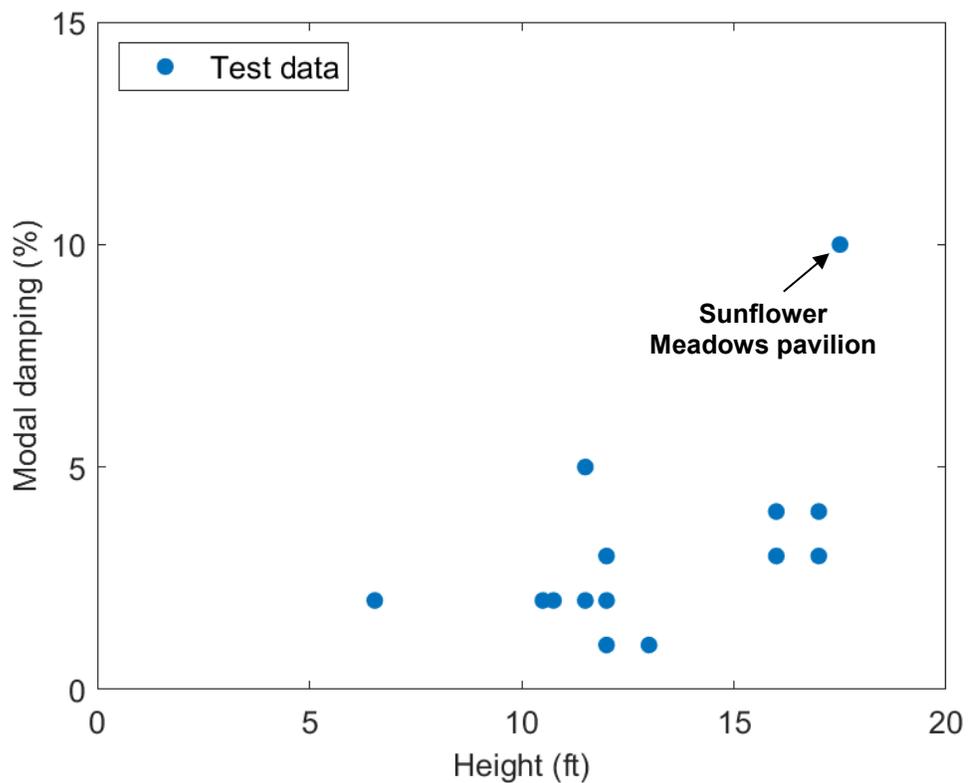
Fig. 5.50. Modal damping versus mean roof height.

In Fig. 5.50, the measured estimate of modal damping is plotted against the mean roof height (ft). Each dot in the plot is a test data point. The data points show an increasing trend (taller timber frames generally correlate with increased damping), but as was the case with the fundamental period of vibration, there is no clear mathematical relationship. The damping varied between 1% and 10%, with 2% being the mostly common value. Therefore, based on the data the damping in a bare-frame model of a free-standing timber frame with knee braces can be taken as 2% for low-amplitude excitation, unless there is significant cladding or other building components that would contribute additional damping.

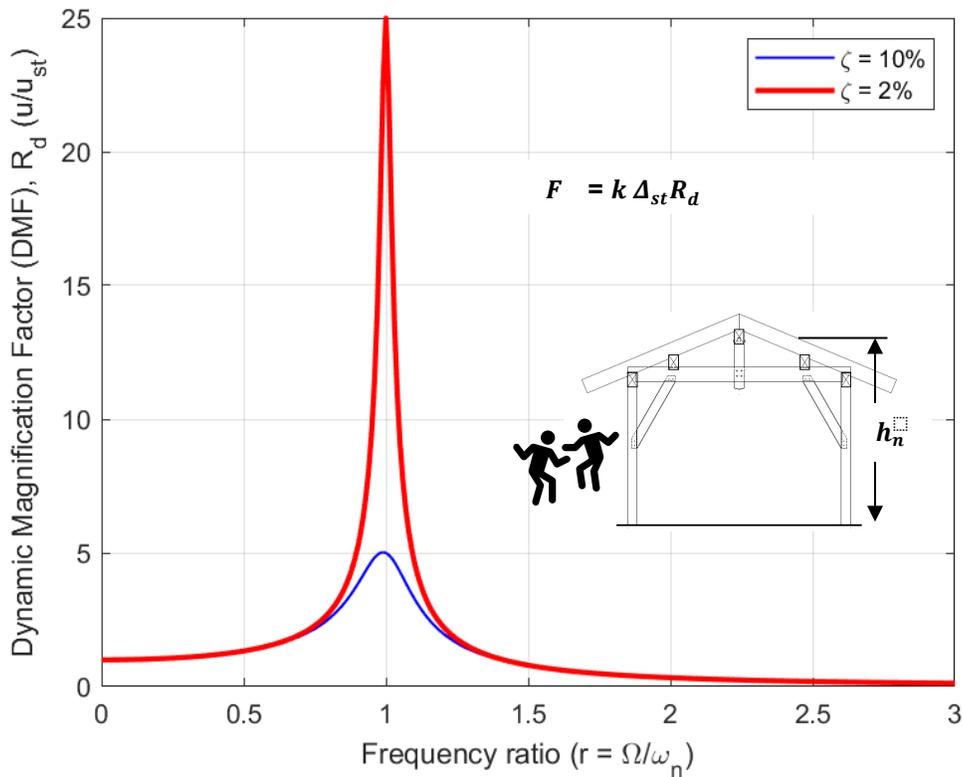
Fig. 5.51. Dynamic magnification factor for a SDOF system versus frequency ratio.

To understand the impact of damping on human induced excitation on free-standing timber frames, such excitation caused by climbing on the frame for maintenance, or excitation caused by vandalism (e.g. teenagers rocking the frame), in Fig. 5.51 the dynamic magnification factor (DMF) for displacement (R_d) for single-degree-of-freedom (SDOF) system is plotted versus the ratio of the forcing frequency (Ω) to the system's fundamental frequency (ω_n). The response is shown for two levels of damping, 2% and 10%. The plot shows that the equivalent elastic force (F) would be 5 to 25 times the static elastic force ($k \Delta_{st}$). If the static force is taken as the "crowd" force of 50 lb/ft defined in ASCE 7 Section 4.5.1.1, the corresponding design force would be 250 lb/ft to 1250 lb/ft. The mean curve fit for the period of vibration, determined previously, could be used in computing the frequency ratio for this purpose.

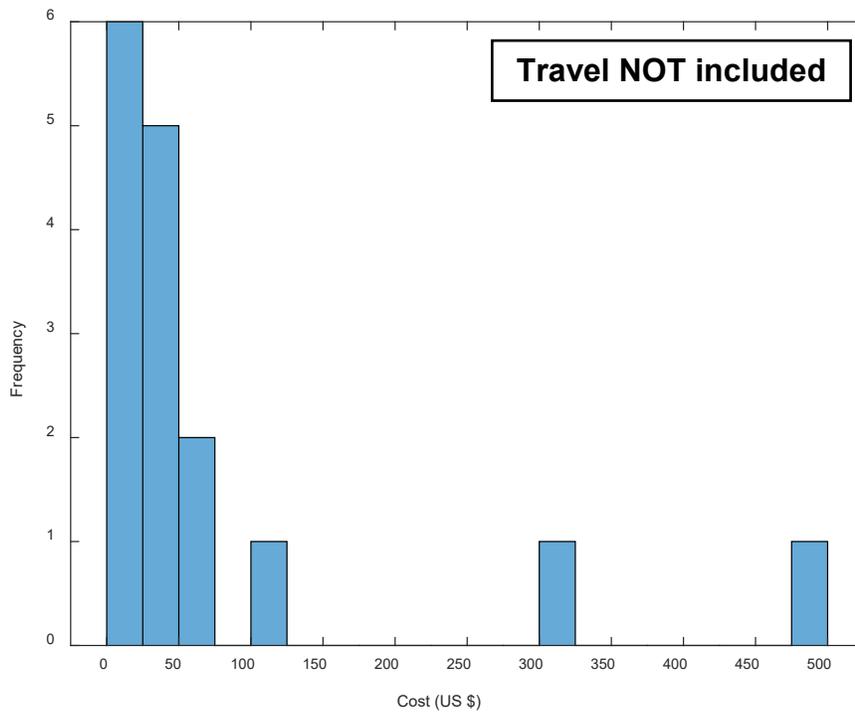
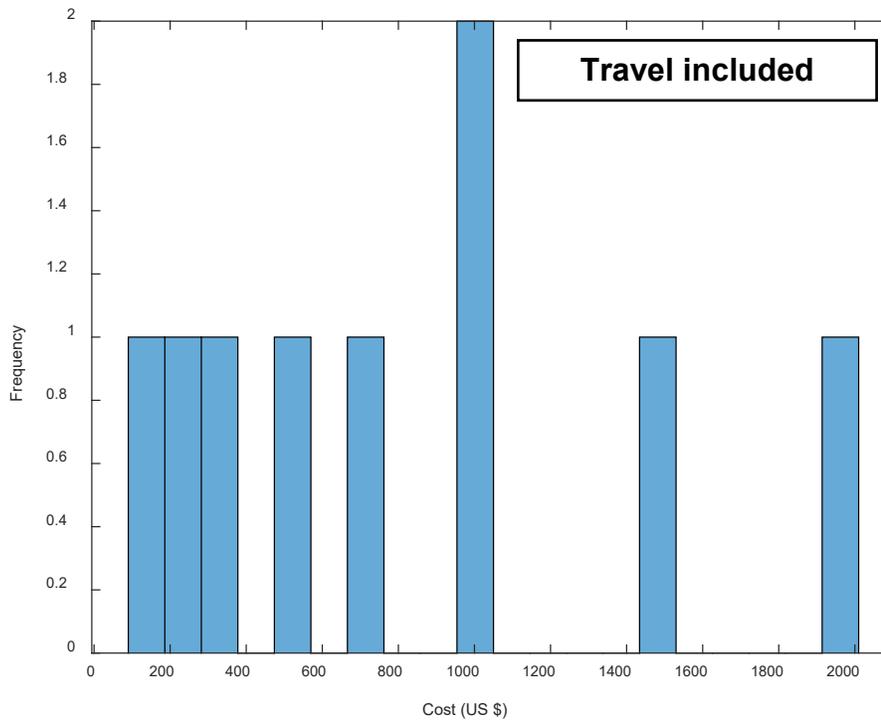
Fig. 6.2. Peg replacement cost.

Histograms of the survey data are shown in Fig. 6.2 through Fig. 6.7 to better understand the distribution of estimated repair costs and time for pegs (Fig. 6.2 and Fig. 6.3), braces (Fig. 6.4 and Fig. 6.5), and frames (Fig. 6.6 and Fig. 6.7). Two histograms are shown in each figure, one with travel included in the estimate of cost and time, and one without.

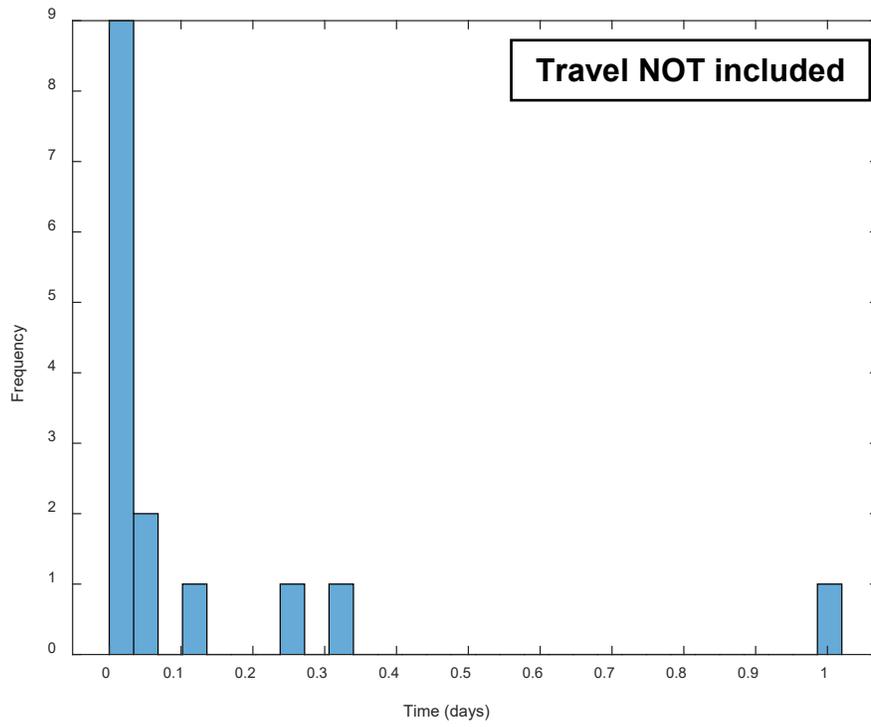
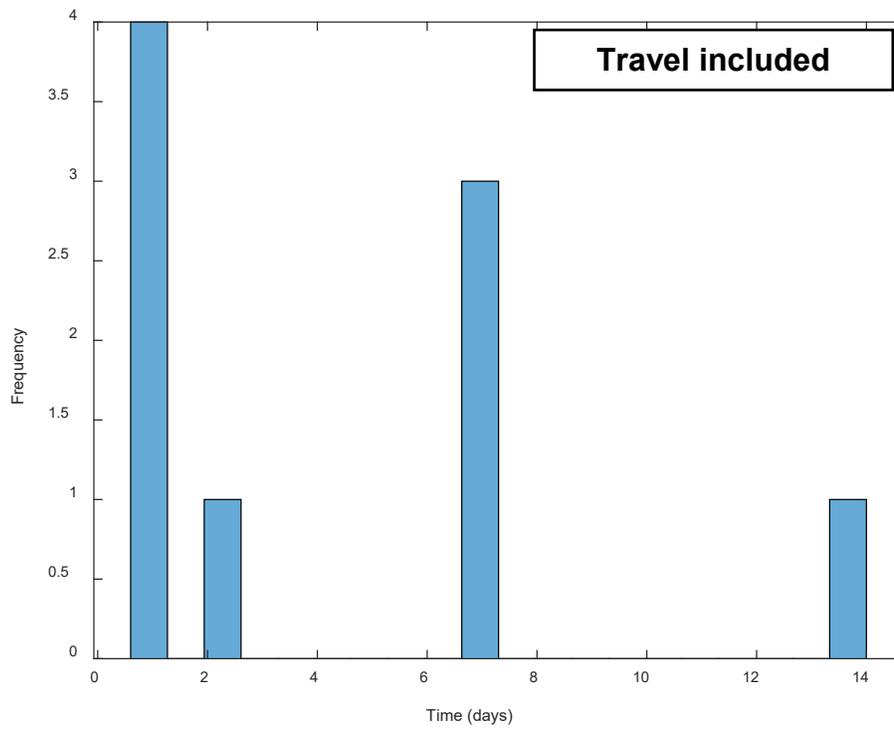
Fig. 6.3. Peg replacement time.

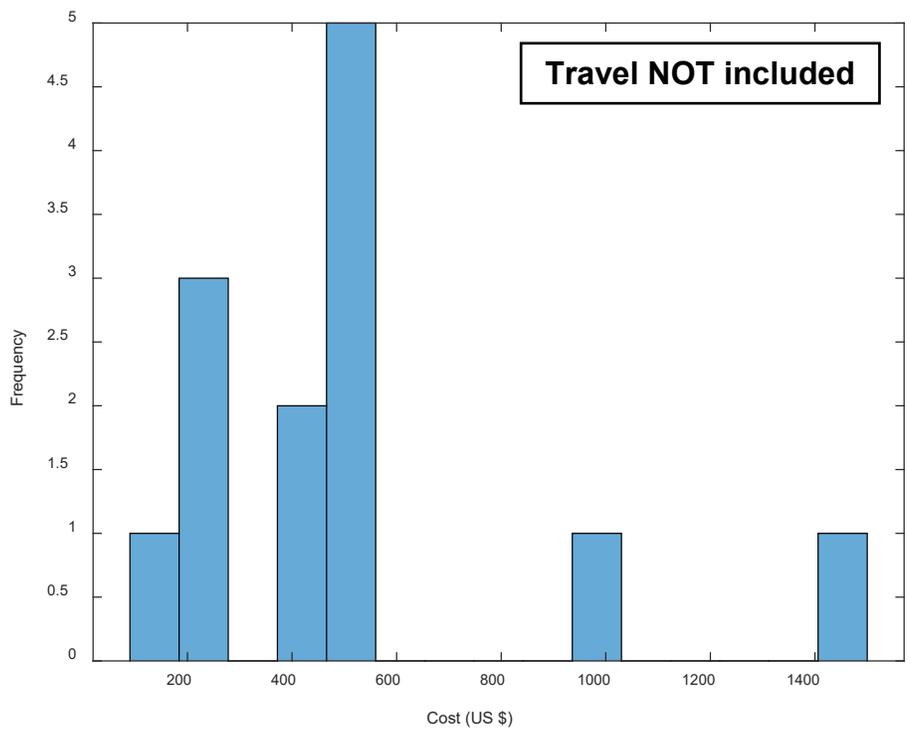
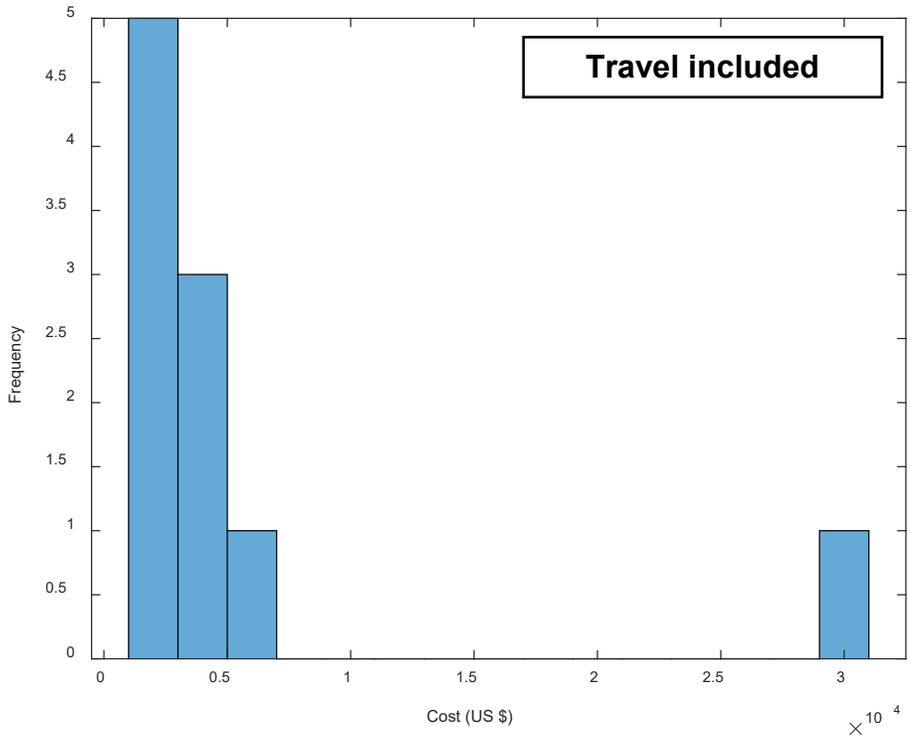
Fig. 6.4. Knee brace replacement cost.

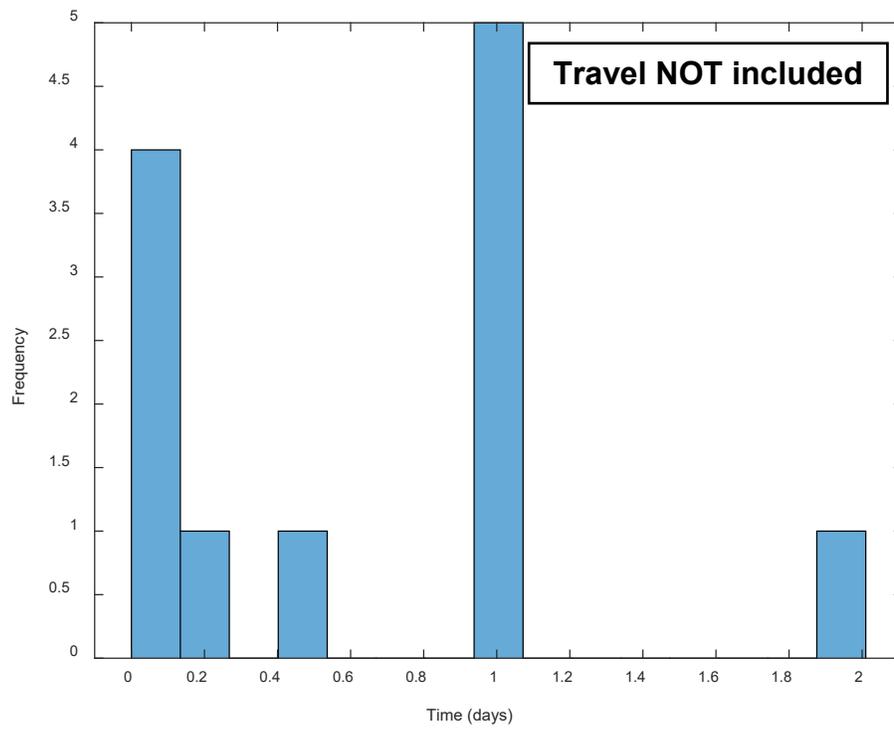
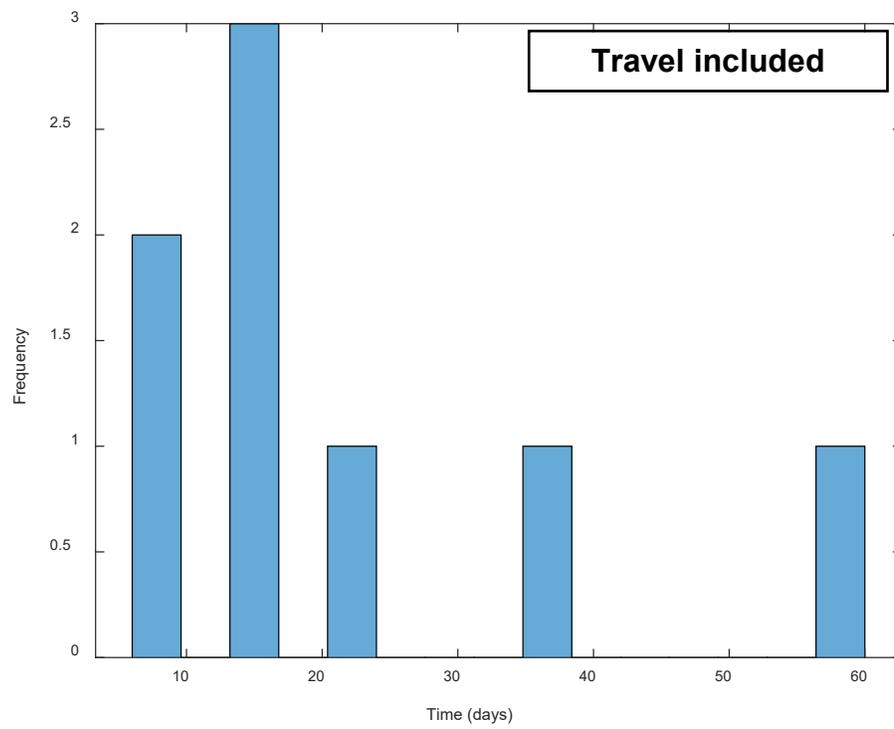
Fig. 6.5. Knee brace replacement time.

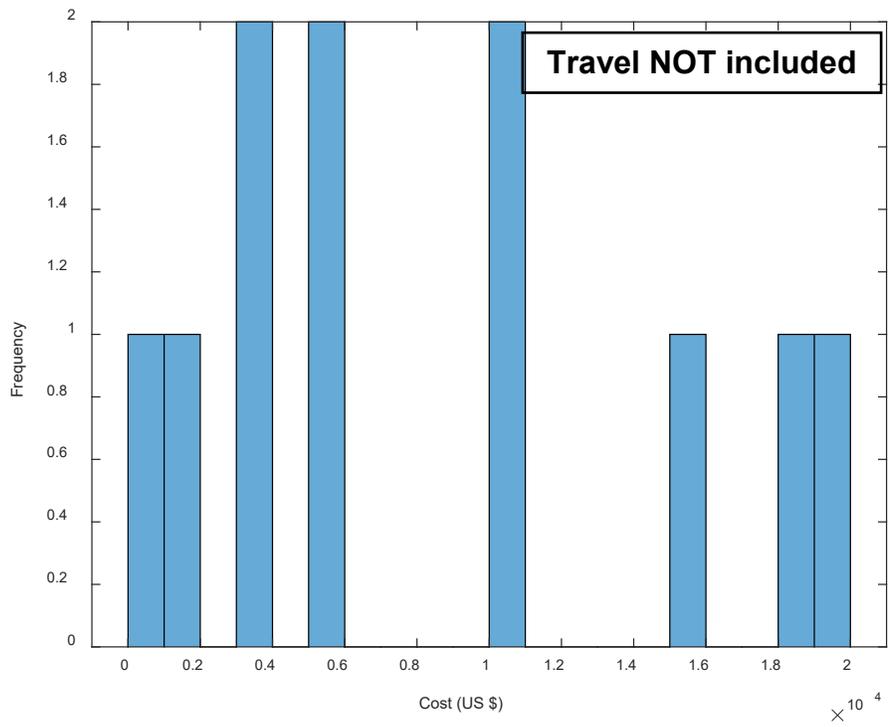
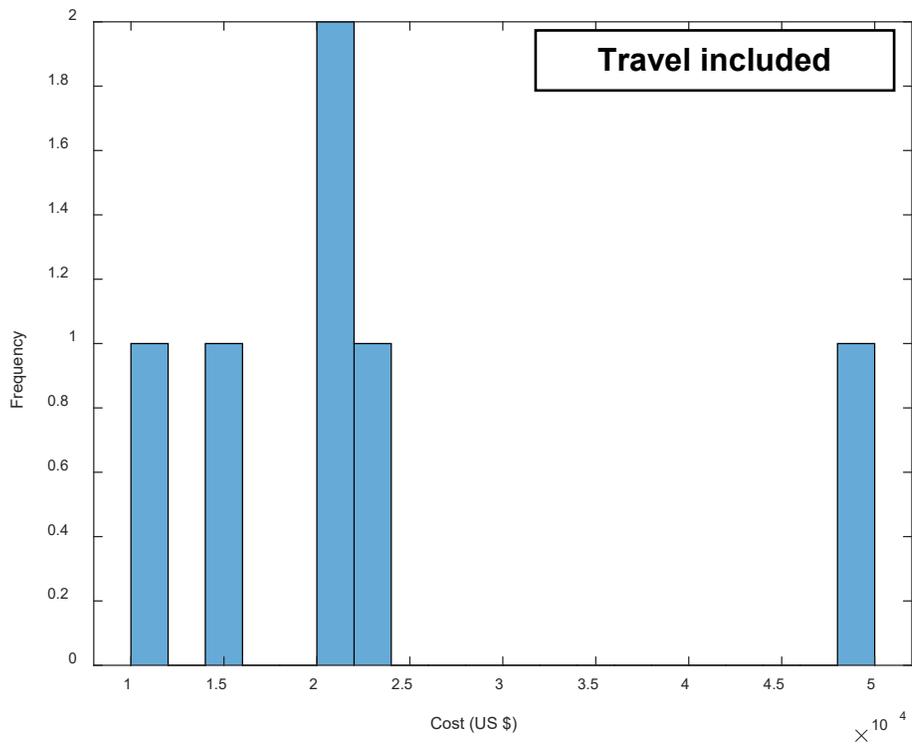
Fig. 6.6. Timber frame bay replacement cost.

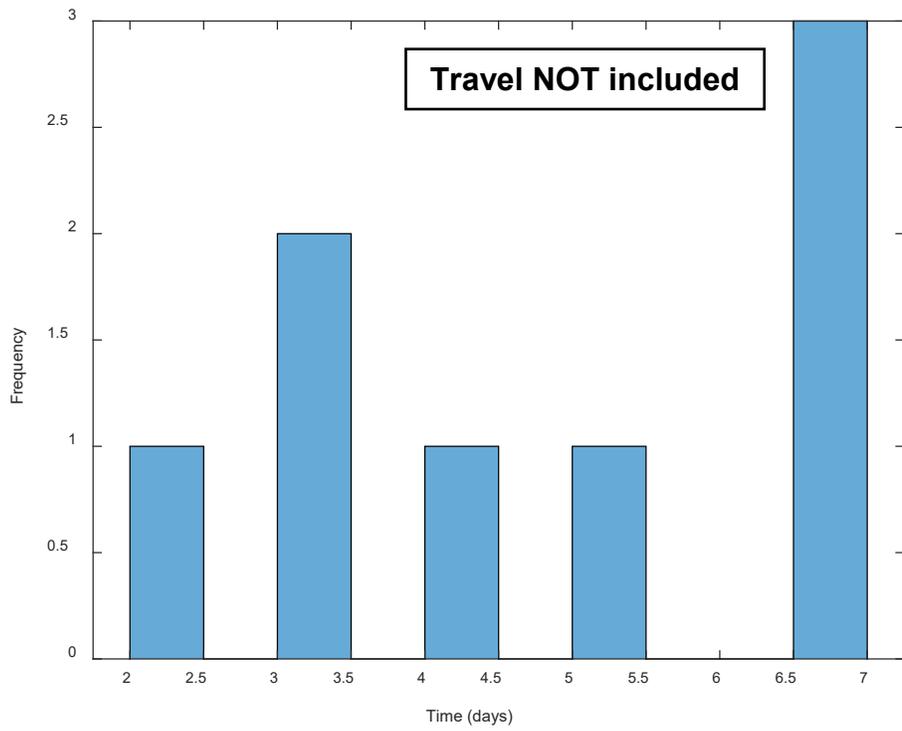
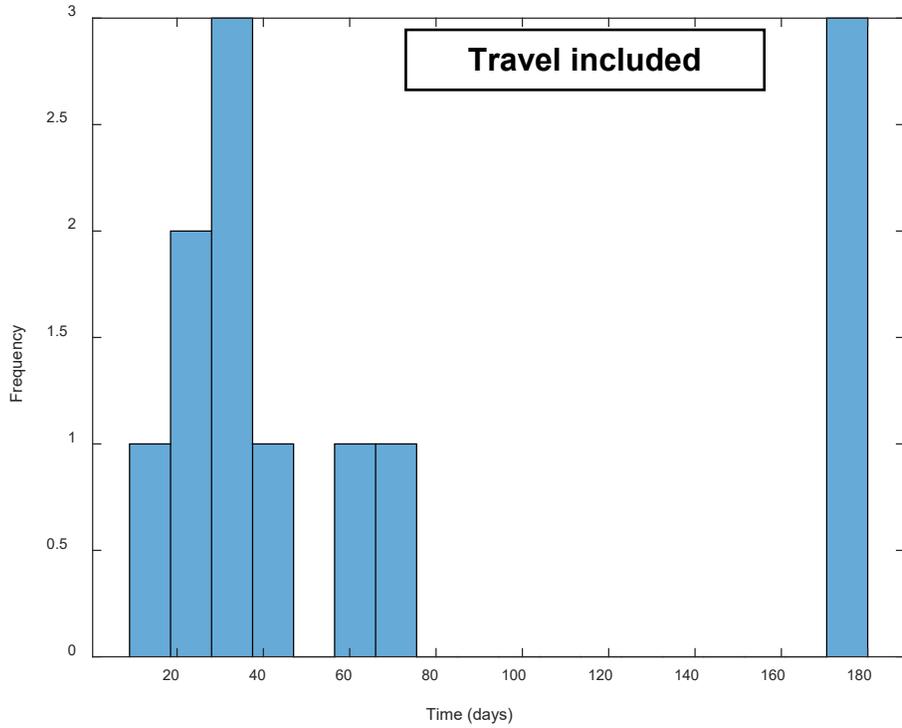
Fig. 6.7. Timber frame bay replacement time.

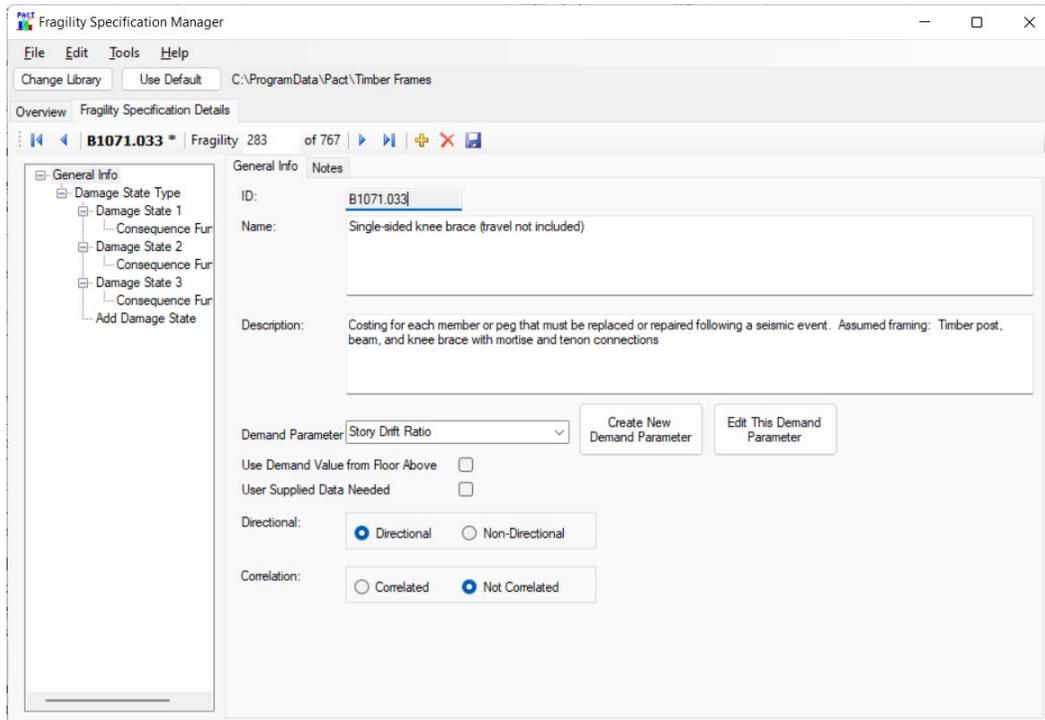
Fig. 6.8. Timber frame fragility B1071.033 general info.

Fig. 6.8 through Fig. 6.11, show what fragility B1707.033 looks like, with a particular focus on the peg shear damage state. The other fragilities are similar in appearance and creation. Fig. 6.8 shows the main screen of B1071.033. The name of the fragility and description are found here, along with the demand parameter that the fragility corresponds to, which in this case is story drift. The fragility is directional because lateral forces could come from multiple directions and the direction could impact the outcome.

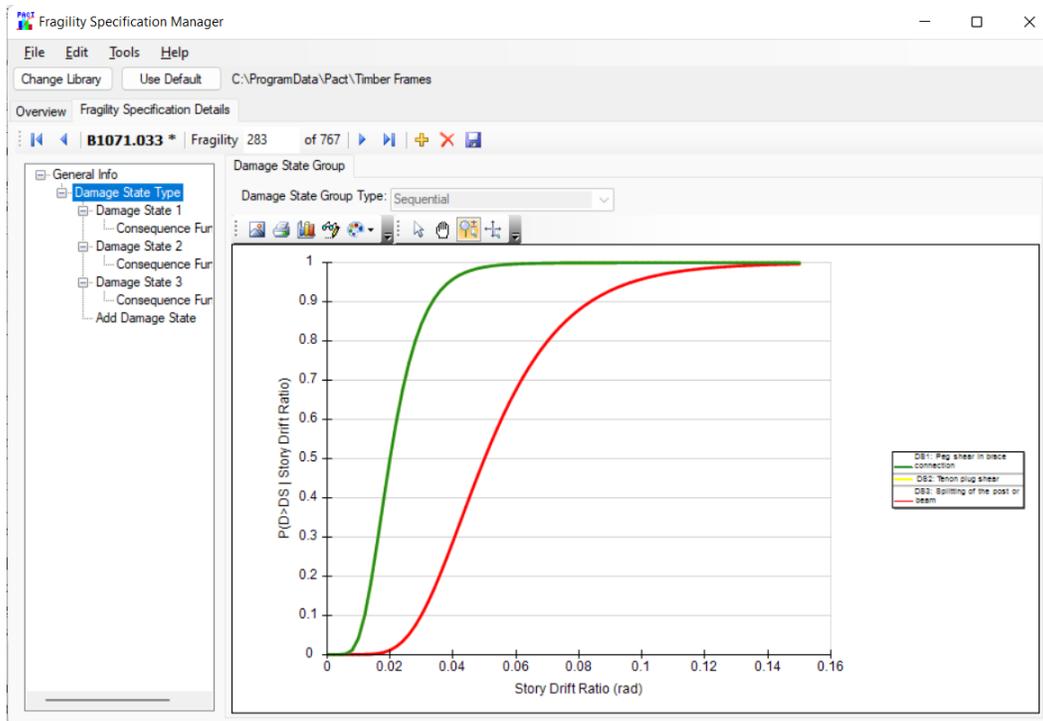
Fig. 6.9. Timber frame fragility B1071.033 Damage State group.

Fig. 6.9 shows the Damage State Type screen. This fragility is sequential because some of the damage states occur at lower drift ratios than others, as shown by the graph. Peg shear and tenon plug shear both occur at an average ratio of 0.02 radians, while posts and beams tend to crack around a drift ratio of 0.05 radians.

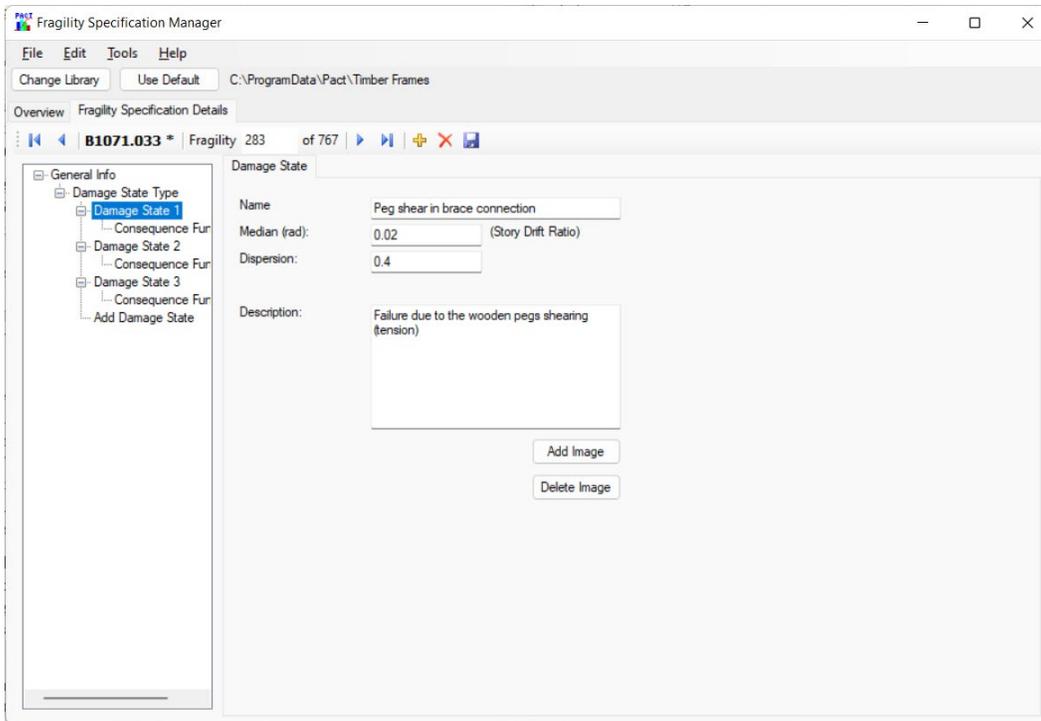
Fig. 6.10. Timber frame fragility B1071.033 Damage State 1 (peg shear).

The screen shown by Fig. 6.10 gives an overview of the damage state as well as the drift ratio that failure occurs at. This value was taken from test data. There are four tabs under Consequence Functions. The first shows repair measures (Fig. 6.11), the second gives repair cost consequences (Fig. 6.12), the third gives repair time consequences (Fig. 6.13), and the fourth gives environmental and other consequences not covered in the second and third tabs (Fig. 6.14). Due to the relative simplicity of a free-standing timber frame, unsafe placard consequences and non-collapse casualties were not included in the fragility analysis. When a dispersion for a value was not known during the fragility creation process, a dispersion of 0.4 was assumed.

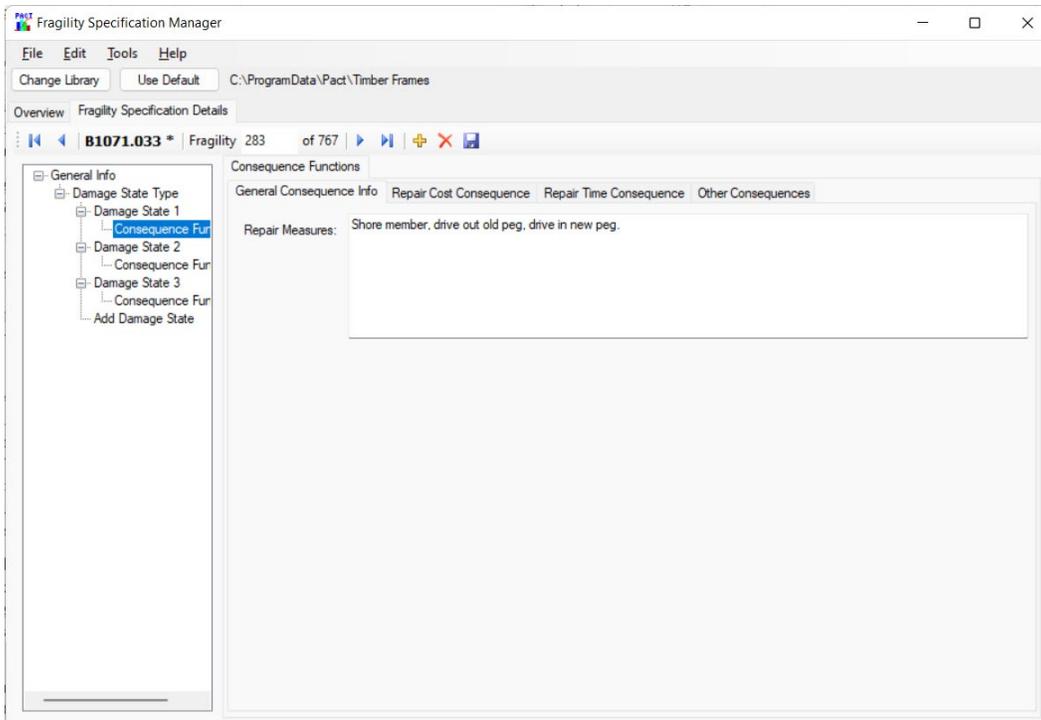
Fig. 6.11. Timber frame fragility B1071.033 Damage State 1: consequence information.

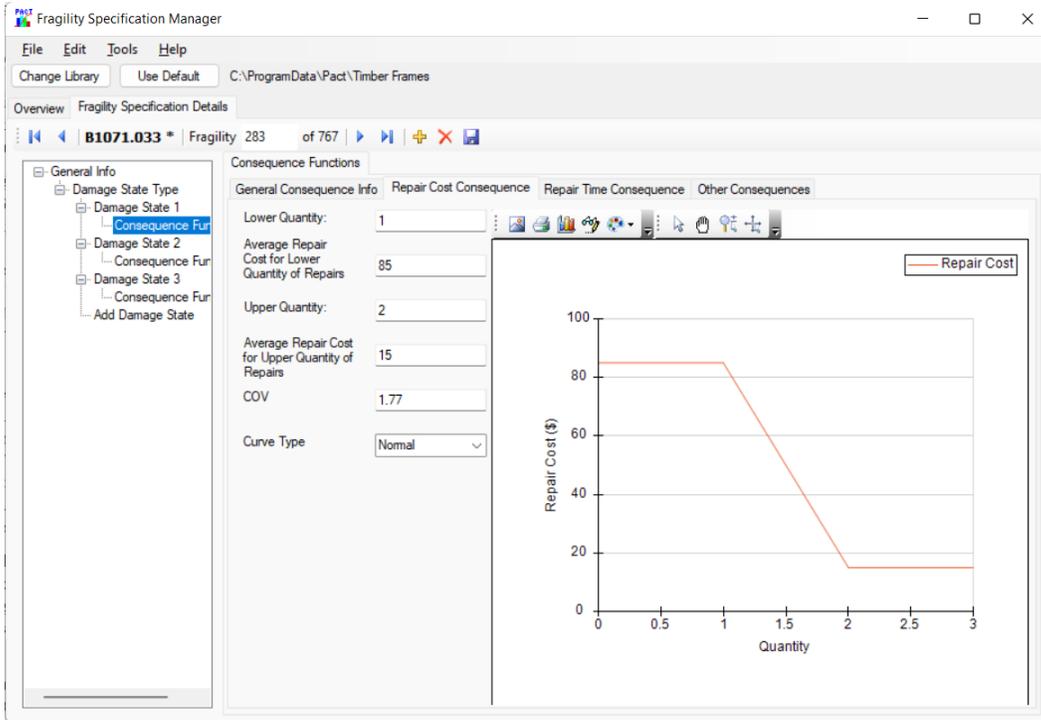
Fig. 6.12. Timber frame fragility B1071.033 Damage State 1: repair cost consequences.

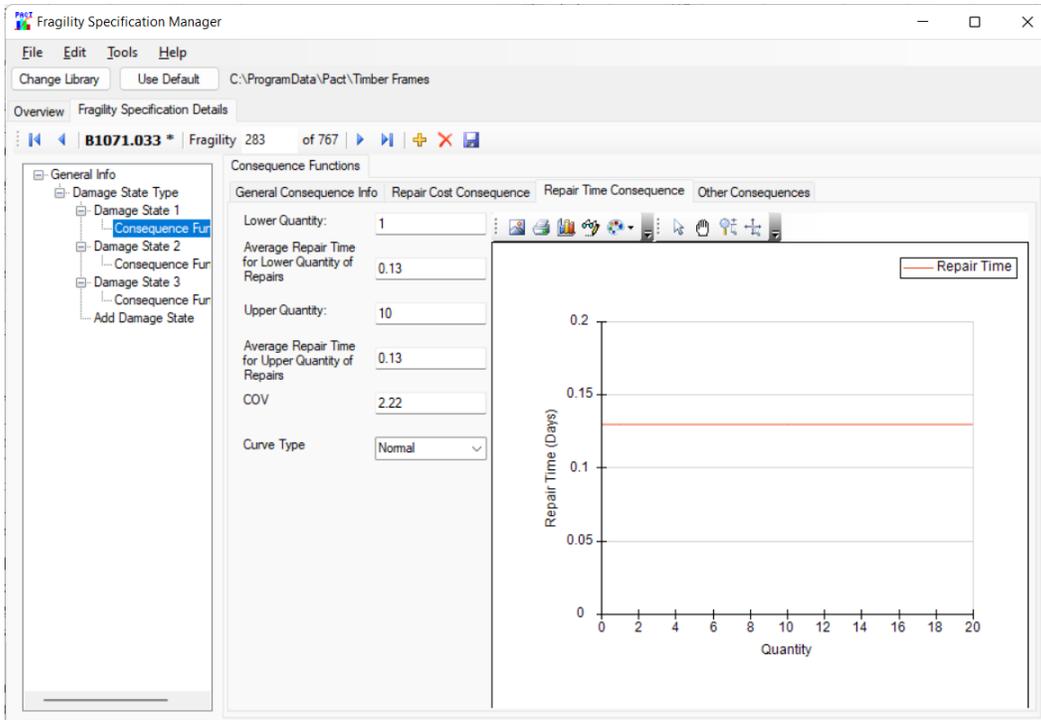
Fig. 6.13. Timber frame fragility B1071.033 Damage State 1: repair time consequences.

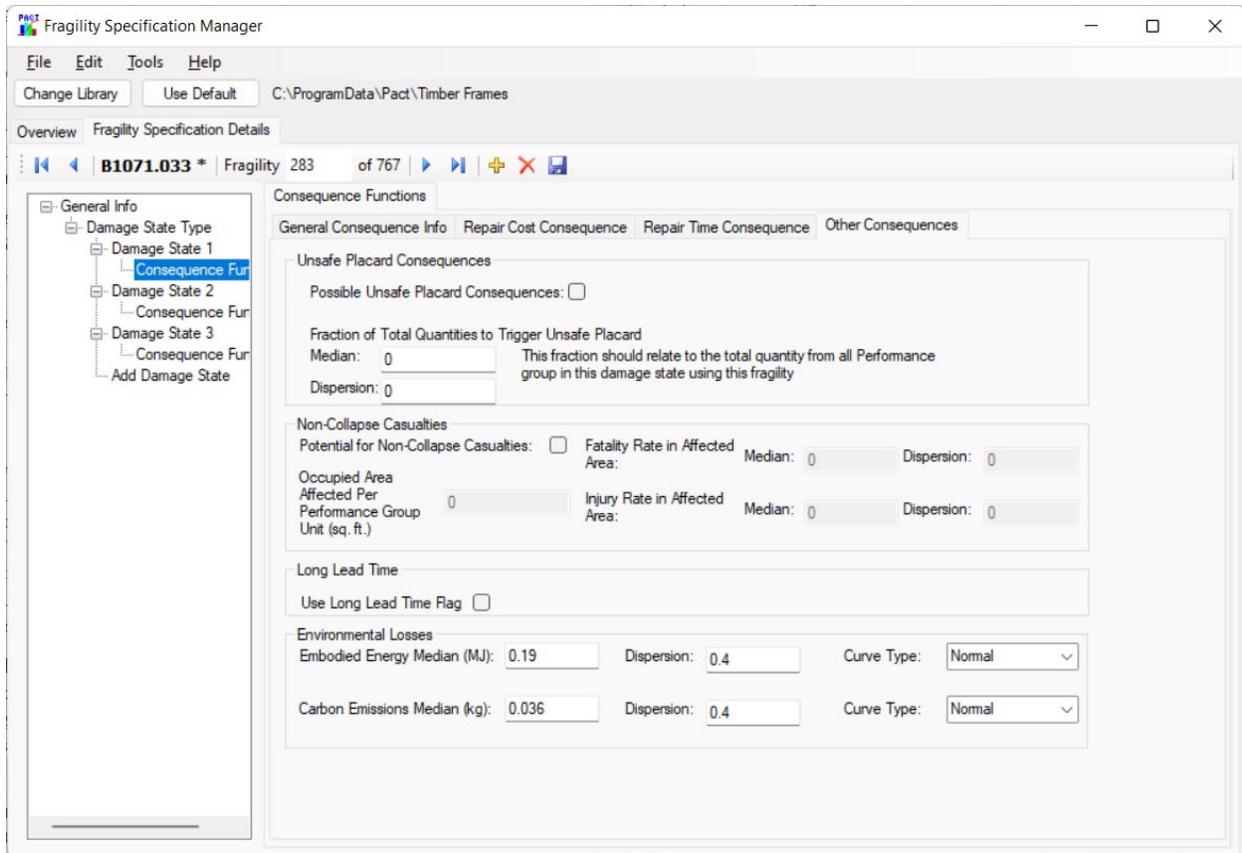
Fig. 6.14. Timber frame fragility B1071.033 Damage State 1: other consequences.
