# TIMBER FRAMING

JOURNAL OF THE TIMBER FRAMERS GUILD

Number 123, March 2017

## The St. Andrew's Cross

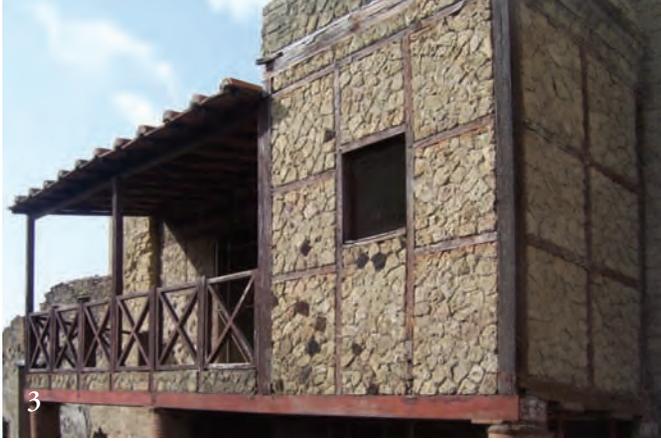
3 House of the *Opus Craticium*, Herculaneum, Italy, 1st century, restored in the 1920s. X-bracing in railing only.

The Roman construction technique *Opus craticium* (Figs. 3, 4), described by the architect Marcus Vitruvius Pollio (b. 75 BCE) in

his multivolume work *De architectura*, likely included (we have no direct evidence) X-bracing in its half-timber wall technique of wattle and daub or masonry infill between members, and anticipates *himiş* construction in Turkey, *Fachwerk* in Germany, *colombage* or *pan de bois* in France, *entramadi de madera* in Spain and *Pombalino gaiola* in Portugal. The X-bracing would have been used primarily in wall sections to prevent racking, and in later times specifically to resist the effects of earthquakes (Figs. 5, 6).

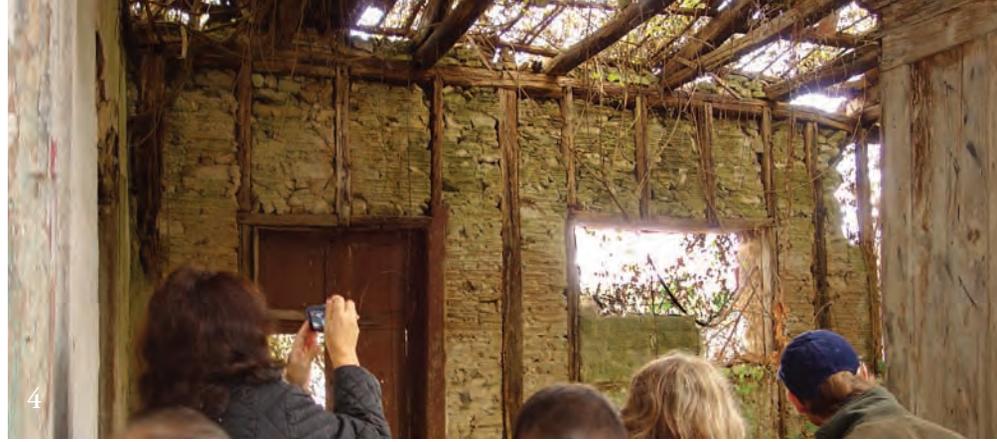
4 Roofless house with braceless infill frame, Mileto, Italy, 18th century.

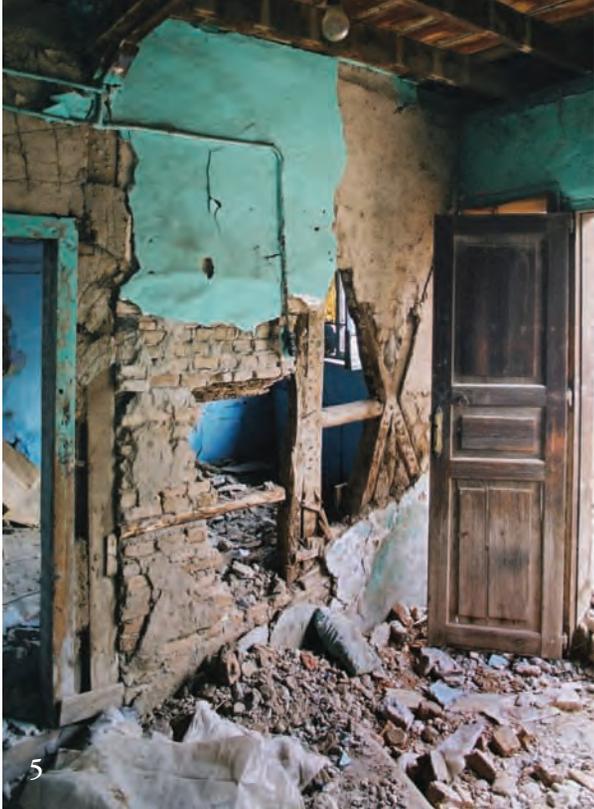
5 Interior wall of *himiş*-style house in Adapazari, Turkey, after 1999 earthquake.

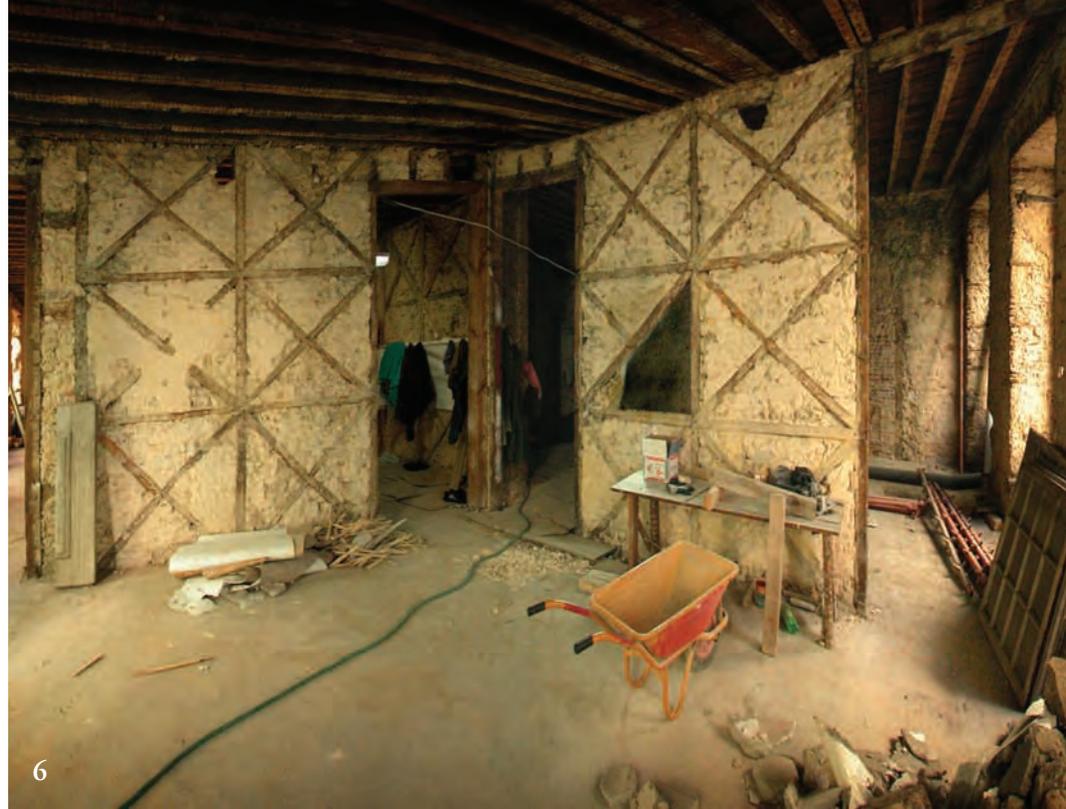
6 Interior of 18th-century building in Lisbon, Portugal, showing *Pombalino gaiola* braced construction technique used after earthquake of 1755.

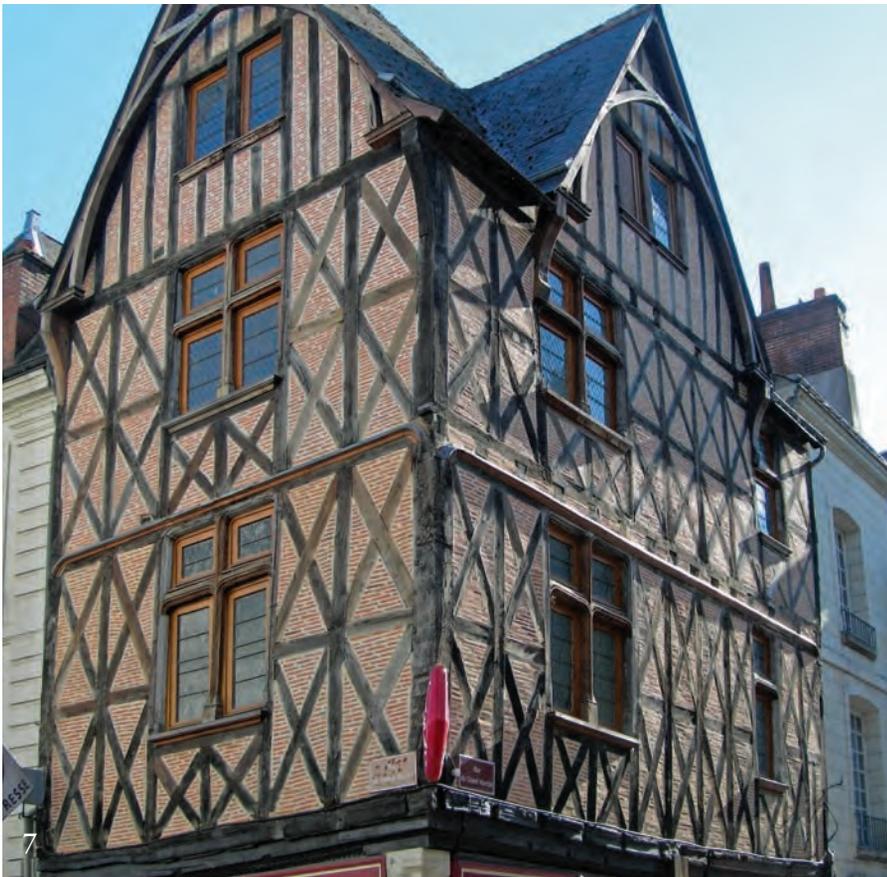
7 Des Quatre Fils Aymon, 15th-century house in Tours, France, with fully braced walls and carved corner post and casings.

Anglo-Saxons who learned about St. Andrew and the legend of his cross in Scotland might have designated the framing technique "St. Andrew's cross" and translated the name into Germany, Alsace, France and other parts of Europe. *La croix de Saint-André* as it is called is used in many parts of France but notably in Alsace, Normandy and Brittany, as well as at Troyes, Auxerre, and Tours (Fig. 7). Germany's *Andreaskreuz* is found in half-timbered work all around the country (Fig. 8).

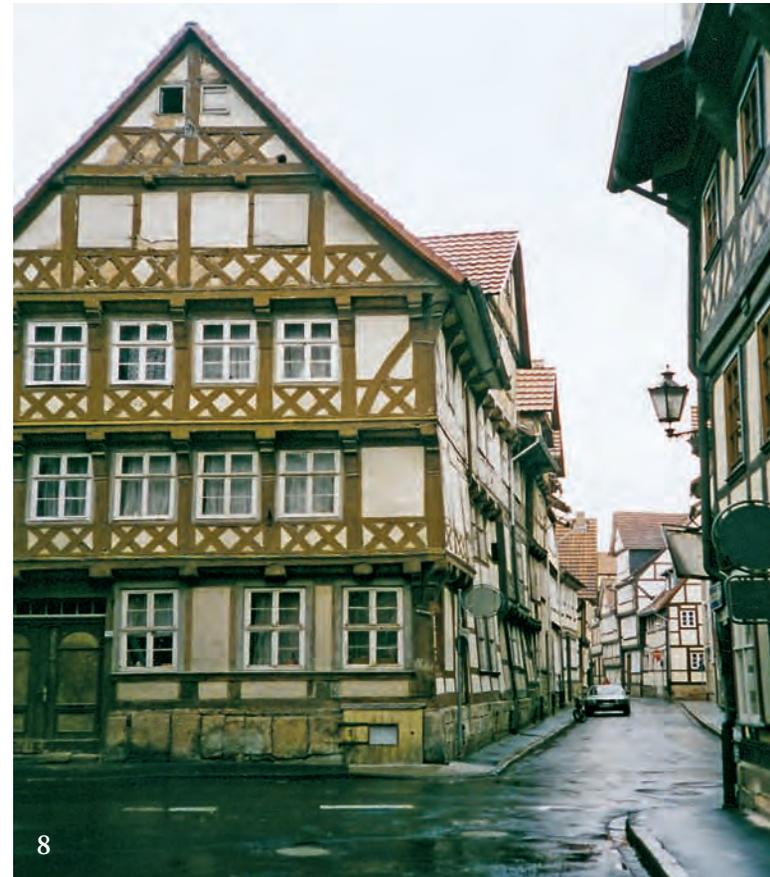
8 House in Rinteln, Lower Saxony, Germany, on the Weser river, in region rich in *Fachwerk* houses, with multiple *Andreaskreuze* beneath windows.

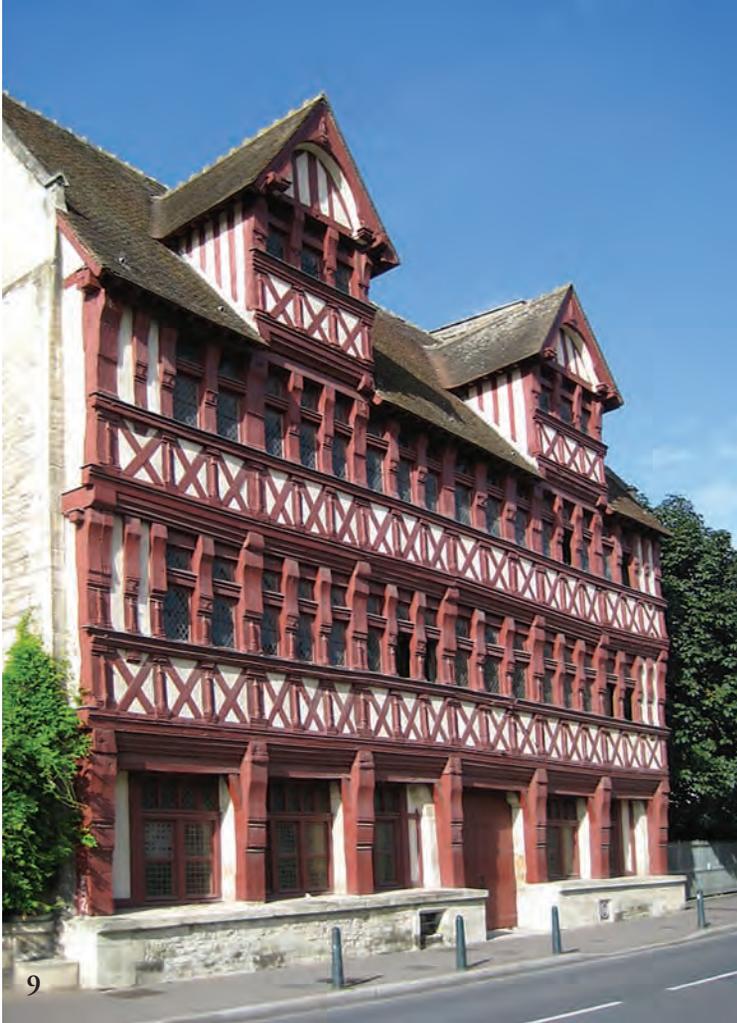
9 Karl Dupart, Wikimedia Commons

9 Maison des Quatrans, Caen, France, 1460. High-status *pans de bois* façade on masonry building. Note progressive overhangs.

The oldest known example of a Saint Andrew's cross in France is probably the façade of the Maison des Quatrans, 1460, in the old part of Caen, though the distinction is uncertain given France's abundance of half-timbered houses (Fig. 9). The oldest known example in England is found the central crossframes of the Barley barn at Cressing Temple, built some time in the 1220s (Fig. 10).

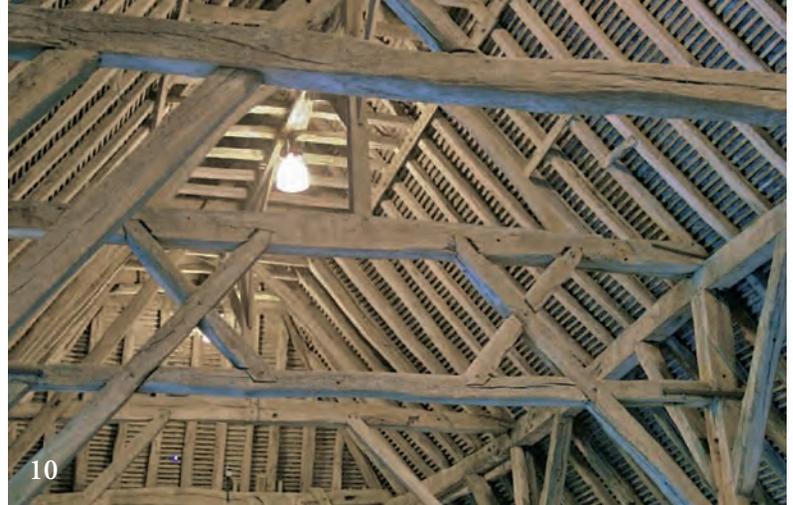
10 Barry Samuels

10 Detail, Barley barn, Cressing Temple, Essex, England, ca. 1220.

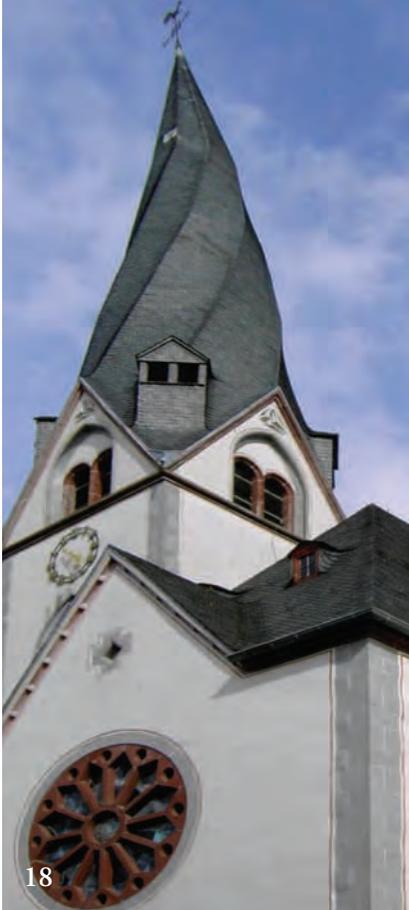
18 Church of St. Clement, Mayen, Germany, ca. 1350. Discontinuity and tilt near peak indicate structural failure.

Les Compagnons du Devoir associations in France hold dearly to the symbolic and structural applications of the St. Andrew's cross. Part of the intense training of an aspirant is to build models including variants of the cross, and it can be found in the masterpieces built by journeymen to be accepted as Compagnons, such as the French trestle (Fig. 16). One of the last studies undertaken by most aspiring carpenters on their Tour de France is the St. Andrew's cross in a conical or partly conical tower (Fig. 17), also found in masterpieces. The use of such bracing helps to prevent torsion and possible consequent failure, which is not unheard of (Fig. 18 overleaf).

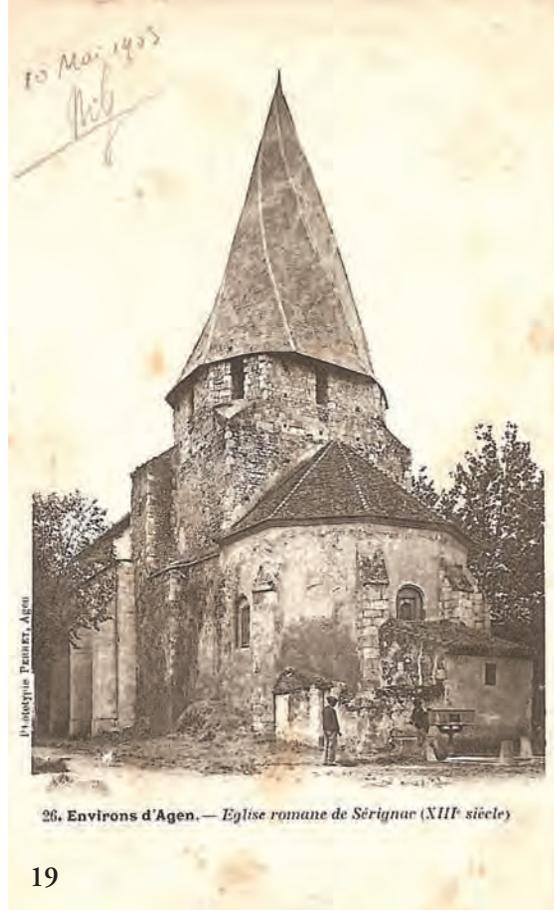
19

19–21 Église-Notre-Dame-de-l'Assomption, Sérignac-sur-Garonne, France, 13th century. Postcard dated 1903 shows no significant discontinuity in spire, built 16th century, restored 1816, removed 1922, rebuilt 1988 with frame of bolted glulams, including twisted St. Andrew's cross to stiffen spire.

A contemporary example of the St. Andrew's cross in a twisted steeple is found in the reconstruction of the church spire in Sérignac, Tarn-et-Garonne, France, rebuilt in 1988 using modern glue-laminated pieces (Figs. 19–21). Sérignac's Notre Dame de l'Assomption, built in the 13th century, had an original twisted steeple that had partially failed some time after 1903. In 1922 it was demolished as being a danger to the public. In 1988 a group of Compagnon carpenters gathered to rebuild the twisted spire with bolted glulams. Fig. 21 shows a twisted St. Andrew's cross

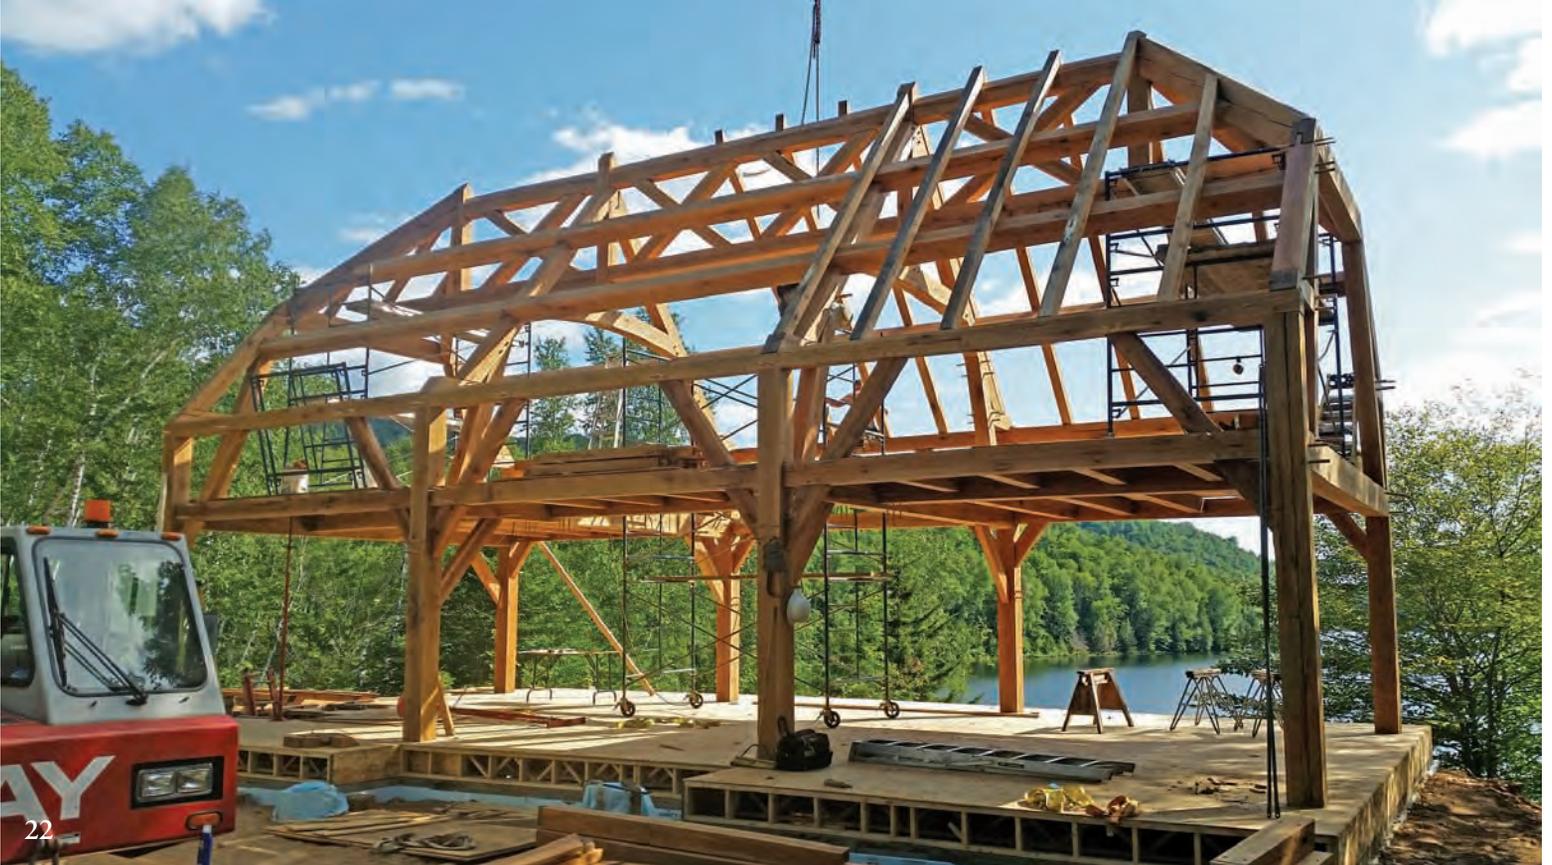
22 Domestic framing by Hamlet Heavy Timberworks, Rigaud, Québec, 2016.

the façades of half-timbered structures. If more widely known as X-bracing, the St. Andrew's cross lives on as well in modern framed structures (Figs. 22 and 24), scaffolding, commercial steel construction (Fig. 25) and electrical towers. —PATRICK MOORE  
*Patrick Moore (lamidutrait@gmail.com), a native of Canada, is a Compagnon carpenter and the founder of the School of Practical Stereotomy. He teaches stereotomy and l'art du trait (developed drawing) as applied to timber framing and carpentry. A longer version of this article is available from the author at [historicalcarpentry.com](http://historicalcarpentry.com).*

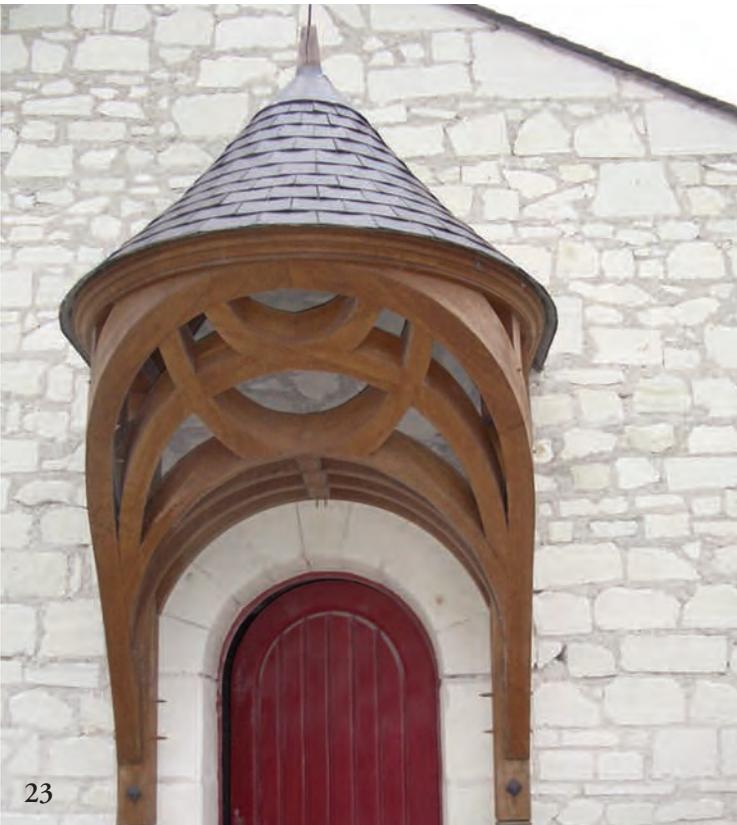
23 Contemporary *guitarde* over doorway, Le Veudre, Allier, France.

Today the cross can also be seen in the thousands of 19th-century *guitarde*s (see TF 121), console-like roof forms over dormers or doorways, spread throughout France (Fig. 23). In the case of a *guitarde*, the fancy X-shaped pieces (pincer links) are essentially similar to the curule seats that we have already seen on

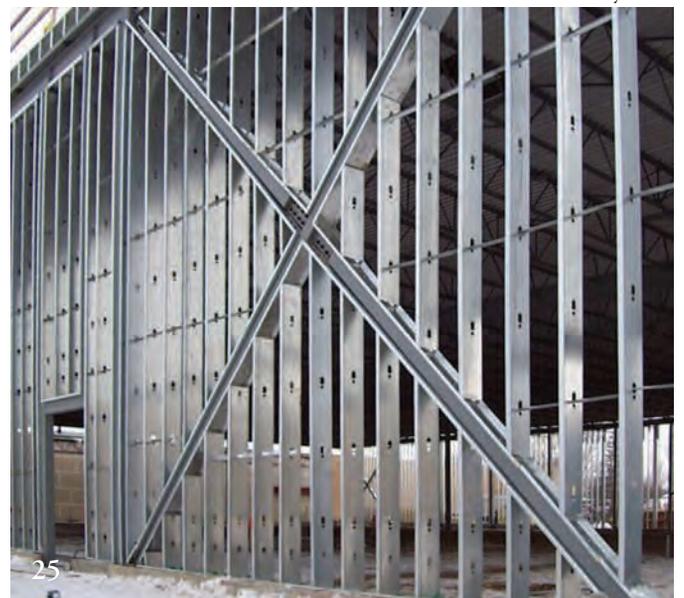
25 Full-height X-bracing, industrial structural steel framing in Canada.
